David Mindess School: White Oak Review

August, 23, 2021

The Bartlett Tree Experts
50 Bear Hill Rd
Waltham, MA 02451

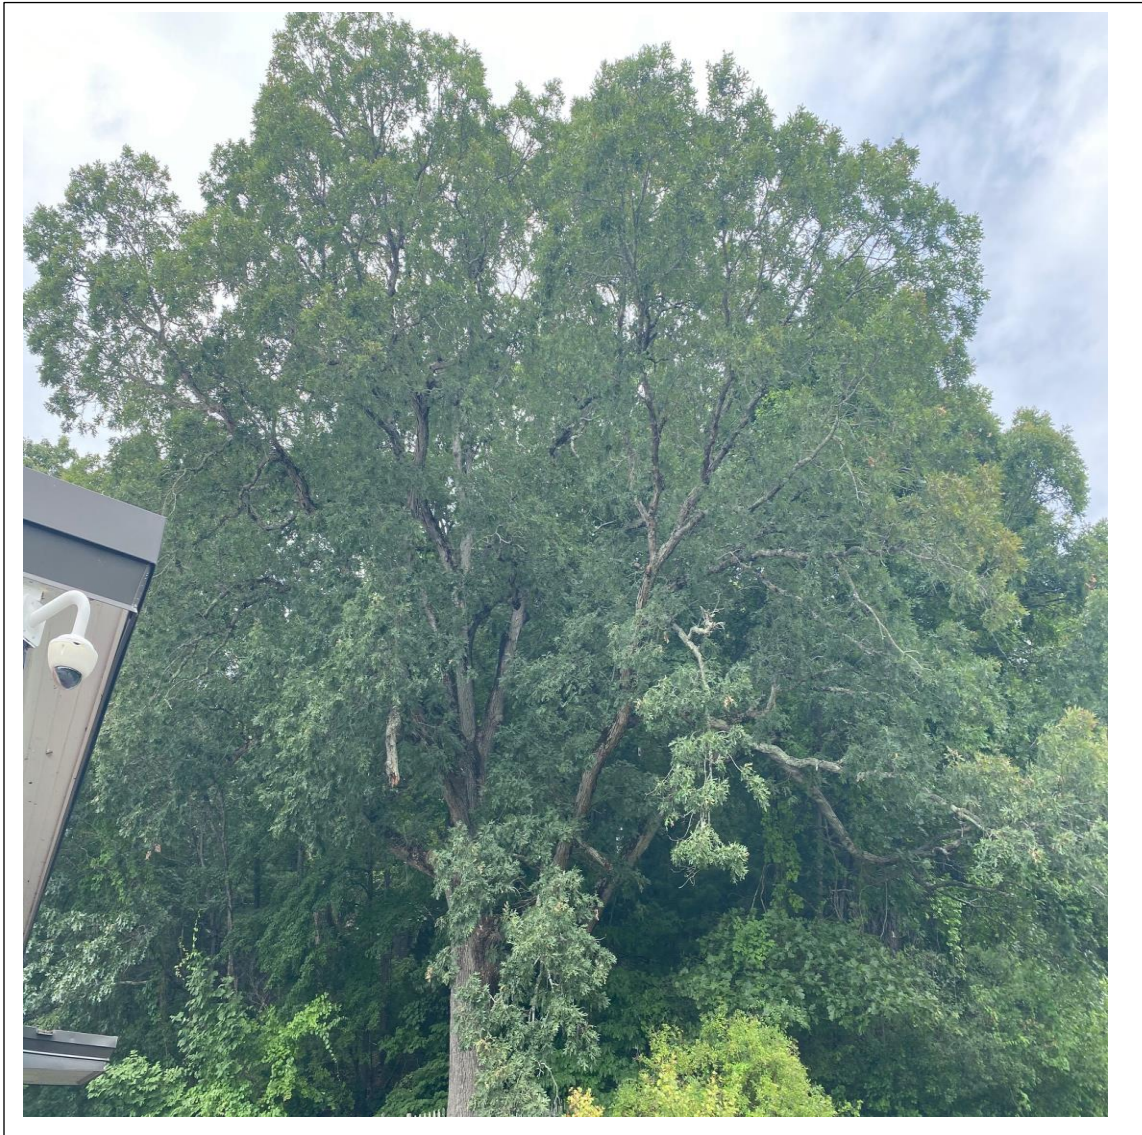
- Specific Notes
 - The tree had a dense canopy with appropriate leaf size and color.
 - Growth rates were typical of species characteristics and no decline was evident in the canopy.
 - The root-flare was exposed and appeared healthy with no visible signs of decay.
 - Minor defects including dead branches (between 2''-8'' in diameter) were located throughout the canopy.
 - Response growth was visible on previous branch wounds throughout the canopy.
 - There were no signs and or symptoms of pest/disease.
 - The root zone had been previously reduced per the construction of a cement retaining wall. Root zone infringement was +/-50% of surface root area.
 - The tree was assigned an age class of "Mature" defined as : "The tree was within its full growth potential."

40" White oak in "Good" Condition

- With consideration to the existing conditions and proposed construction, the tree is not suitable for preservation.
- If the tree were to be preserved, a Tree Protection Zone of 33' would be required.

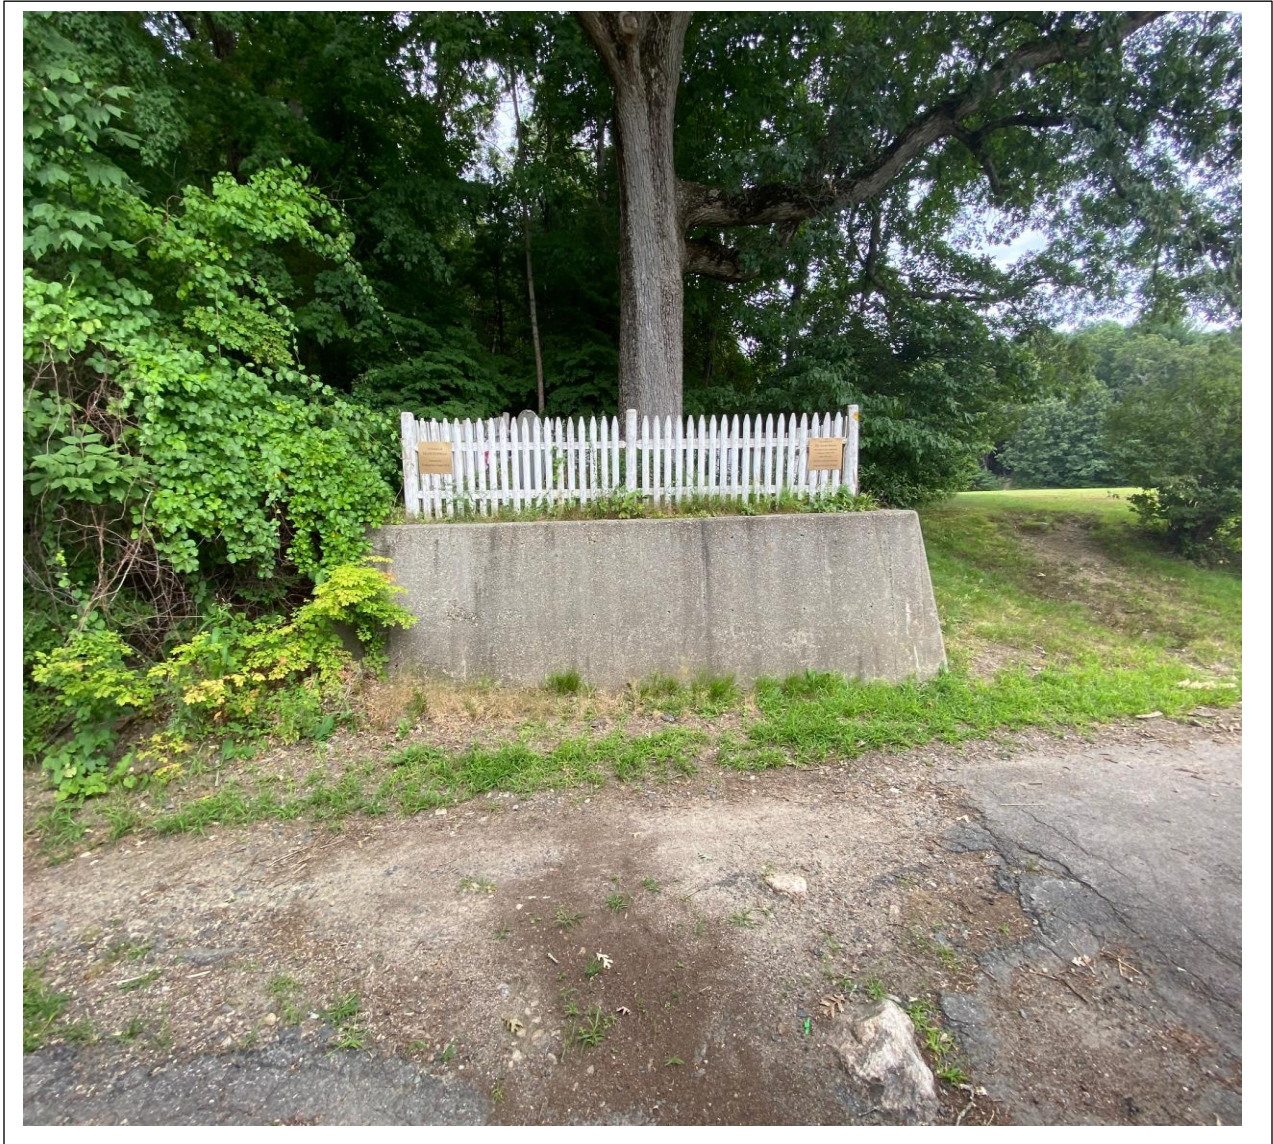
Cement retaining wall at +-10' from the center of tree

- With consideration to the previous constructed retaining wall, the existing trees root system has been greatly reduced by +-50%. The proposed construction would eliminate the existing viable root zone on the north side of the tree and would lead to both short term and long term decline.

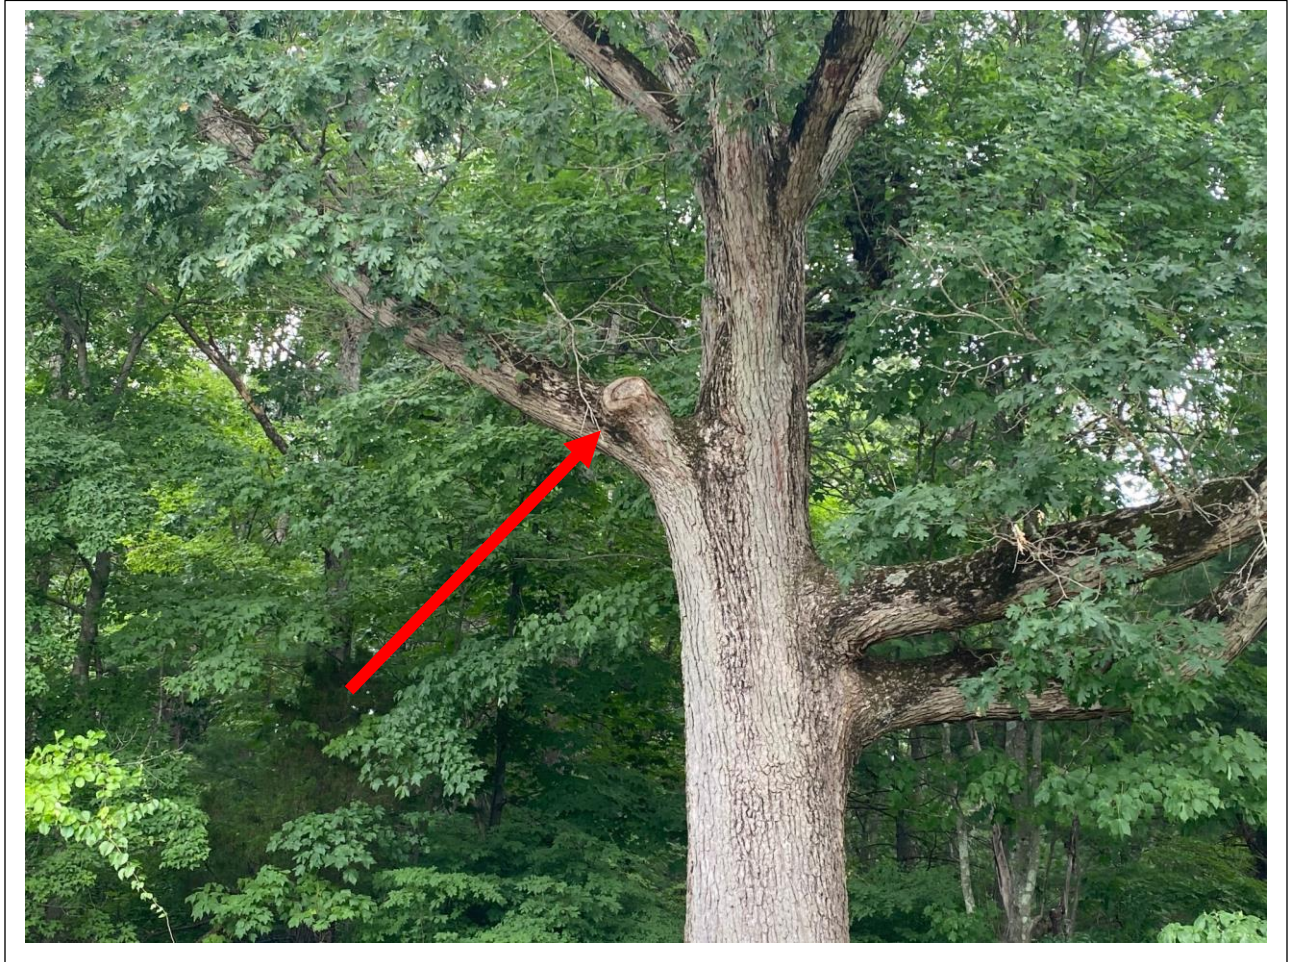
Response growth per previous pruning cut

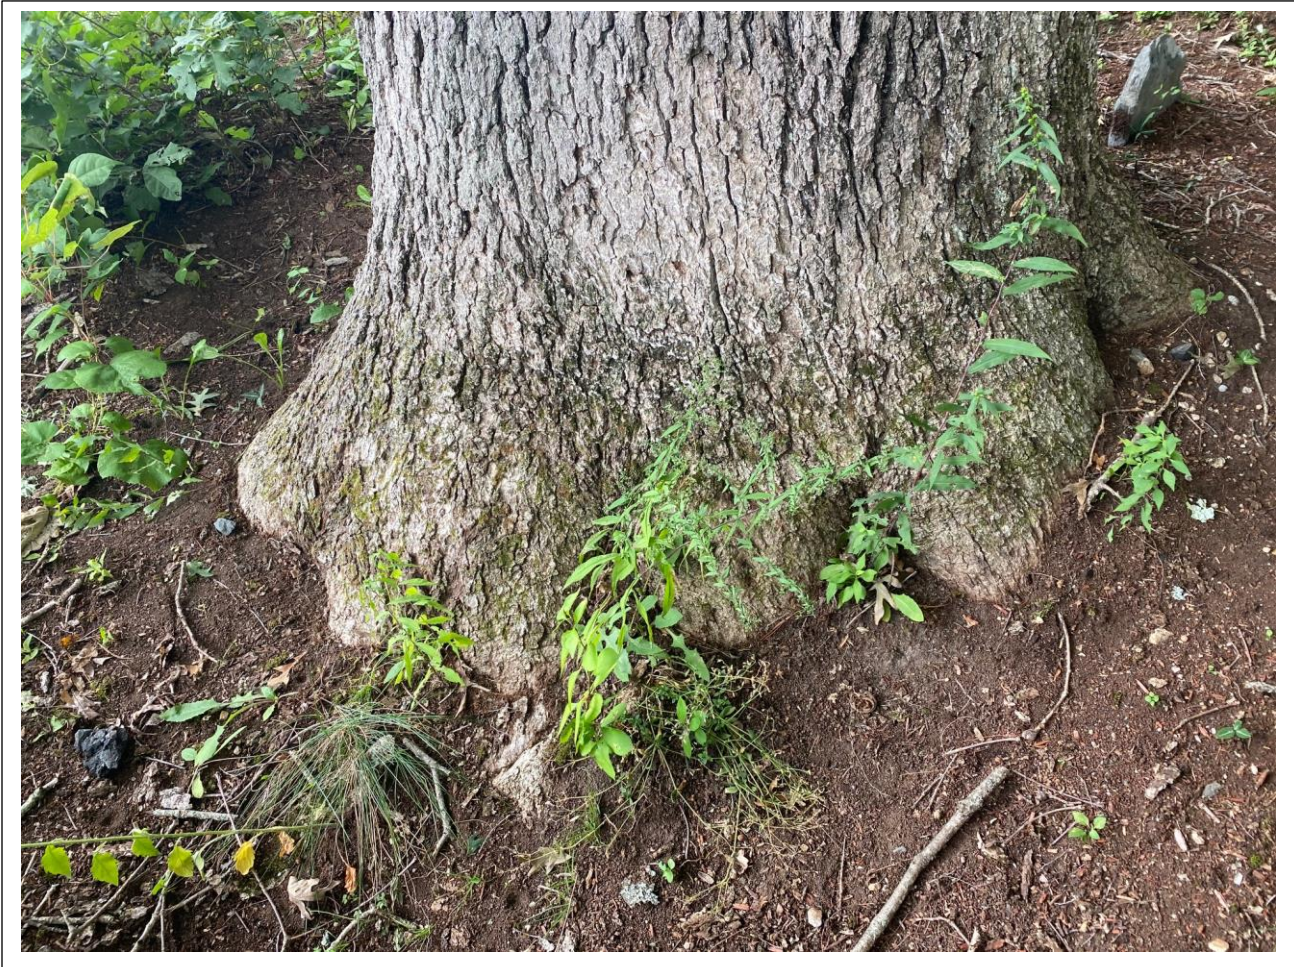
Healthy Exposed Root Flare
