**REMOVAL PROGRAM
AFTER ACTION REPORT
FOR THE
COLONIAL LACQUER & CHEMICAL CO. SITE
ASHLAND, MIDDLESEX COUNTY, MASSACHUSETTS
28 SEPTEMBER 2015 THROUGH 8 DECEMBER 2015**

Weston Solutions, Inc.
Superfund Technical Assessment and Response Team IV (START)
101 Billerica Avenue, Building 5, Suite 103
North Billerica, Massachusetts 01862

March 2016

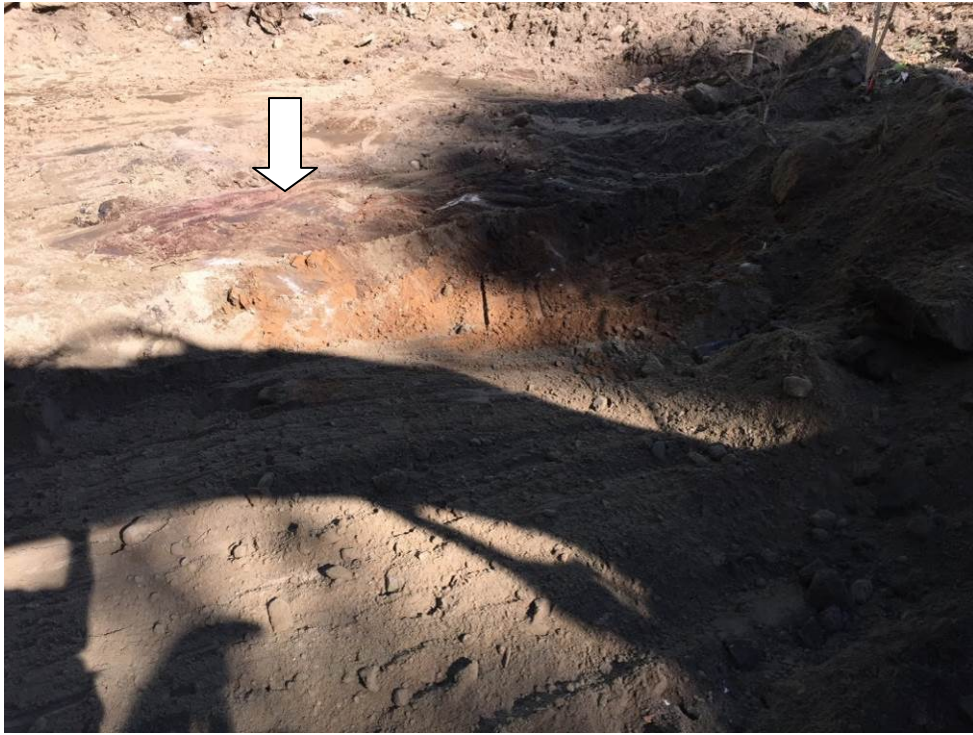
Sample Location No.	Scribe Sample No.	Date	Time	Corresponding PA/SI or Removal Action Sample No.	Total PCBs (mg/Kg)			Sample Location/Description
					NERL ¹	ERRS ²	CLP ³	
RS01 ⁴	01LK-0001	10/7/2015	1020	N/A	0.11	---	---	Red-stained soil at base of 2-foot manufacturing building excavation near storage shed.
RS02	01LK-0002	10/9/2015	1145	SS-04/114/414	ND	---	---	In woods at base of excavation.
RS03	01LK-0003	10/9/2015	1210	SS--301	ND	---	---	South end of 3-foot manufacturing building excavation.
RS04	01LK-0004	10/9/2015	1212	SS-203	ND	---	---	North edge of 2-foot manufacturing building excavation.
RS05	01LK-0005	10/9/2015	1215	SS-302	0.76	---	---	West edge of 3-foot manufacturing building excavation.
RS06	01LK-0006	10/16/2015	0945	N/A	1.73	---	---	Northwest edge of 2-foot excavation north of manufacturing building, in front of trees, easternmost.
RS07	01LK-0007	10/16/2015	0950	N/A	0.93	---	---	Northwest edge of 2-foot excavation north of manufacturing building, in front of trees, center.

SCENE: View of sample RS01 and the red-stained soil in the 2-foot excavation south of the manufacturing building. Photograph taken facing north.

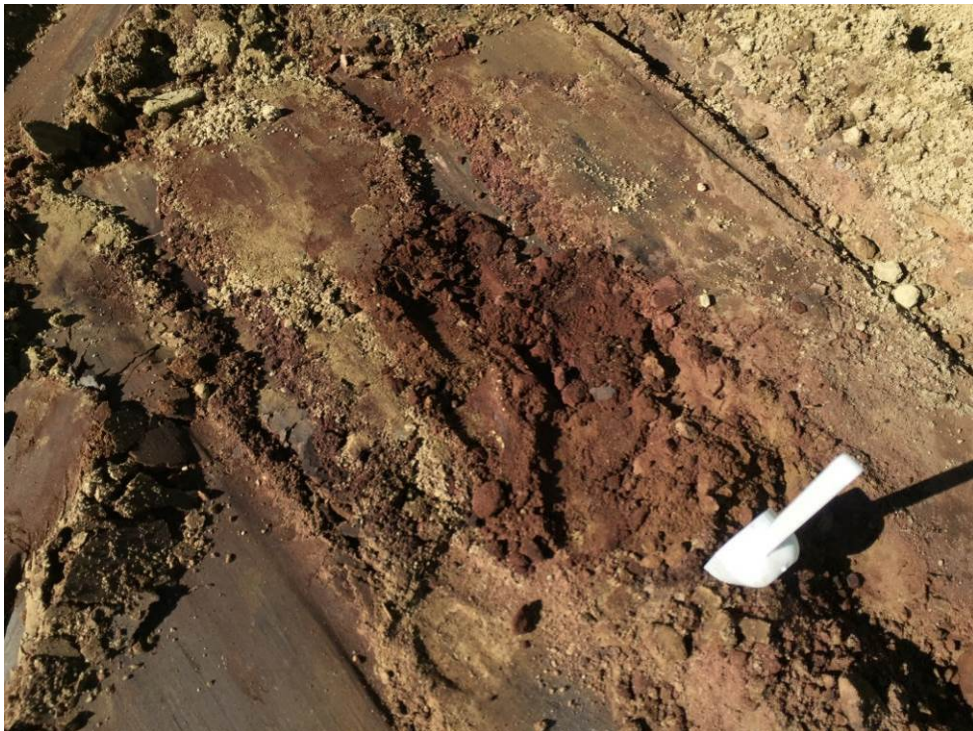
SCENE: View of sample RS01 and close-up of the red-stained soil in 2-foot excavation south of the manufacturing building.

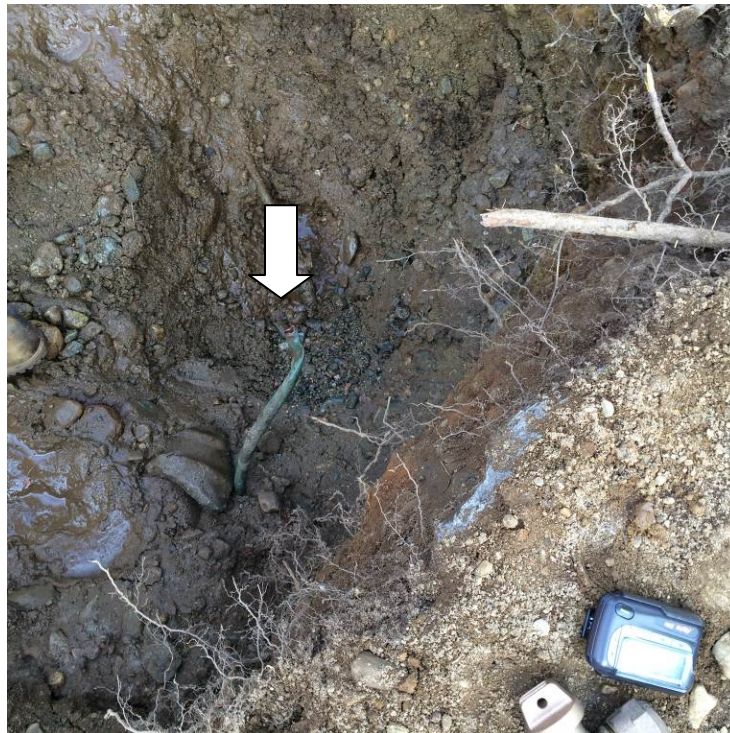
SCENE: View of the unmarked (not identified by DigSafe) water service line damaged during excavation.

A report was provided by NERL pertaining to a sample collected from the bottom of the excavation at the point where the water and sewer line repair took place. Test results indicated the total concentration of PCBs was less than 1 ppm. In conjunction with the Ashland Water Department, a new valve and riser were installed on the water line, and the excavated area was backfilled first with sand around the valve and pipe, then clean fill up to grade.

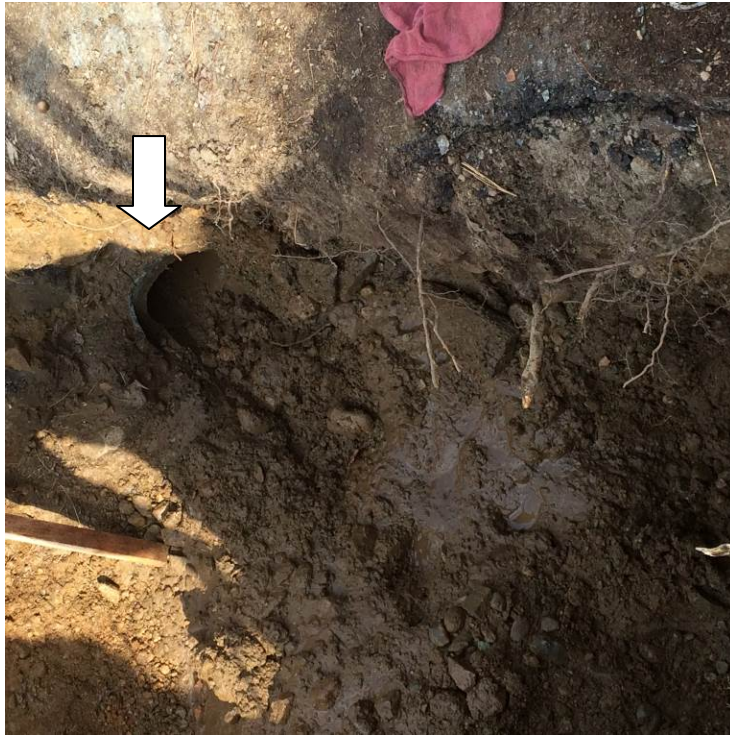
SCENE: View of unmarked (not identified by DigSafe) sewer line damaged in same water service line excavation.

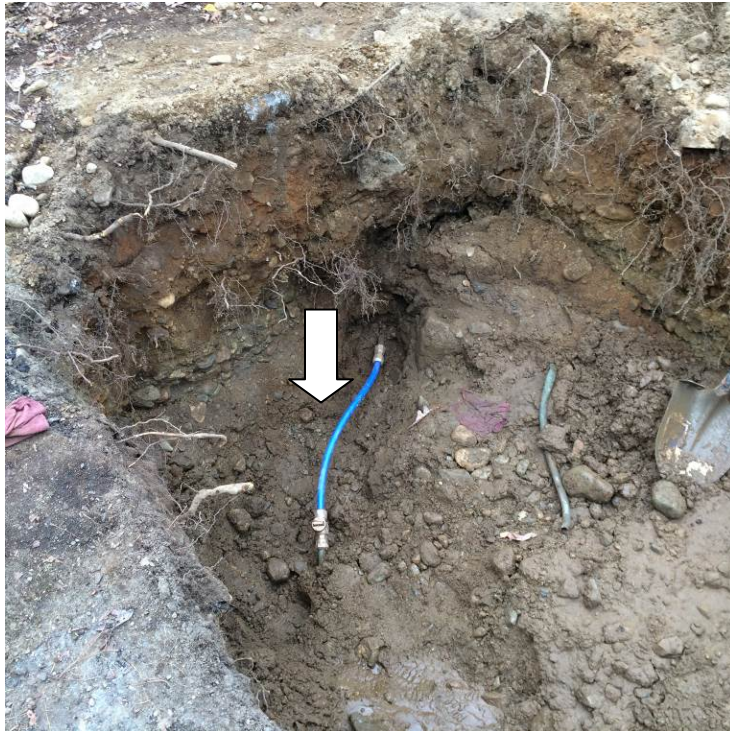
SCENE: View of temporary repair of damaged water service line. Photograph taken facing northeast.

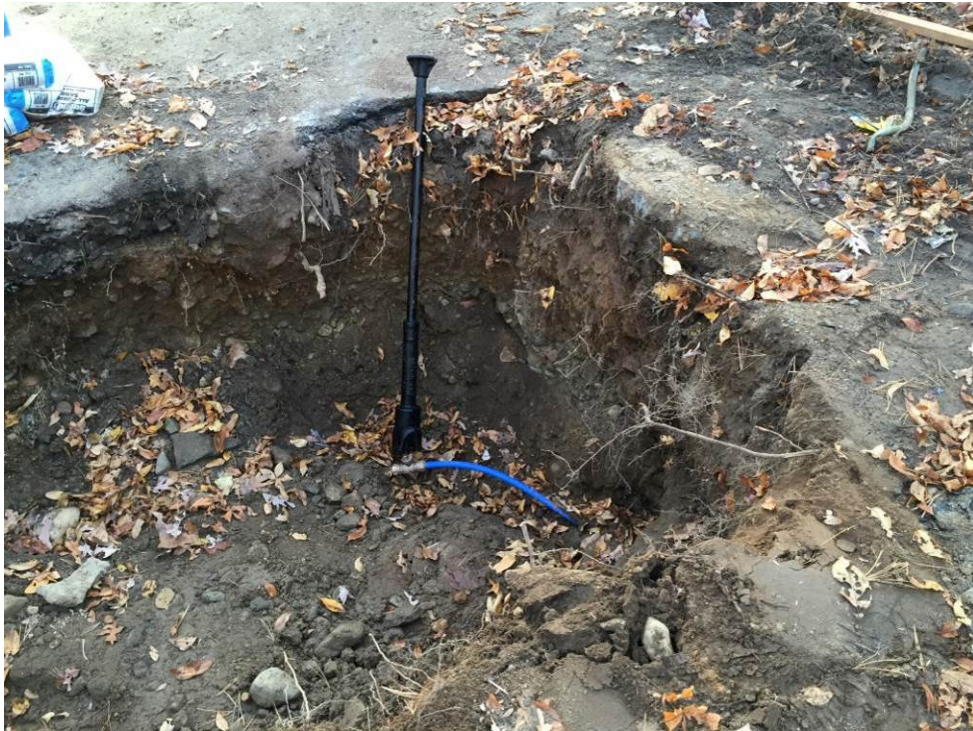
SCENE: View of the repaired water service line showing extended valve stem. Photograph taken facing south.

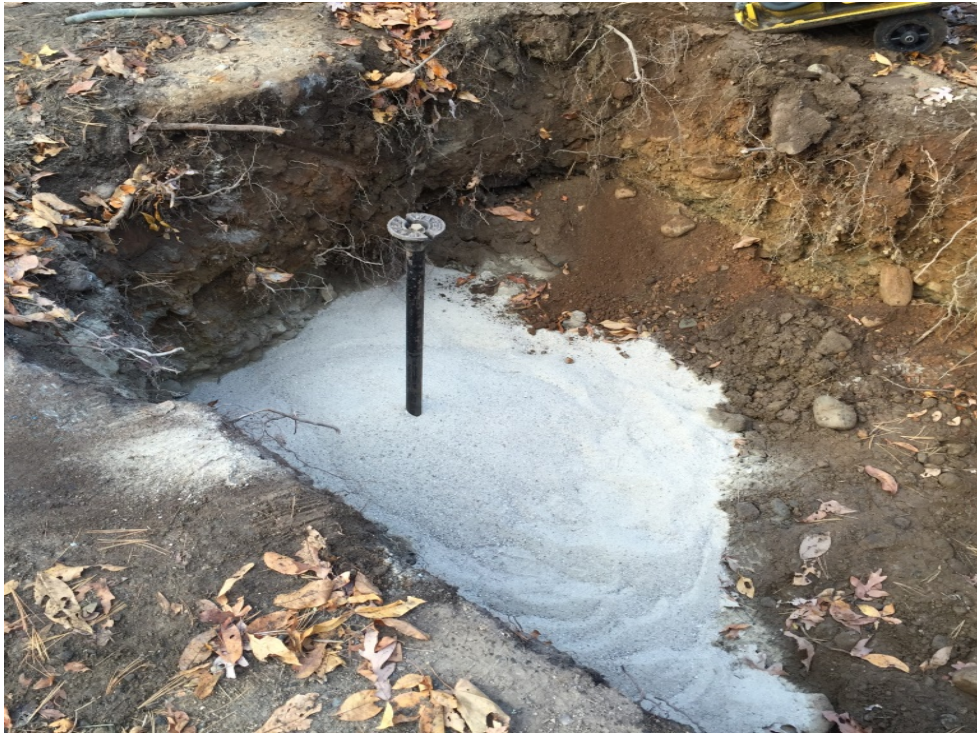
SCENE: View of the repaired water service line after backfilling with sand around pipe and valve. Photograph taken facing south.

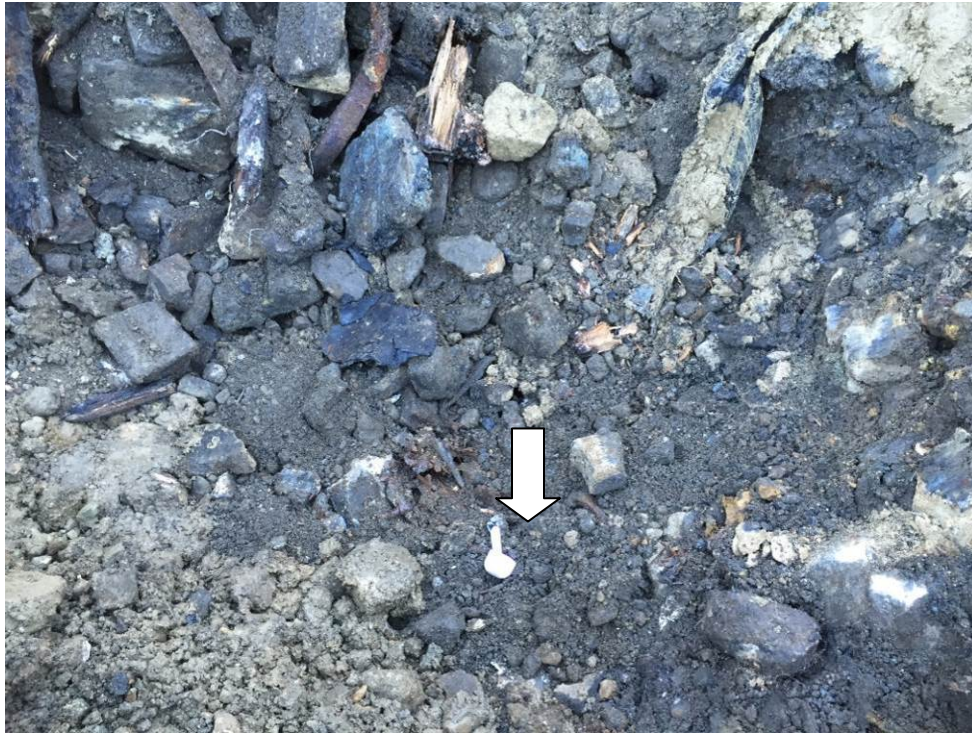
SCENE: View of sample RS69 in the additional excavated area near sample RS63/SS-300 at the 4.5-foot depth showing burnt building debris and blackened soil.

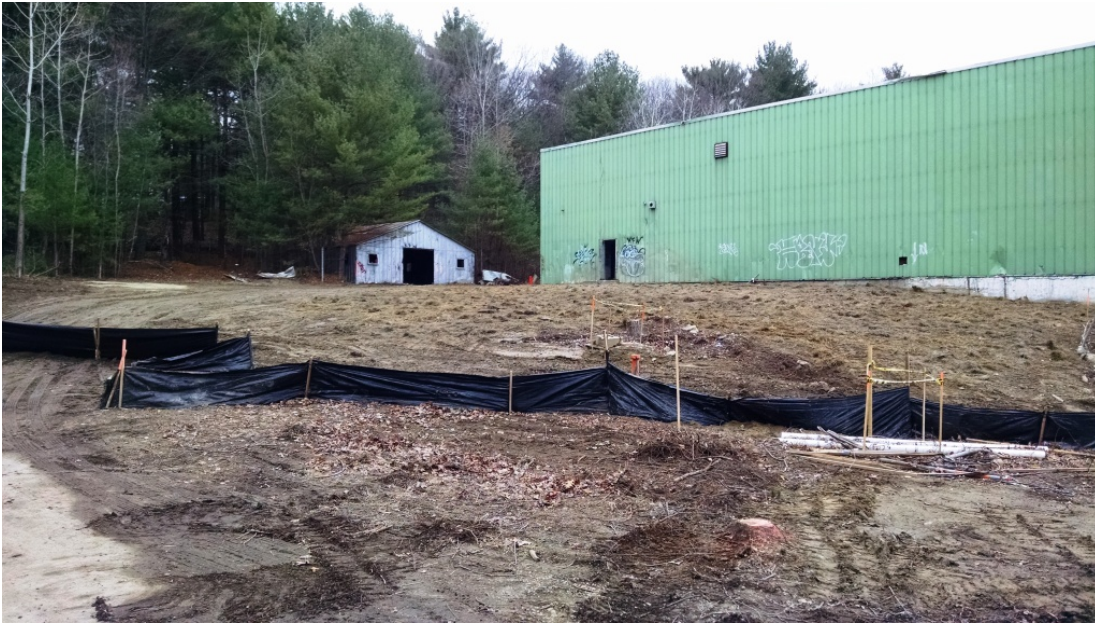
SCENE: View of final site conditions of the backfilled road area south of the manufacturing building. Stakes and caution tape established to identify two slip/trip hazards for site workers were left in place. Photograph taken facing northwest.
