**REMOVAL PROGRAM
AFTER ACTION REPORT
FOR THE
COLONIAL LACQUER & CHEMICAL CO. SITE
ASHLAND, MIDDLESEX COUNTY, MASSACHUSETTS
28 SEPTEMBER 2015 THROUGH 8 DECEMBER 2015**

Weston Solutions, Inc.
Superfund Technical Assessment and Response Team IV (START)
101 Billerica Avenue, Building 5, Suite 103
North Billerica, Massachusetts 01862

March 2016

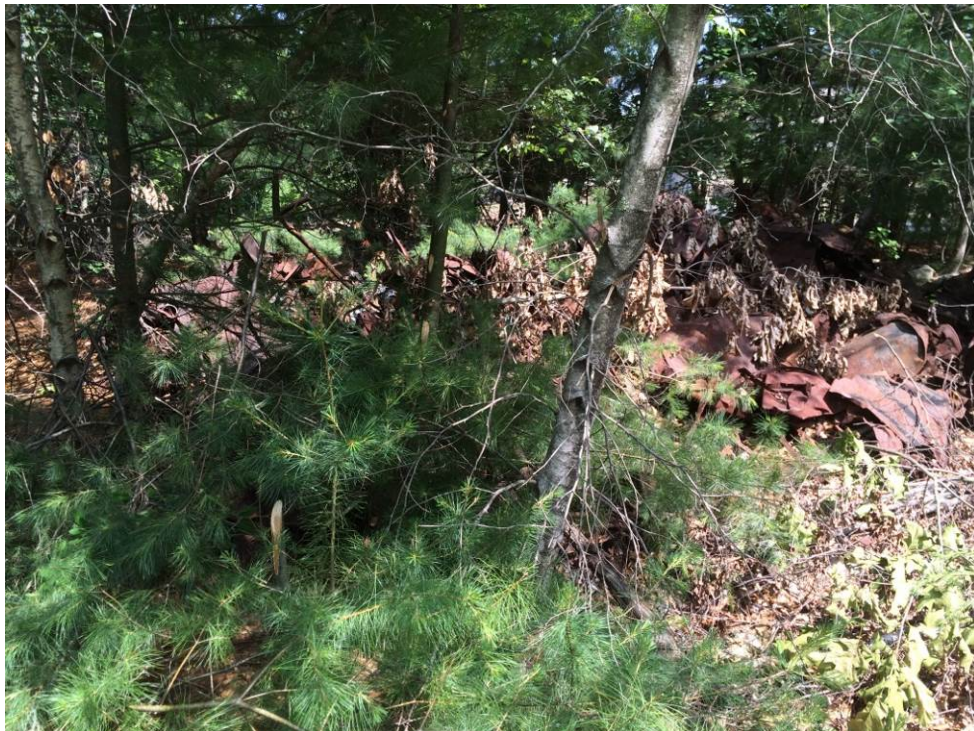
SCENE: View of a drum carcass pile prior to vegetation clearing. Photograph taken facing southeast.

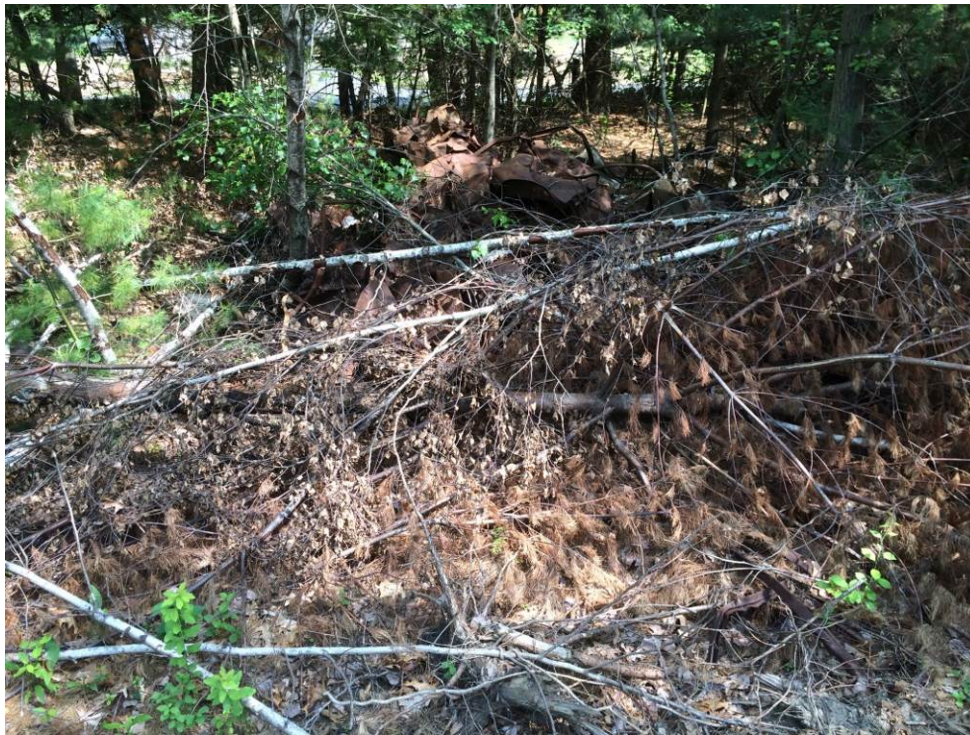
SCENE: View of a drum carcass pile prior to vegetation clearing. Photograph taken facing east.

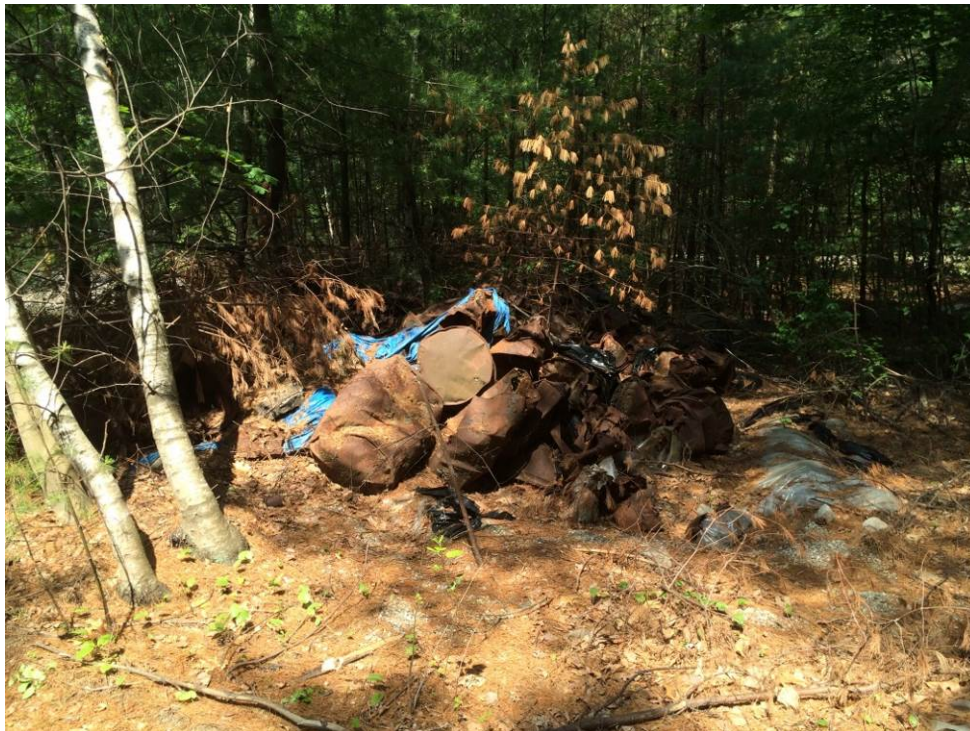
SCENE: View of a drum carcass pile prior to vegetation clearing. Photograph taken facing east.

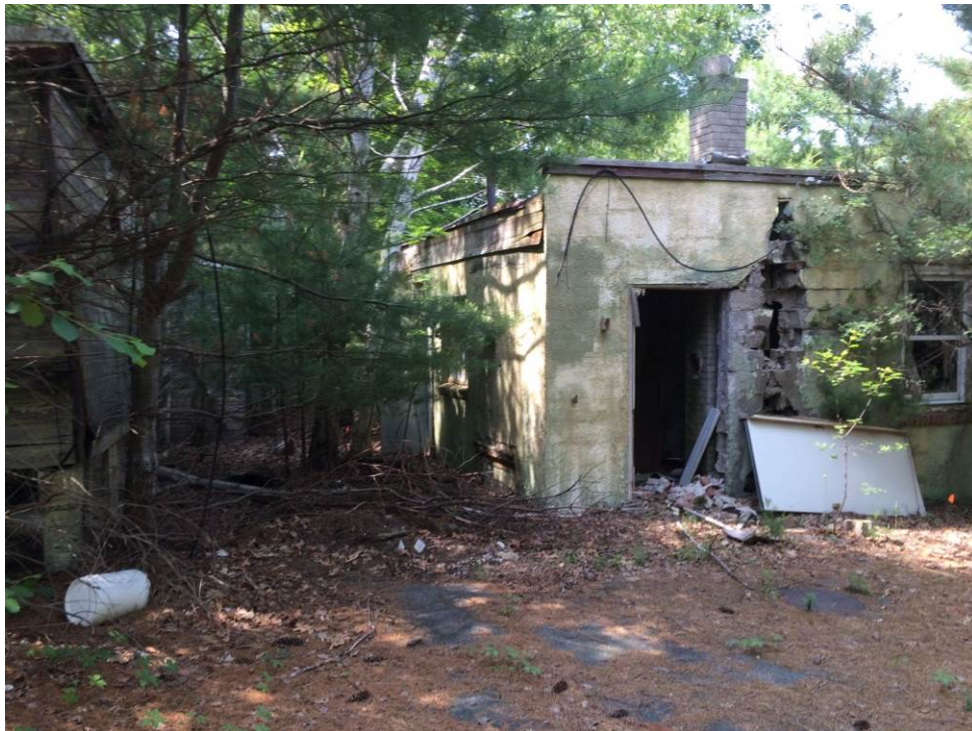
SCENE: View of the indented contaminated soil area on southeast side of the lab building prior to vegetation clearing. Photograph taken facing northwest.

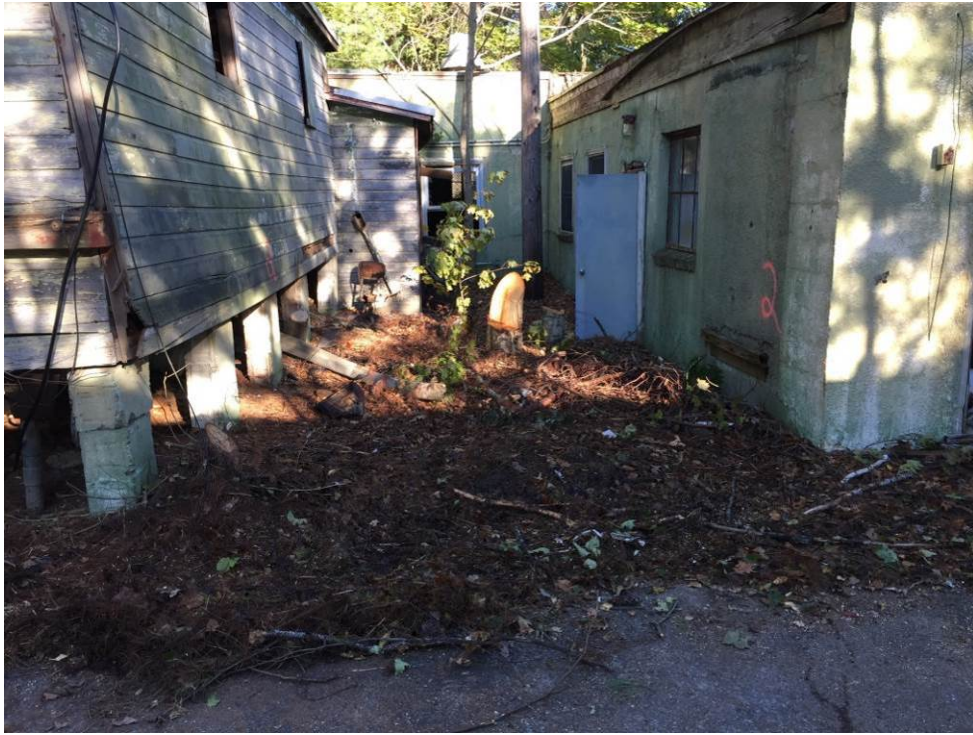
SCENE: View of the indented contaminated soil area on southeast side of the lab building after vegetation clearing. Photograph taken facing northwest.

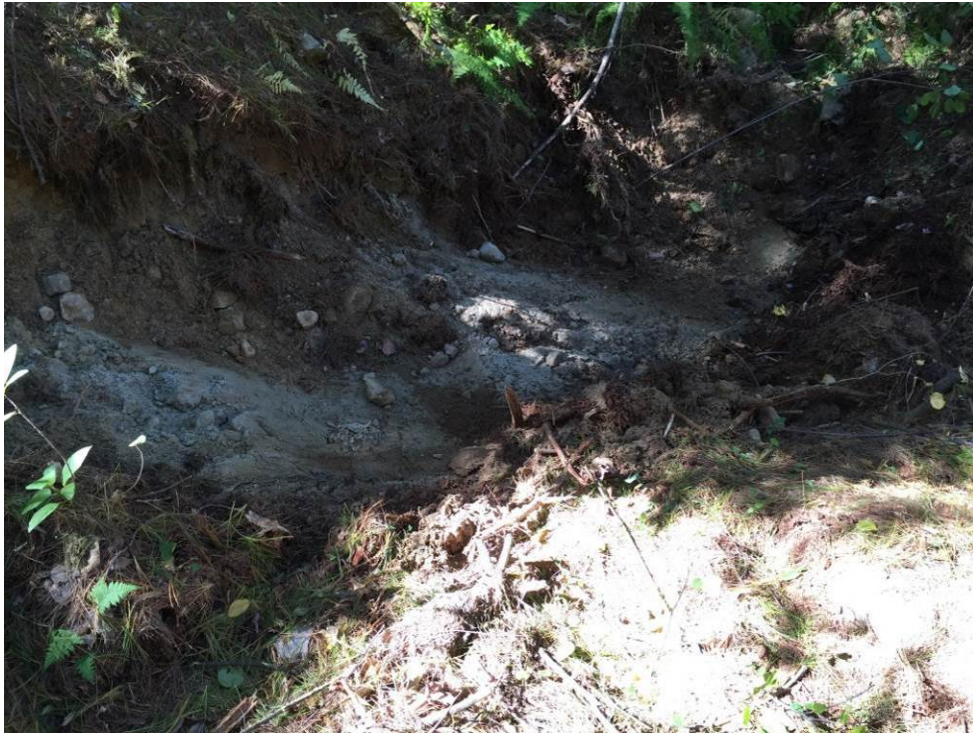
SCENE: View of the contaminated area in the depression in the woods at the southern end of the property after excavation activities. Photograph taken facing west.

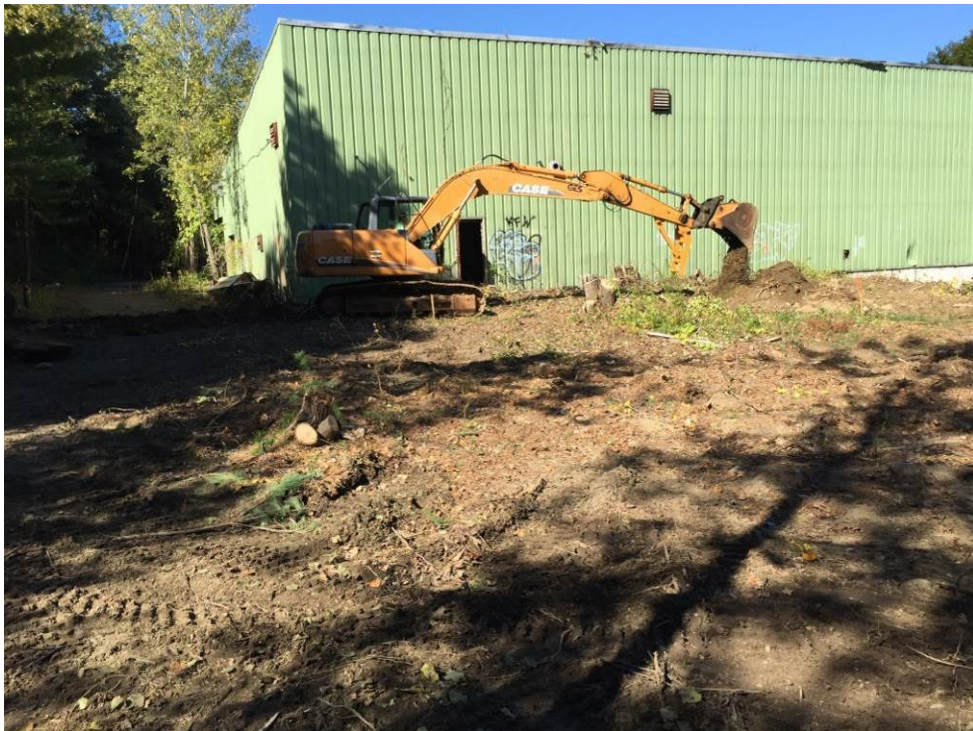
SCENE: View of the contaminated area south of the manufacturing building during initial excavation activities. Photograph taken facing north.

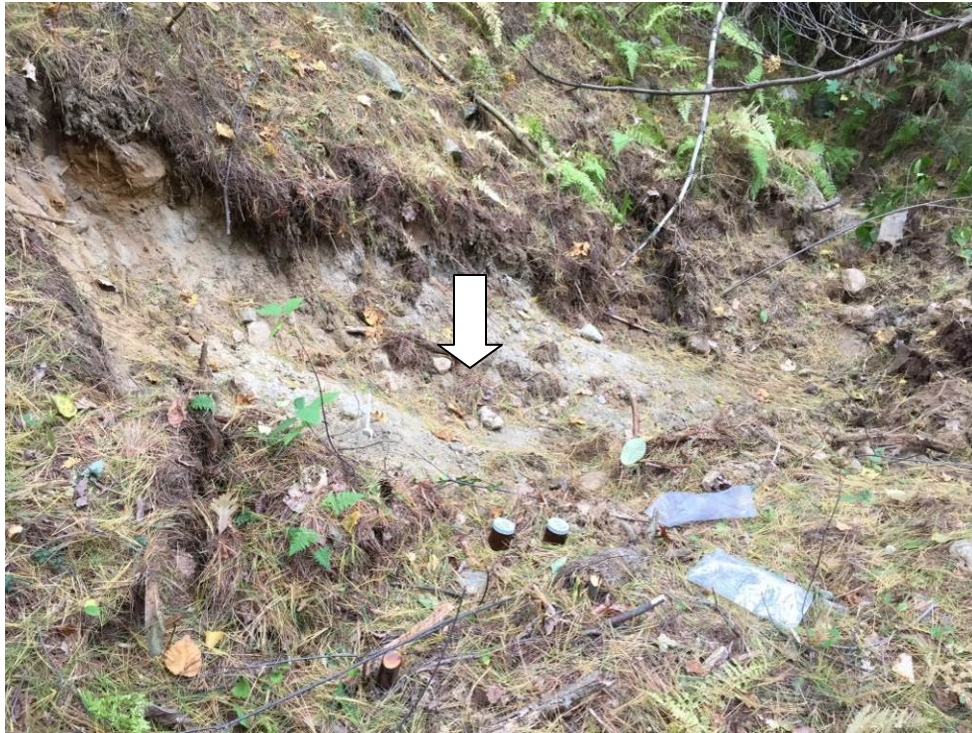
SCENE: View of sample RS02/SS-04/SS-114 following the excavation of the depression in the woods at the southern end of the site. Photograph taken facing west.

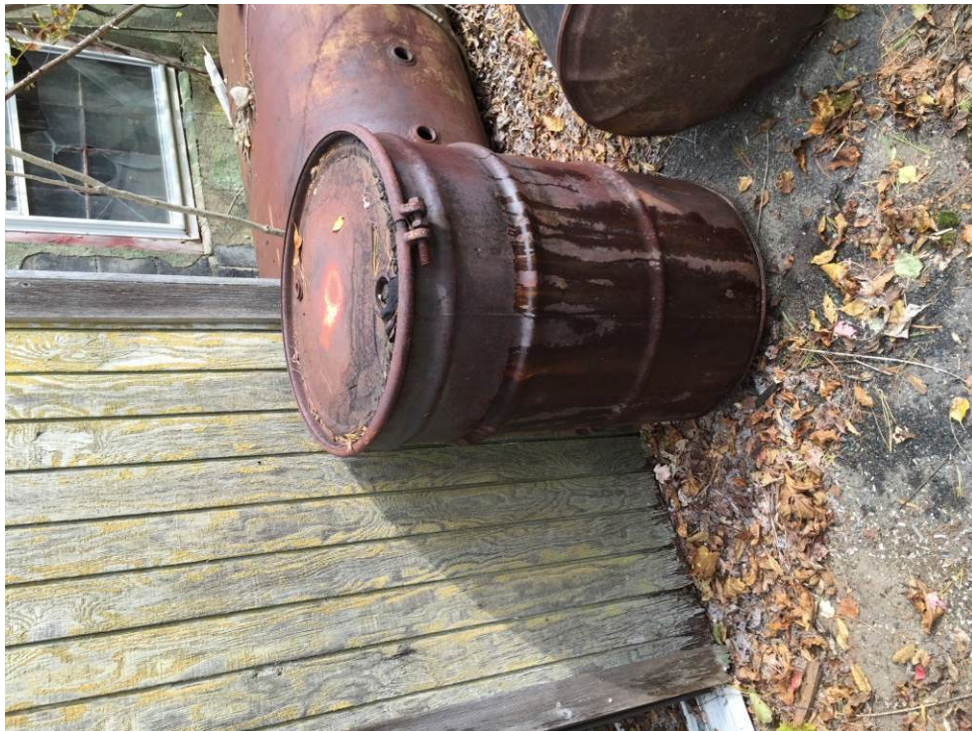
SCENE: View of the liquid-containing drum south of the office building. Photograph taken facing northeast.

Lab test results of the drum sample were received. Based on the nearly complete absence of contaminants, the contents were added to the soil stockpile. The empty drum was crushed and added to the existing crushed drum pile categorized as non-hazardous waste based on testing performed during the site investigation.

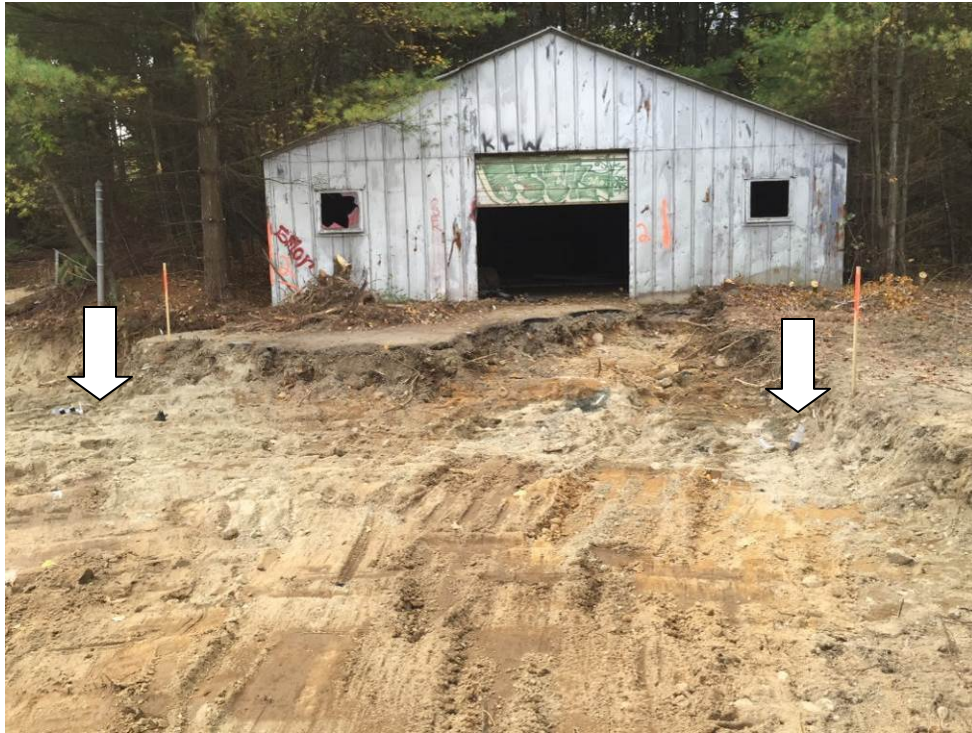
SCENE: View of sample RS04/SS-203 by the stake to the right, and RS05/SS-302 by the stake to the left, in the 2-foot excavation south of manufacturing building, and an area of asphalt that had been covered by approximately 6 inches of soil. Photograph taken facing southwest.

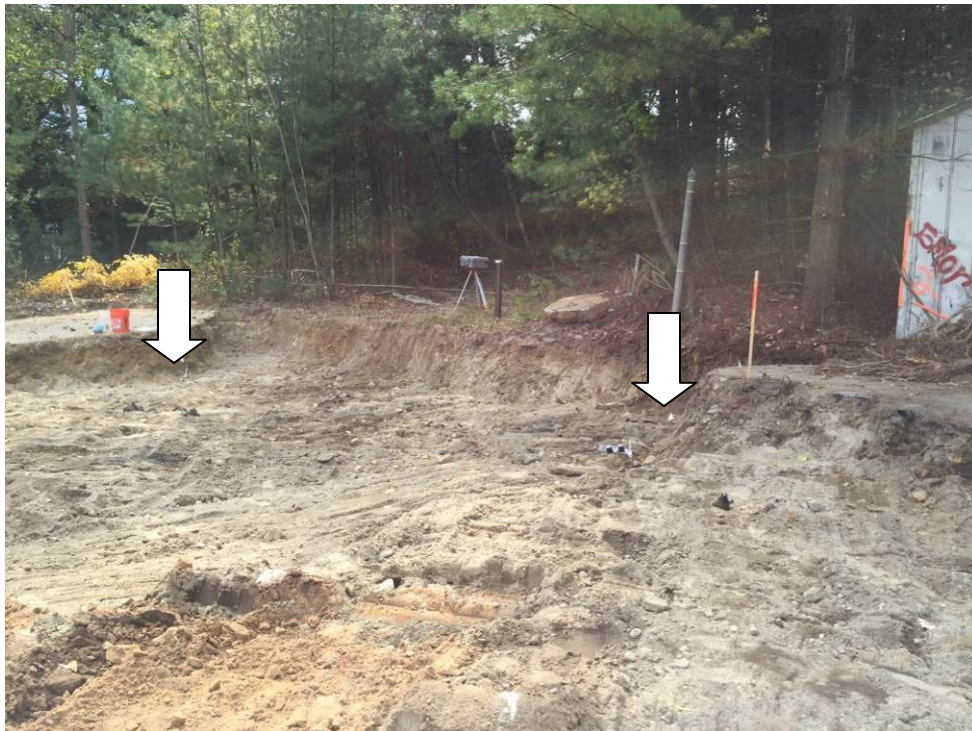
SCENE: View of sample RS05/SS-302 by the stake to the right, and RS03/SS-301 by the orange bucket to the left, in 3-foot excavated areas south of manufacturing building, and a second area of asphalt on the left by the orange bucket. Photograph taken facing south.

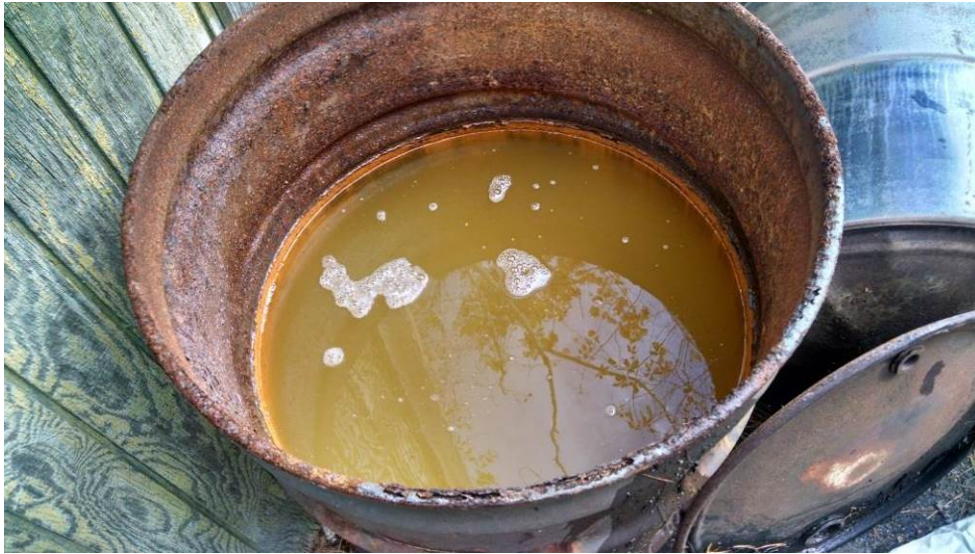
SCENE: View of the contents of the drum south of the office building, which were sampled for disposal parameters.

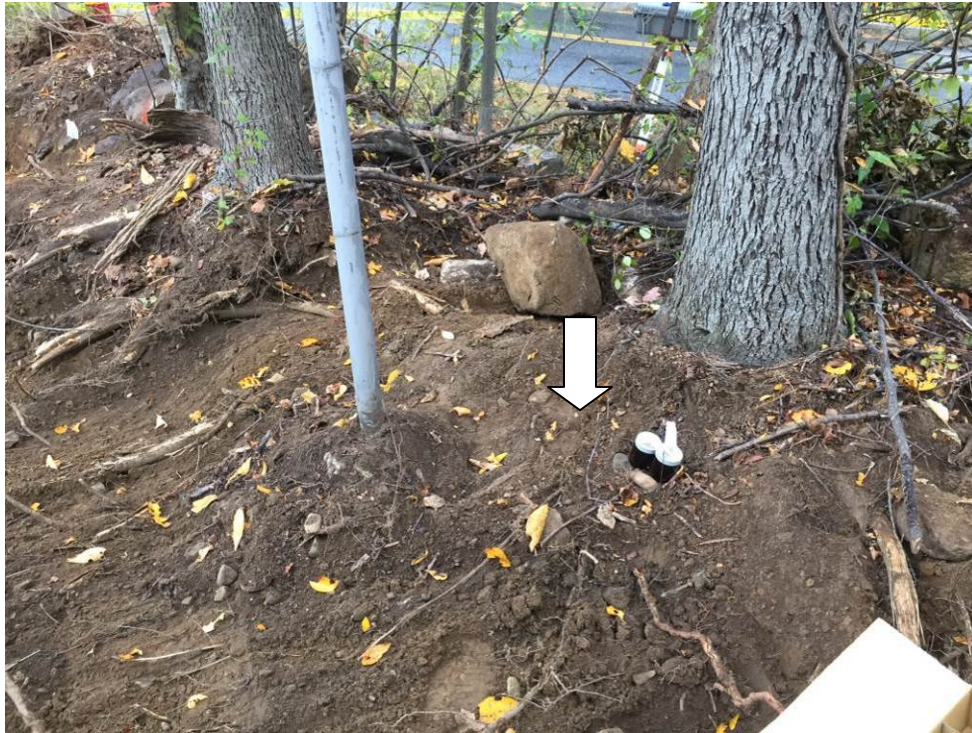
SCENE: View of sample RS06, easternmost of three samples collected by the stone wall at the northern edge of 2-foot excavation northwest of the manufacturing building. Photograph taken facing north.

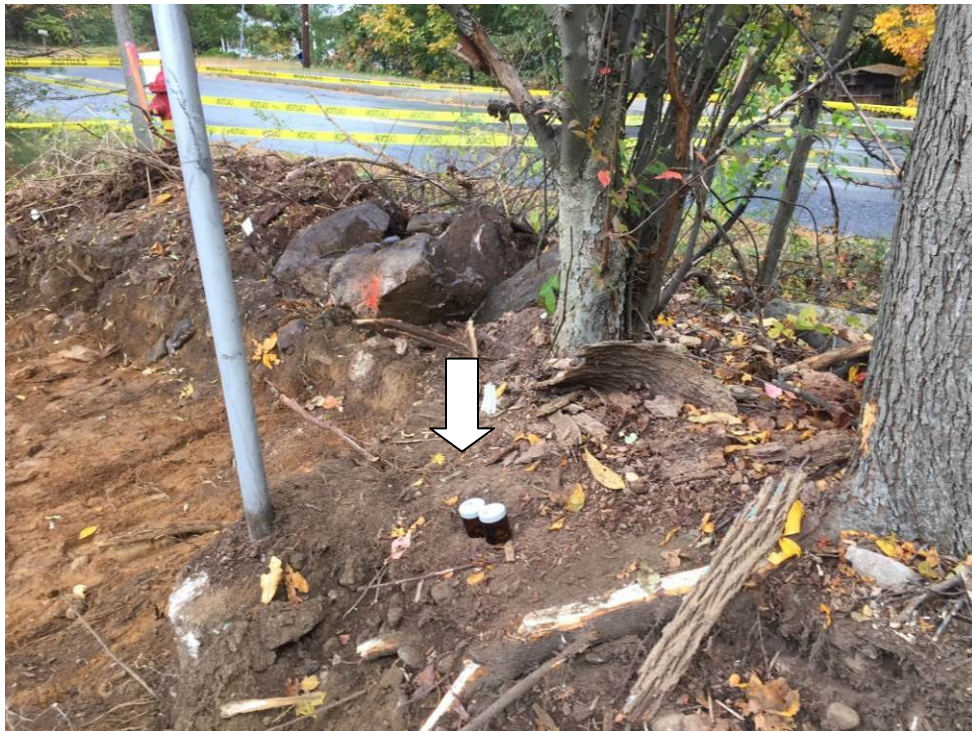
SCENE: View of sample RS07, centermost of three samples collected by the stone wall at the northern edge of 2-foot excavation northwest of the manufacturing building. Photograph taken facing north.

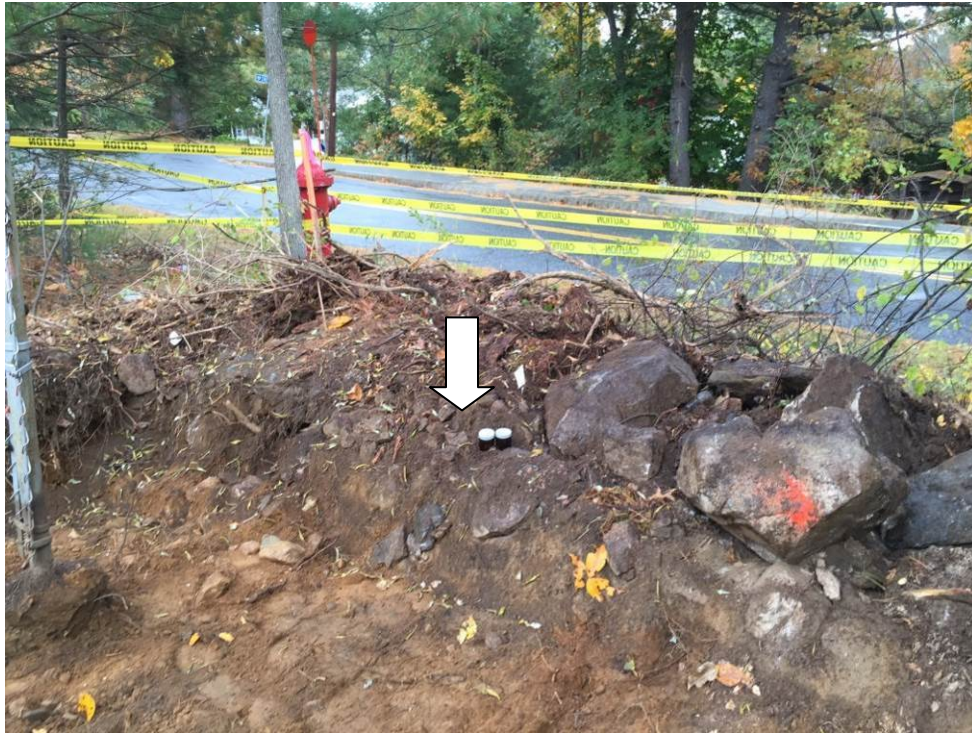
SCENE: View of sample RS08, westernmost of three samples collected by the stone wall at the northern edge of 2-foot excavation northwest of the manufacturing building. Photograph taken facing north.

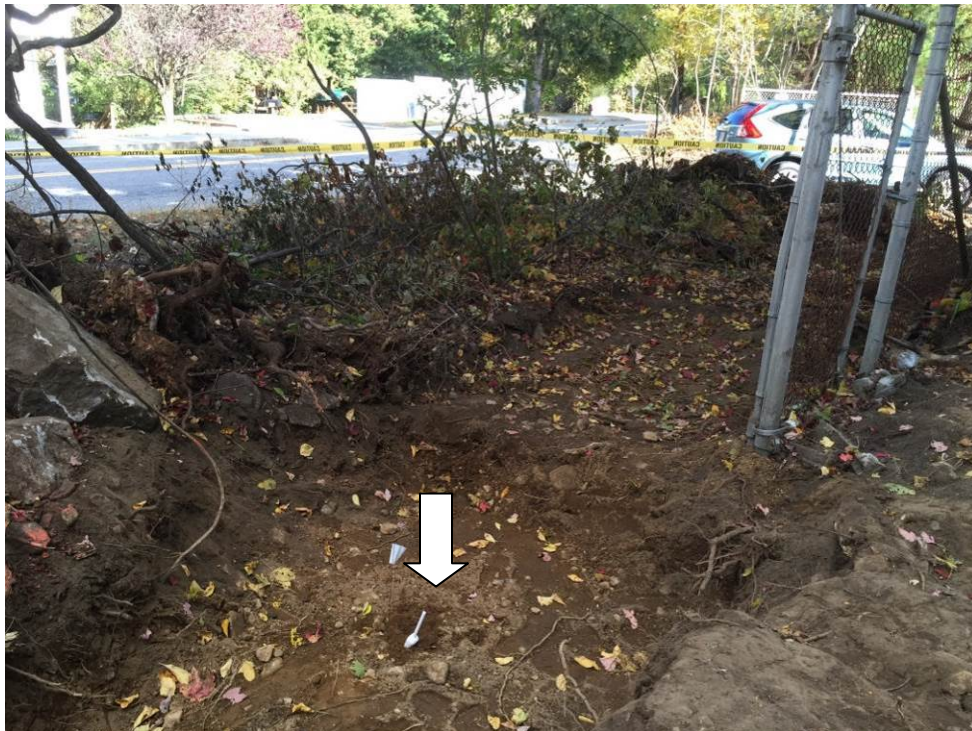
SCENE: View of sample RS09/SS-400 in the 3-foot excavation north of the manufacturing building. Photograph taken facing northeast.

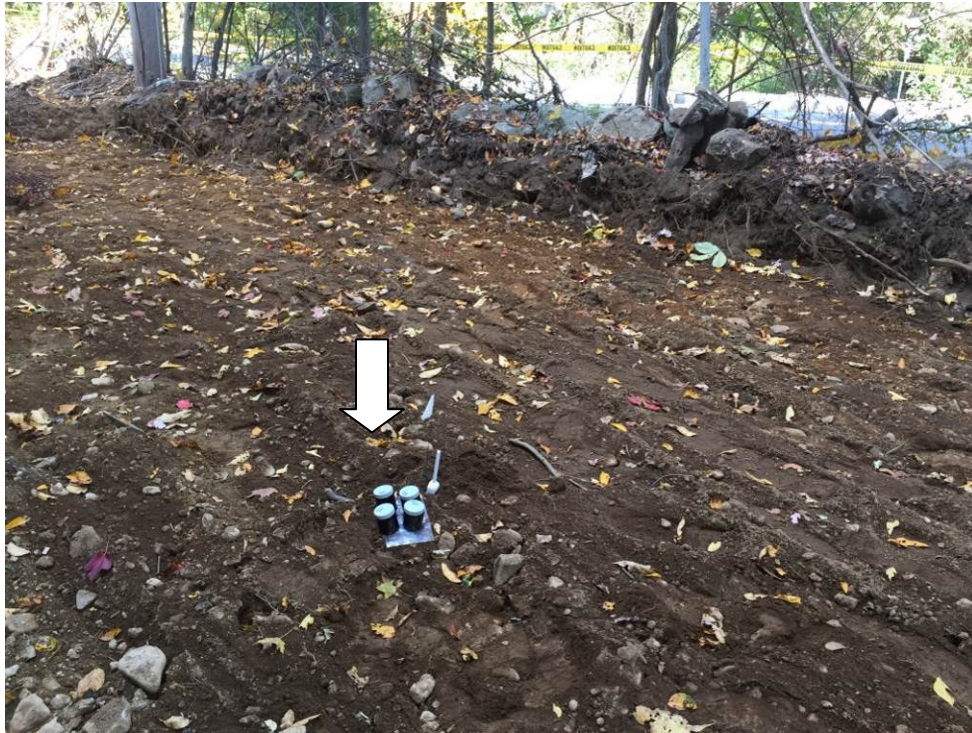
SCENE: View of sample RS10/SS-09 and RS11 (duplicate) in 2-foot excavation north of the manufacturing building. Photograph taken facing north.

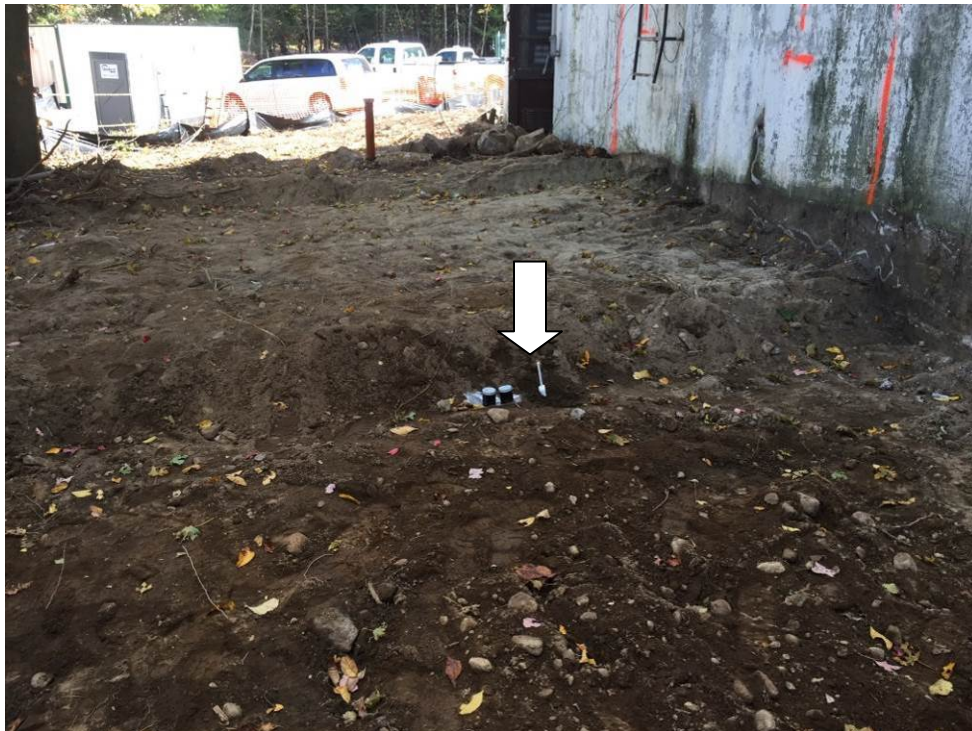
SCENE: View of sample RS12/SS-08 in the 2-foot excavation north of the manufacturing building. Photograph taken facing southeast.

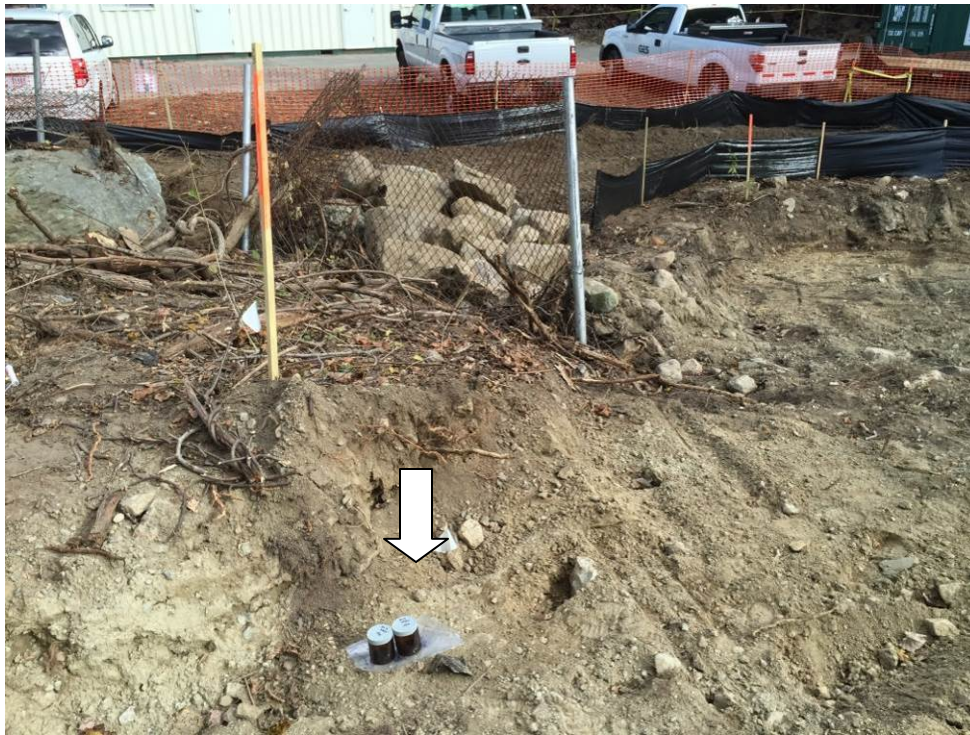
SCENE: View of sample RS13/SS-205 in the 2-foot excavation south of the manufacturing building. Photograph taken facing east.

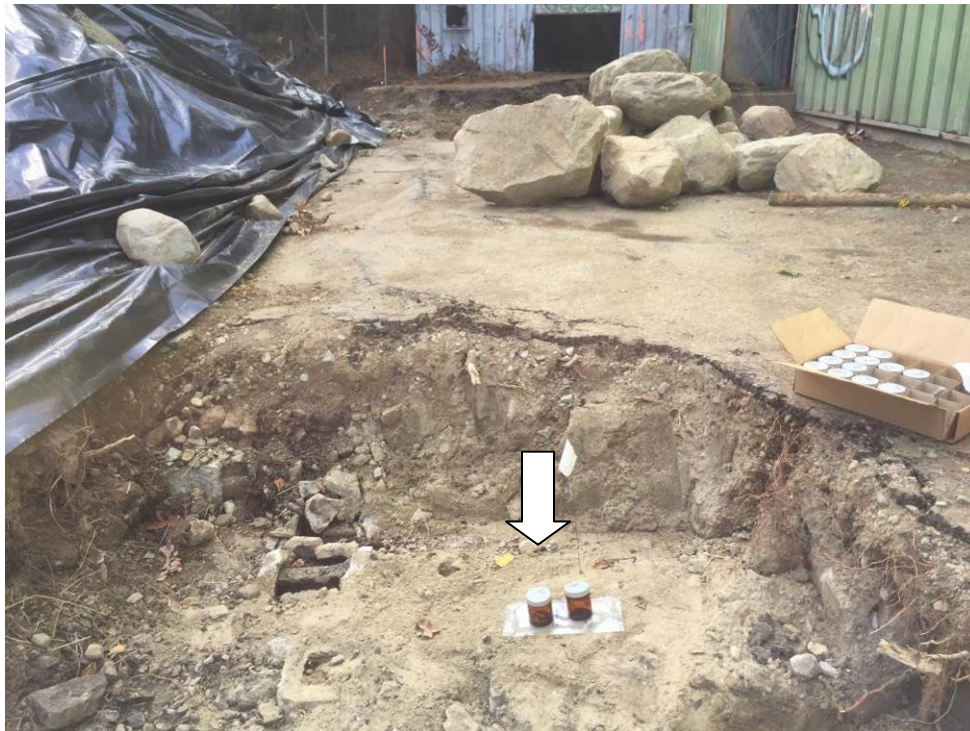
SCENE: View of sample RS14/SS-07 in the 2-foot excavation south of the manufacturing building, a third area of asphalt, and the edge of the first excavated soil stockpile to the left. Photograph taken facing southwest.

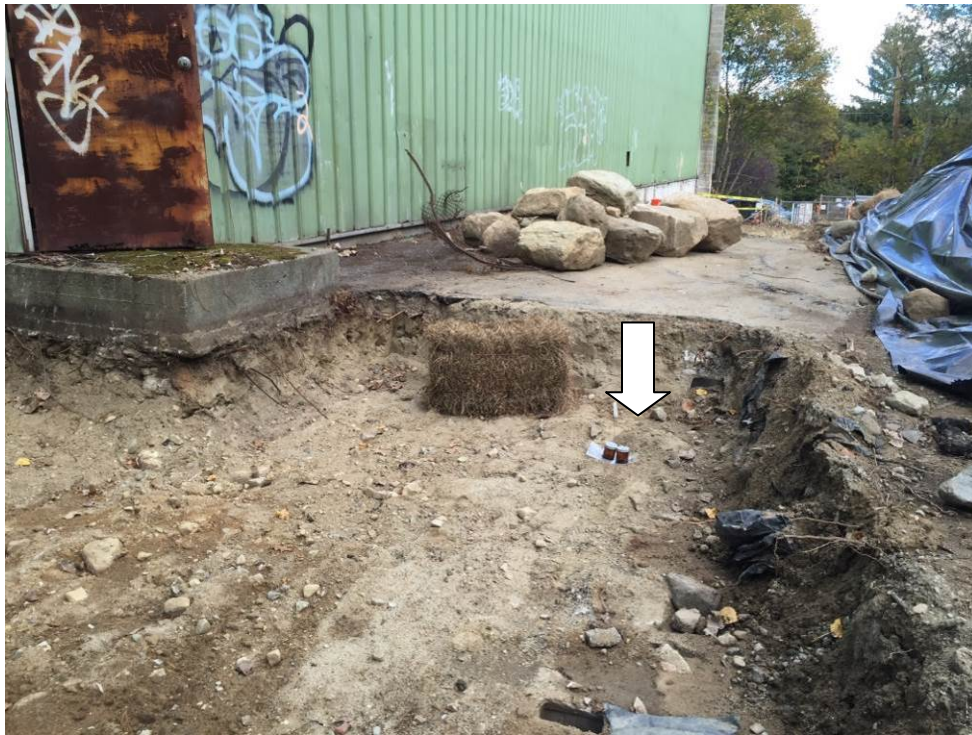
SCENE: View of sample RS15/SS-06 in the 2-foot excavation south of the manufacturing building. Photograph taken facing northeast.

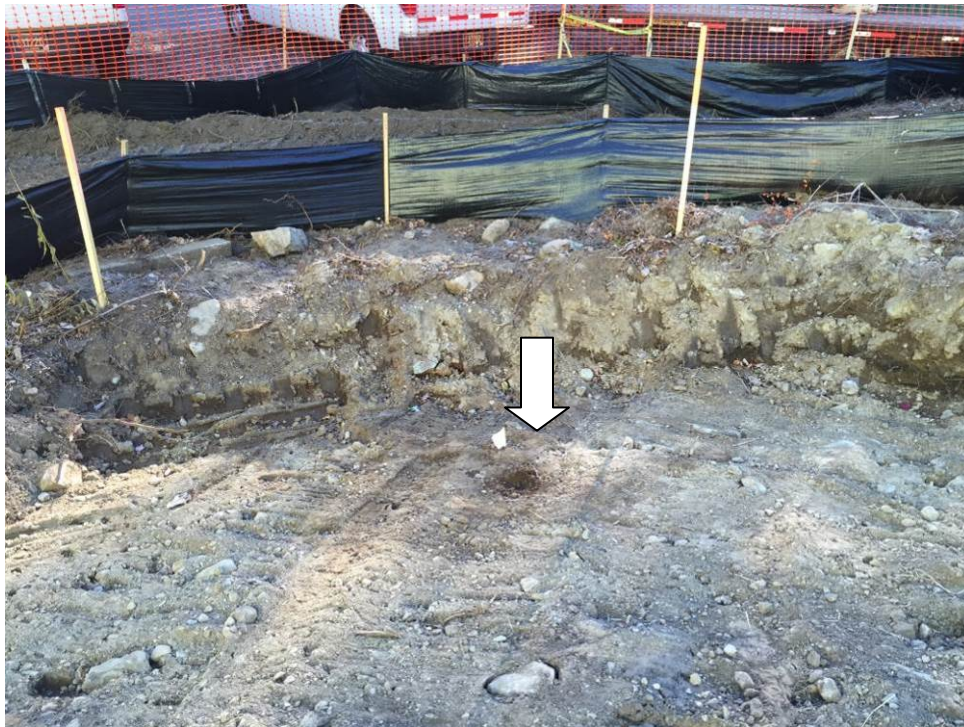
SCENE: View of sample RS16/SS-206/SS-210 in the 2-foot excavation south of the manufacturing building. Photograph taken facing east.

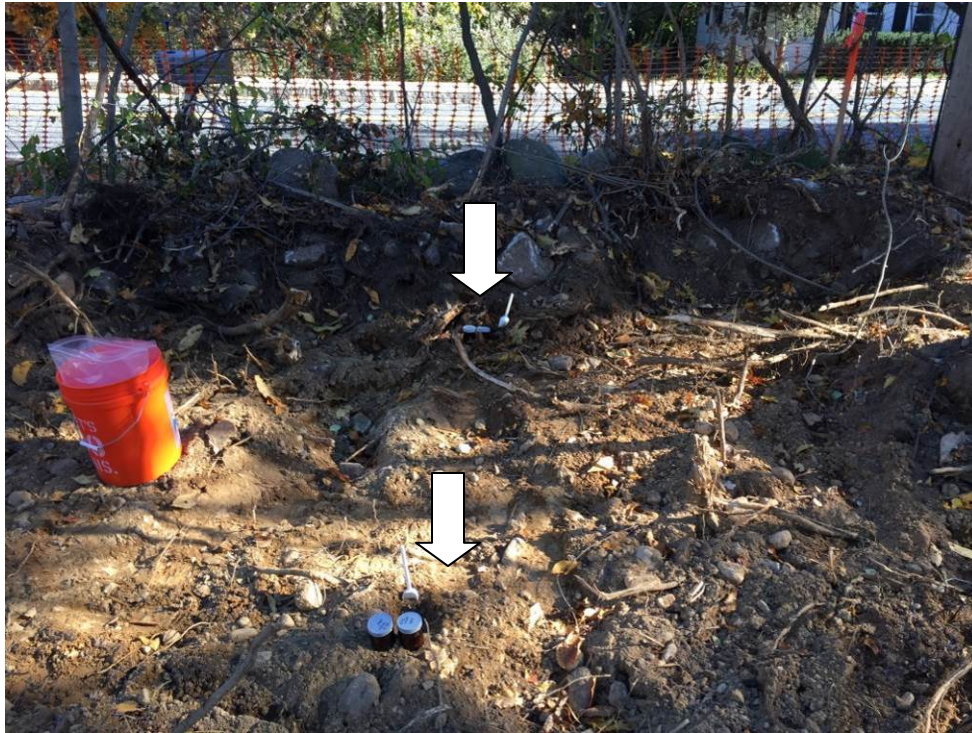
SCENE: View of sample RS17/SS-110 (foreground) and RS18/SS404 (background) in the 2-foot excavation north of the manufacturing building. Photograph taken facing northeast.

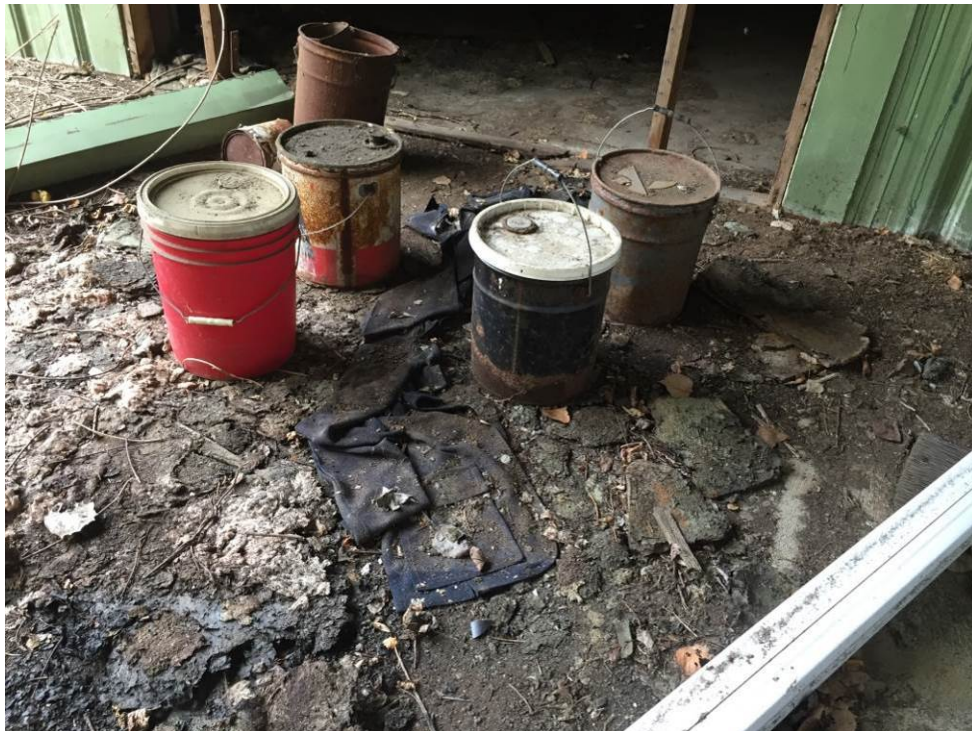
Four 5-gallon buckets found on site were sampled, and hazardous categorization testing was performed. Test results together with container information were used to arrange for disposal.

SCENE: View of the buckets staged on the manufacturing building loading dock. Photograph taken facing southeast.

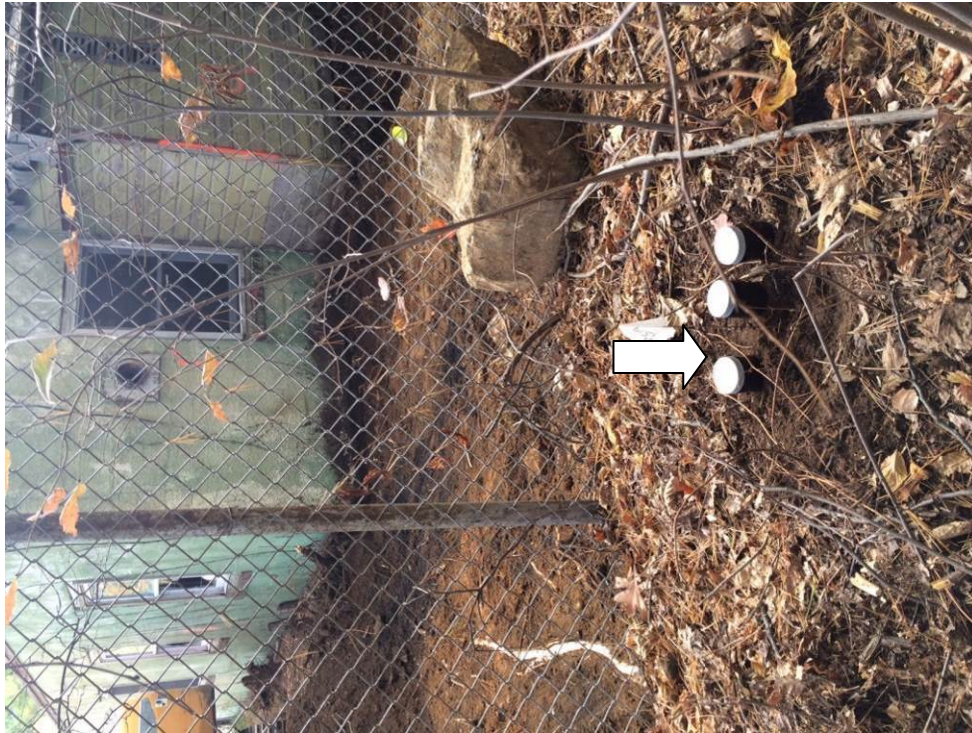
SCENE: View of sample RS19 beyond the fence line along the western site boundary. Photograph taken facing southeast.

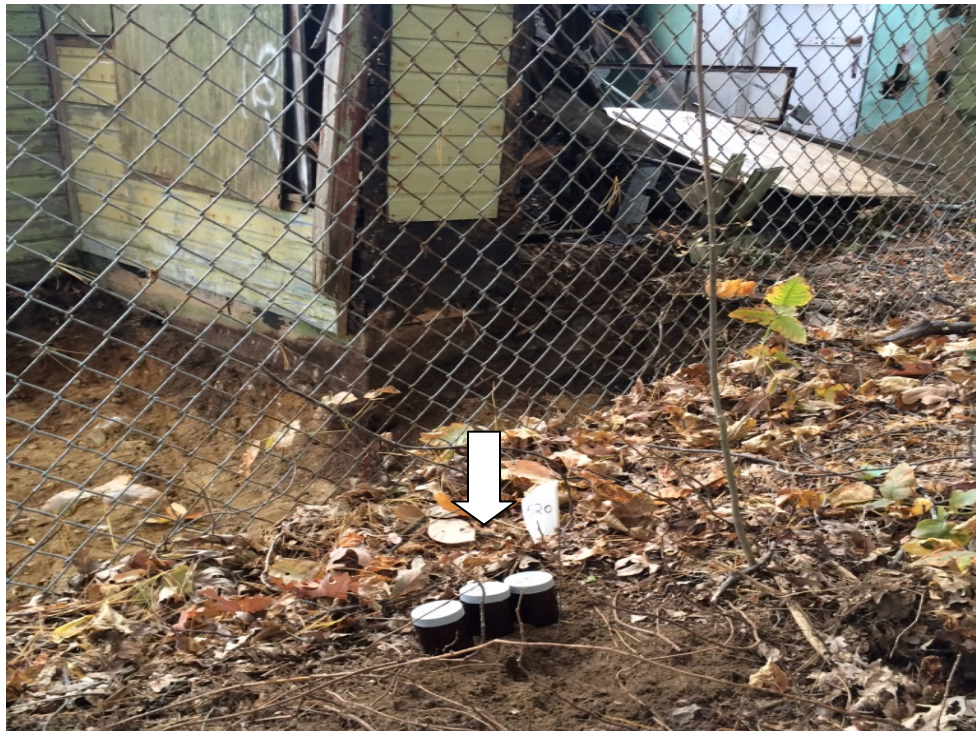
SCENE: View of sample RS20 beyond the fence line along the western site boundary. Photograph taken facing south.

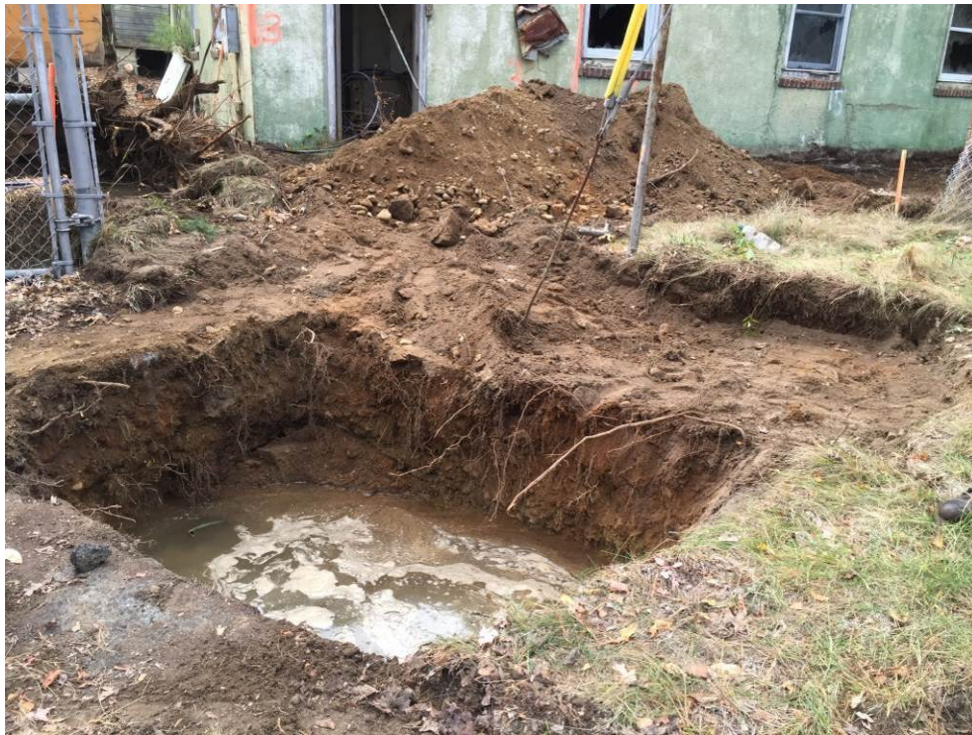
SCENE: View of the excavated area north of the lab building following a water service line break (not identified by DigSafe). Photograph taken facing west.

A report was provided by NERL pertaining to a sample collected from the bottom of the excavation at the point where the water and sewer line repair took place. Test results indicated the total concentration of PCBs was less than 1 ppm. In conjunction with the Ashland Water Department, a new valve and riser were installed on the water line, and the excavated area was backfilled first with sand around the valve and pipe, then clean fill up to grade.

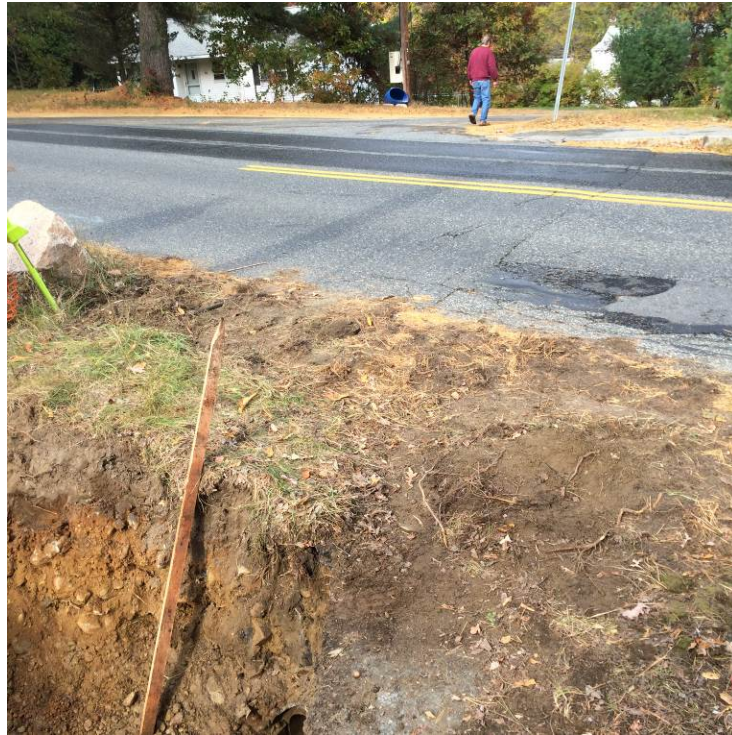
SCENE: View of water service line excavation and Eliot Street, showing lack of DigSafe markings identifying the line. Photograph taken facing north.

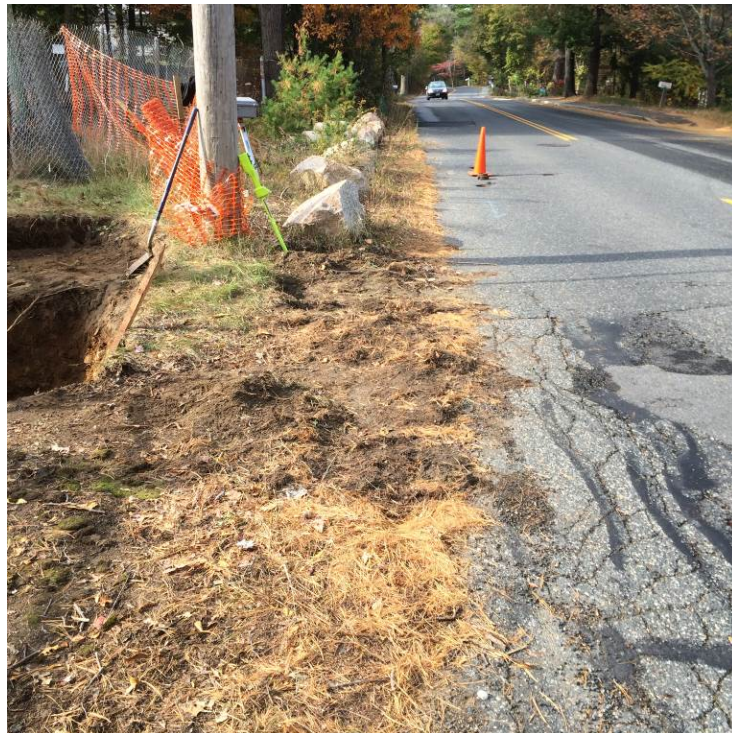
SCENE: View of water service line excavation on left and Eliot Street on right, showing lack of DigSafe markings identifying the line. Photograph taken facing northwest.

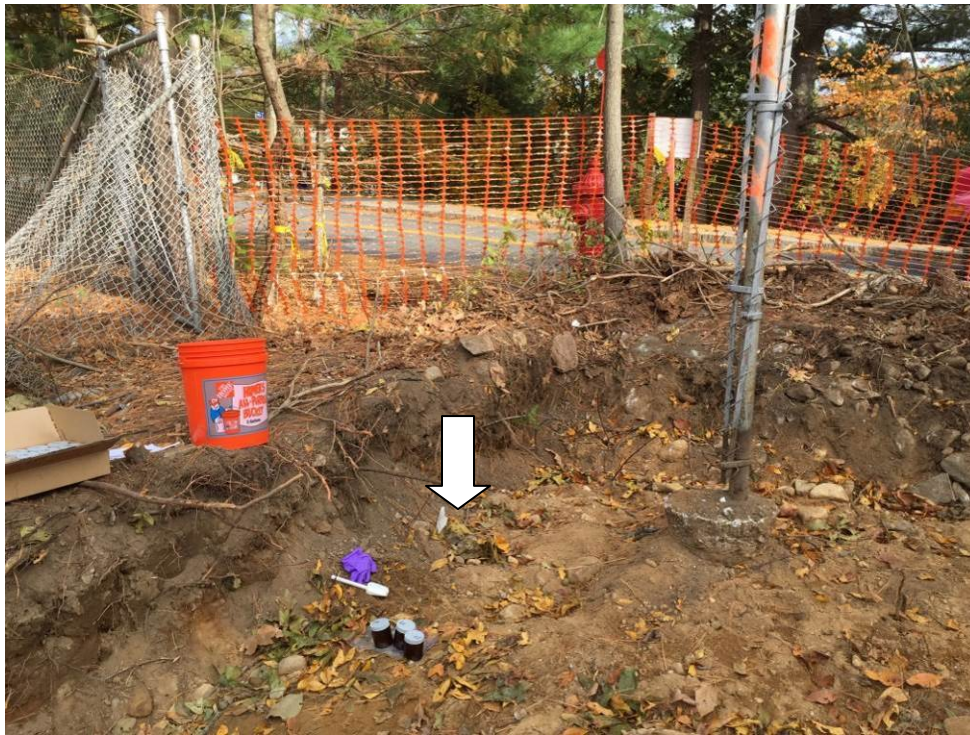
SCENE: View of sample RS22/SS-306 at the northwestern edge of the 2-foot excavation north of the manufacturing building. Photograph taken facing northwest.

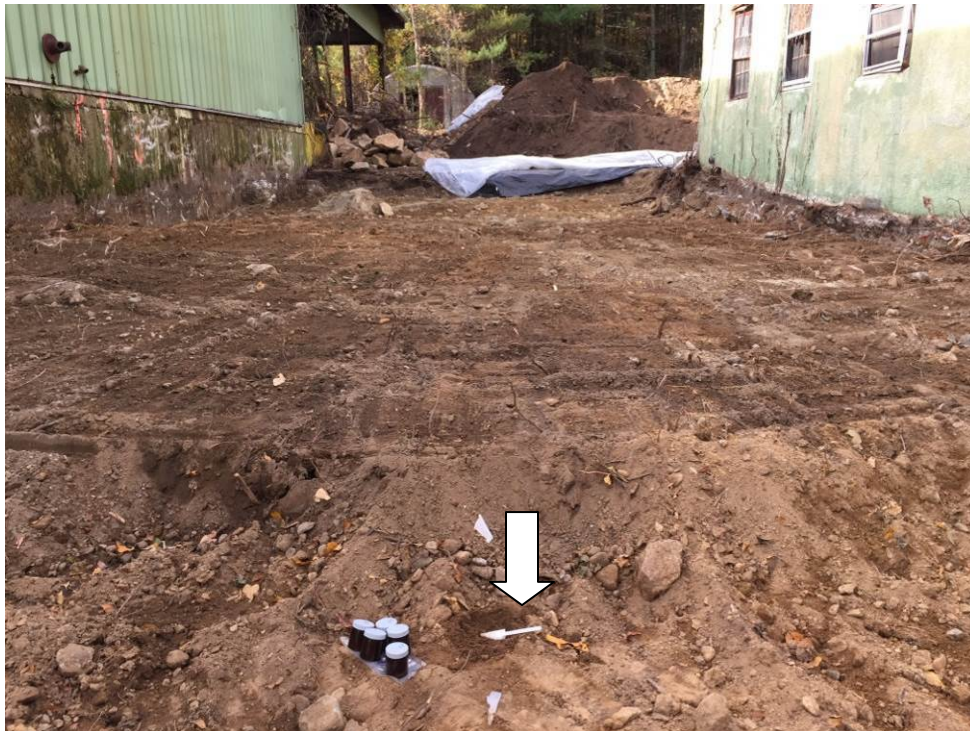
SCENE: View of sample RS21/SS-305 and RS28 (duplicate) in the 2-foot excavation northwest of the manufacturing building, and the second excavated soil stockpile on the paved area shown in photo taken on 6 October 2015 at 0834 hours. Photograph taken facing southwest.
