**REMOVAL PROGRAM
AFTER ACTION REPORT
FOR THE
COLONIAL LACQUER & CHEMICAL CO. SITE
ASHLAND, MIDDLESEX COUNTY, MASSACHUSETTS
28 SEPTEMBER 2015 THROUGH 8 DECEMBER 2015**

Weston Solutions, Inc.
Superfund Technical Assessment and Response Team IV (START)
101 Billerica Avenue, Building 5, Suite 103
North Billerica, Massachusetts 01862

March 2016

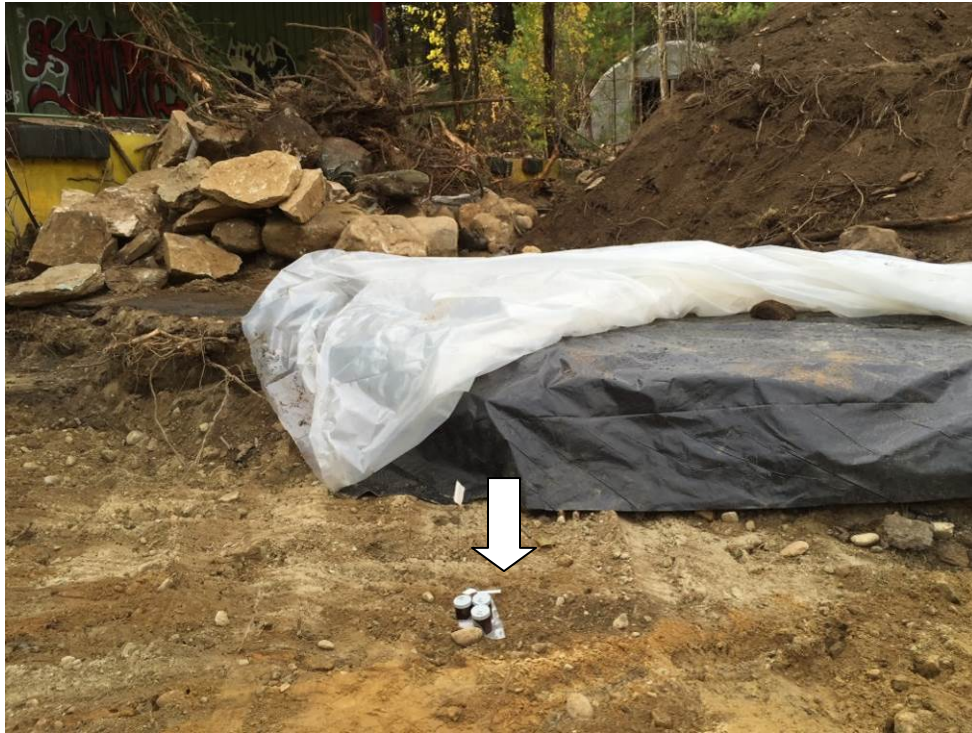
SCENE: View of sample RS24/SS-207 at southern edge of the 3-foot excavation northwest of the manufacturing building, with rocks, vegetation, tree stumps, and contaminated soil stockpiled on the right. Photograph taken facing southwest.

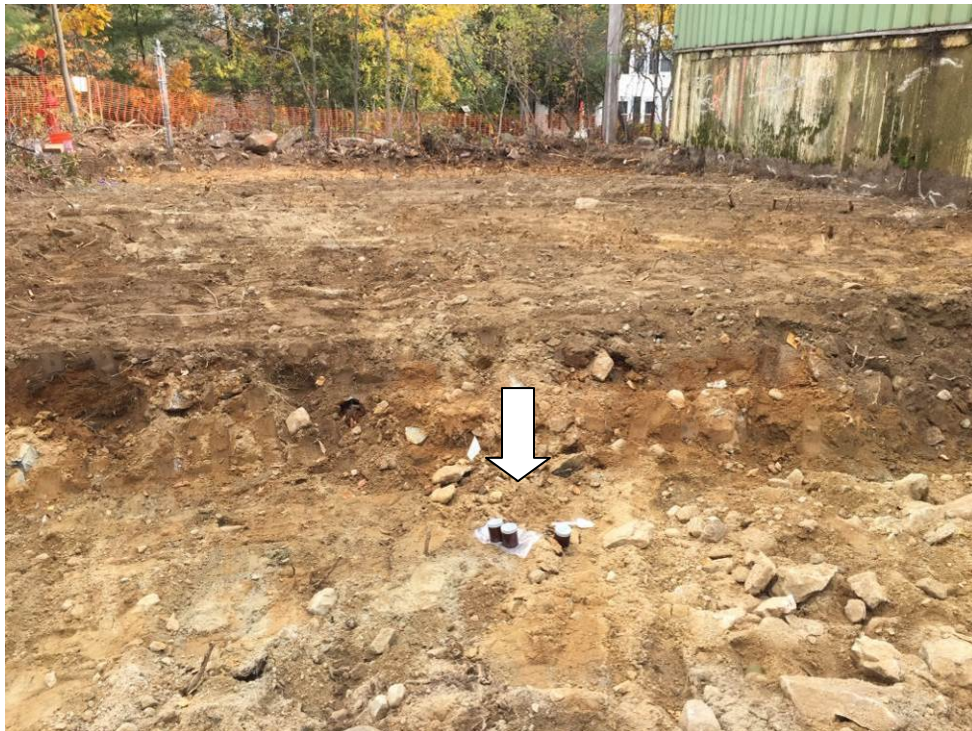
SCENE: View of sample RS23/SS-111 at the northern edge of the 3-foot excavation northwest of the manufacturing building. Photograph taken facing northeast.

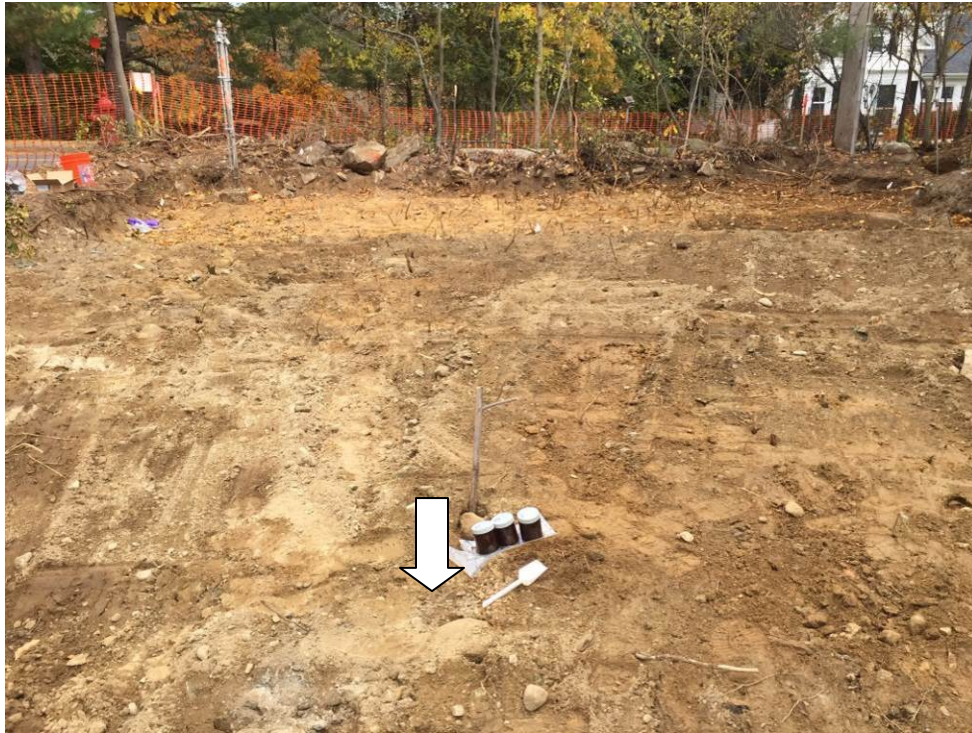
SCENE: View of sample RS26 in the middle of the 1-foot excavation northwest of the manufacturing building. Photograph taken facing northeast.

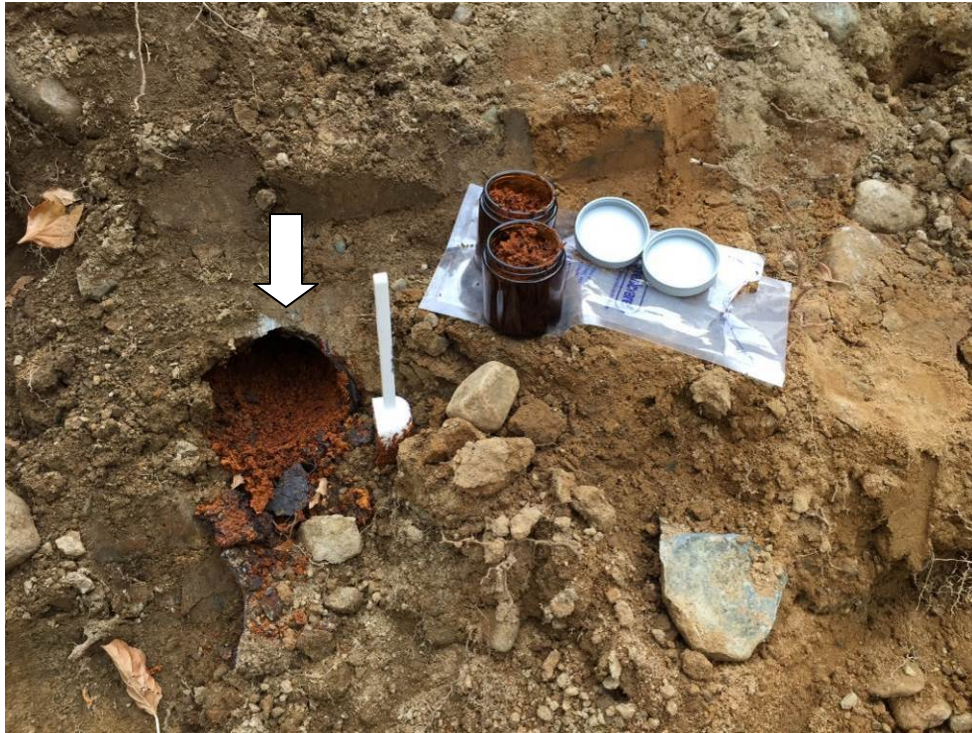
SCENE: View of sample PIPE1 at the intersection of the 1-foot and 3-foot excavation northwest of the manufacturing building. Note this pipe was included with excavated soil when the excavation was increased to a 3-foot depth in the area of Sample RS60. Photograph taken facing northeast.

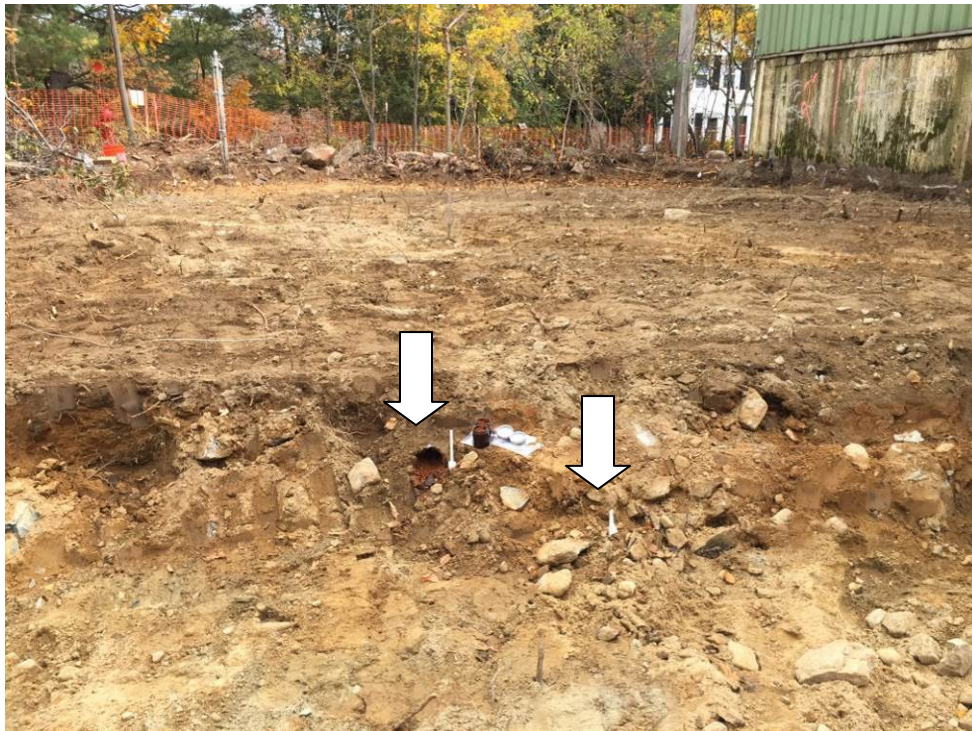
SCENE: View of sample PIPE1 and RS23/SS-111 to right, at the intersection of the 1-foot and 3-foot excavation northwest of the manufacturing building. Photograph taken facing northeast.

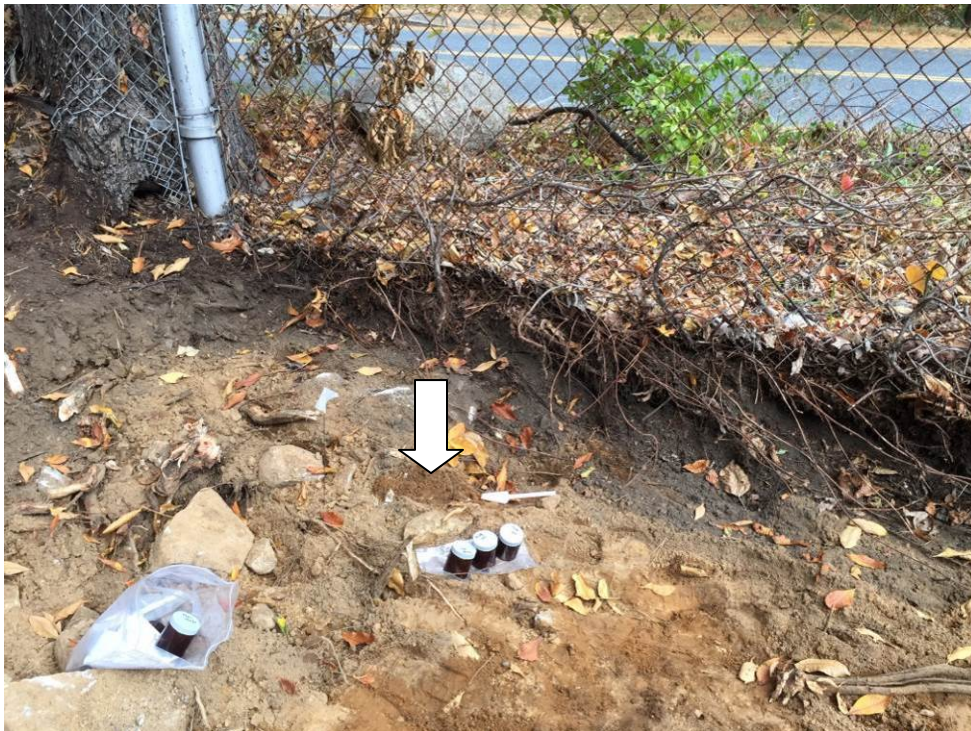
SCENE: View of sample RS25/SS104 in the 1-foot excavation at the northwestern corner of the site. Photograph taken facing northwest.

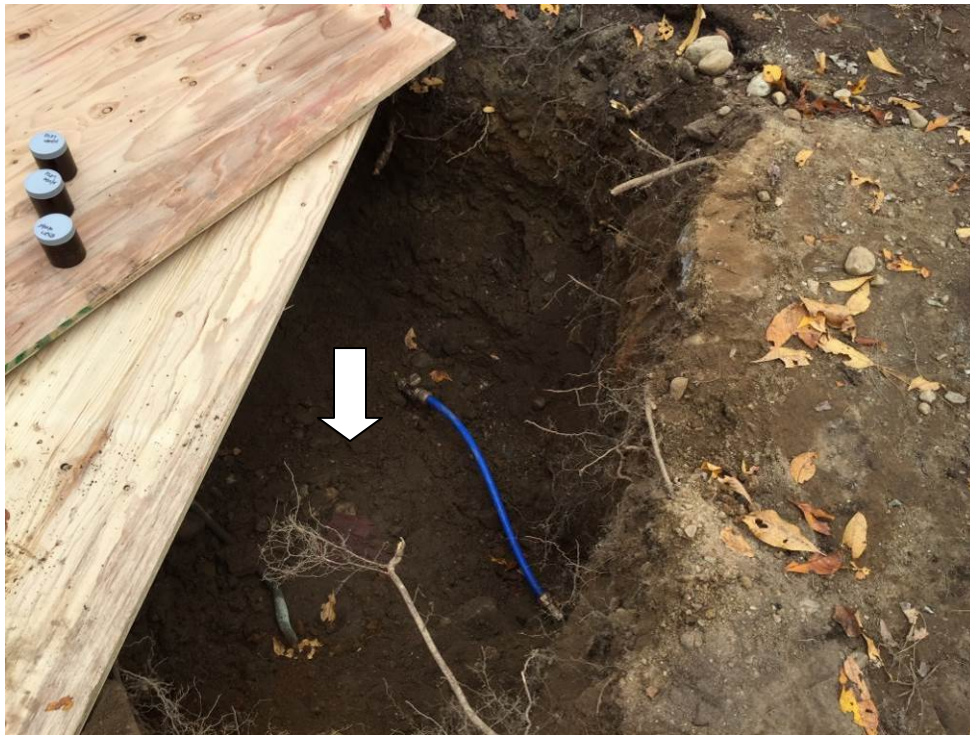
SCENE: SCENE: View of sample RS27/SS-407 location at the bottom of the excavation, and temporary repair of water service line.

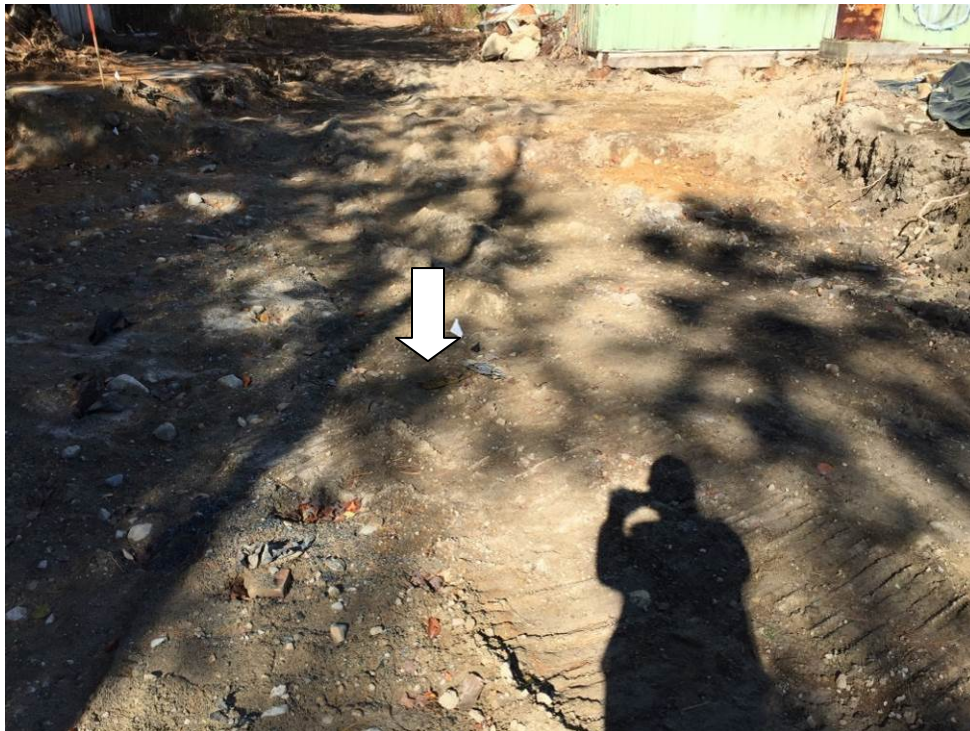
SCENE: View of sample RS29/SS-202 in 3-foot excavation south of the manufacturing building. Photograph taken facing northwest.

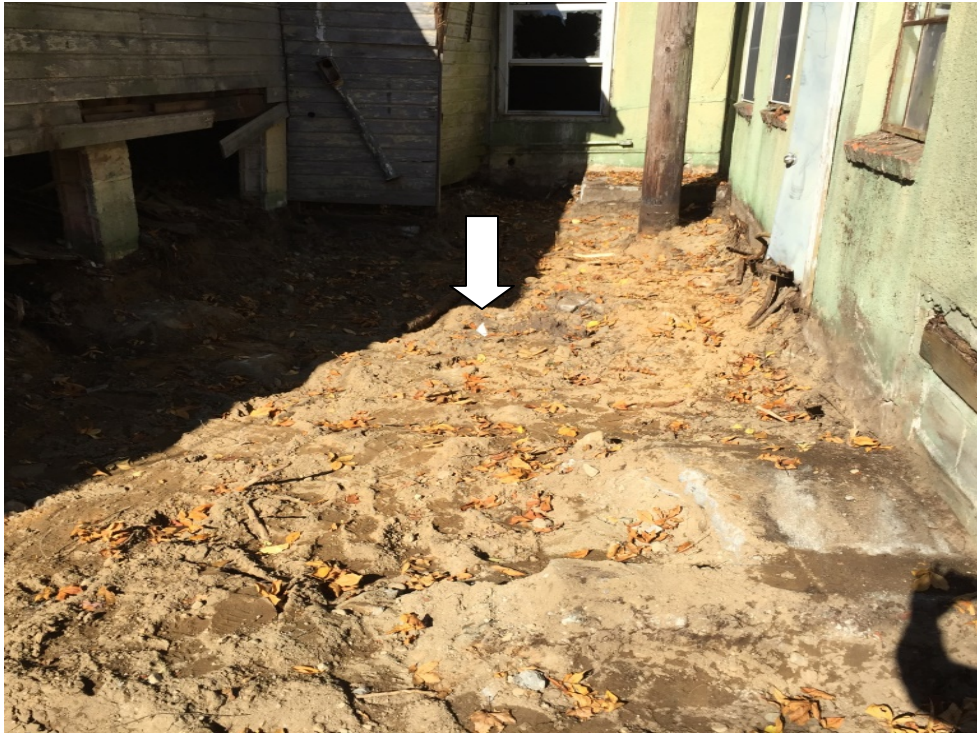
SCENE: View of sample RS32/NobisSS10 in the 2-foot excavation along the southeastern side of the lab building. Photograph taken facing northwest.

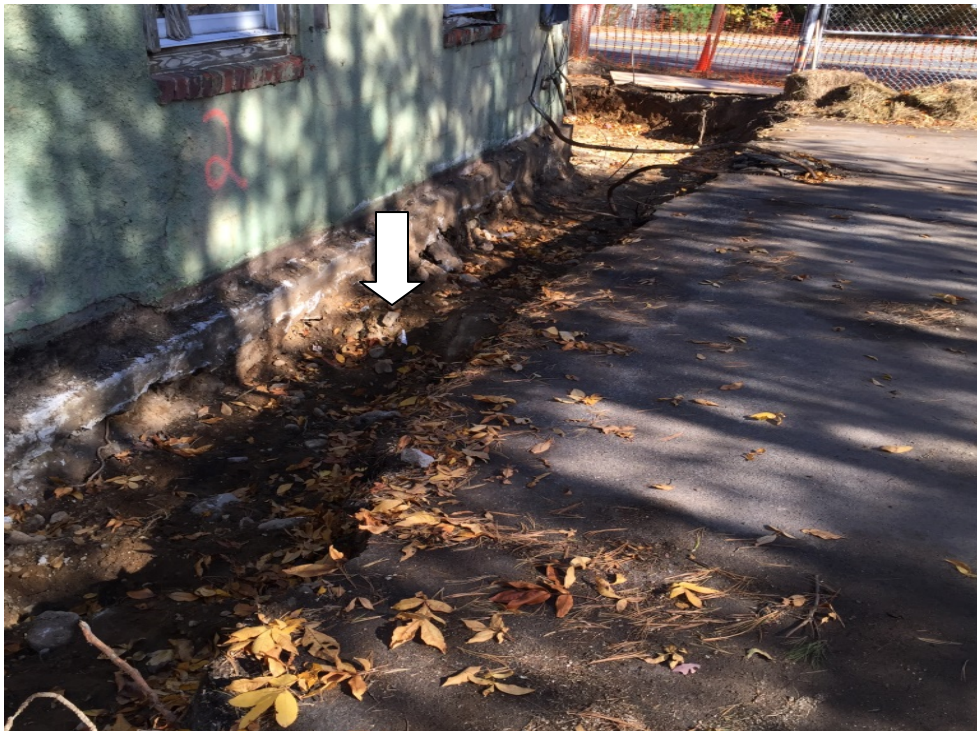
SCENE: View of sample RS31/NobisSS14 in the 2-foot excavation along the southeastern side of the lab building. Photograph taken facing northeast

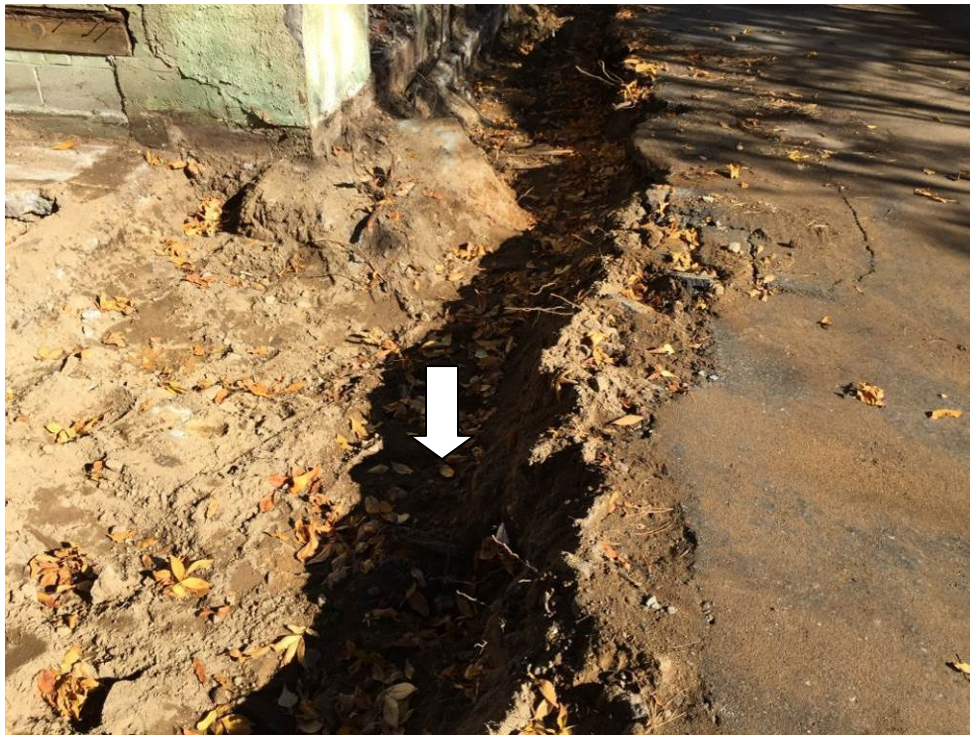
SCENE: View of sample RS30/SS-105 in the 2-foot excavation along the eastern side of the lab building. Photograph taken facing northeast.

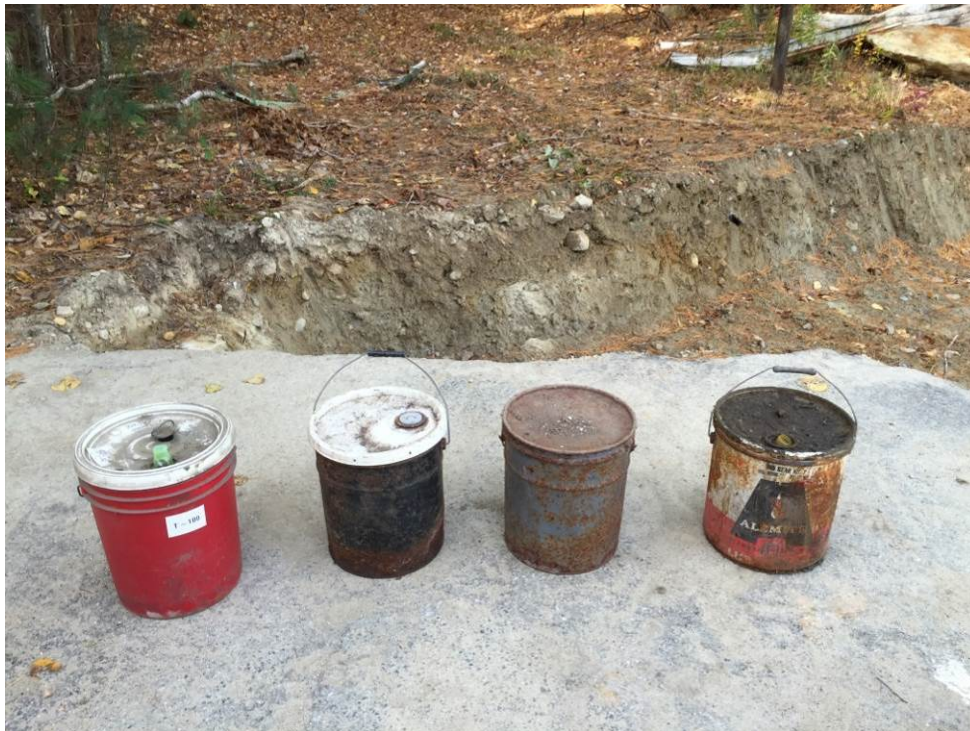
SCENE: View of Bucket Numbers (Nos.) 1, 2, 3, and 4 prior to hazard categorization (hazcat) activities. Photograph taken facing west.

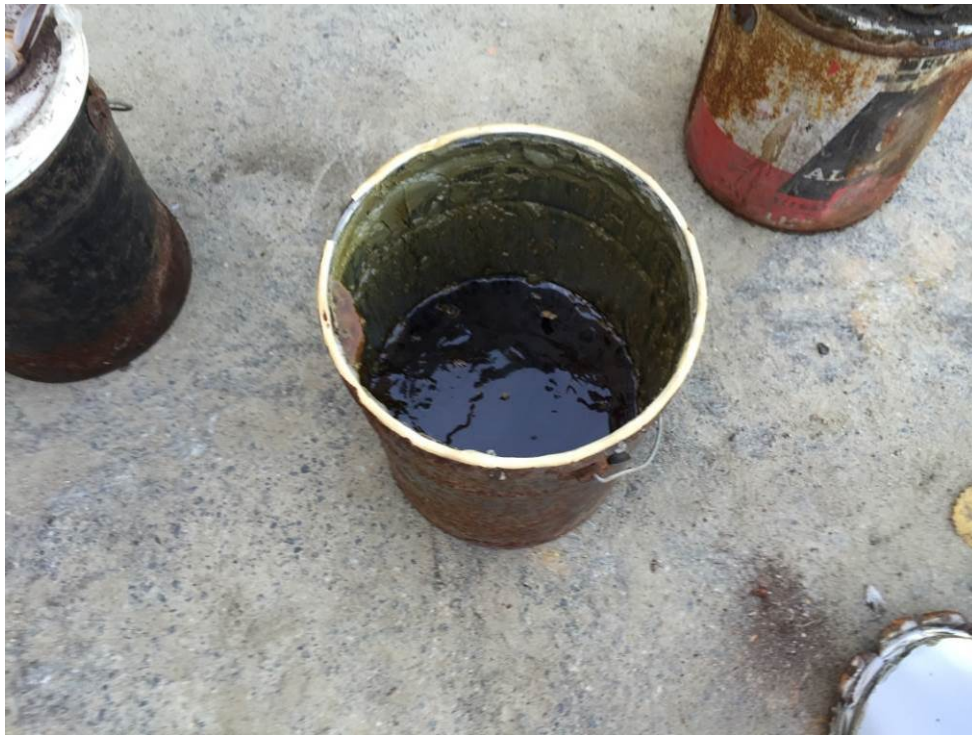
SCENE: View of the contents of Bucket No. 3.

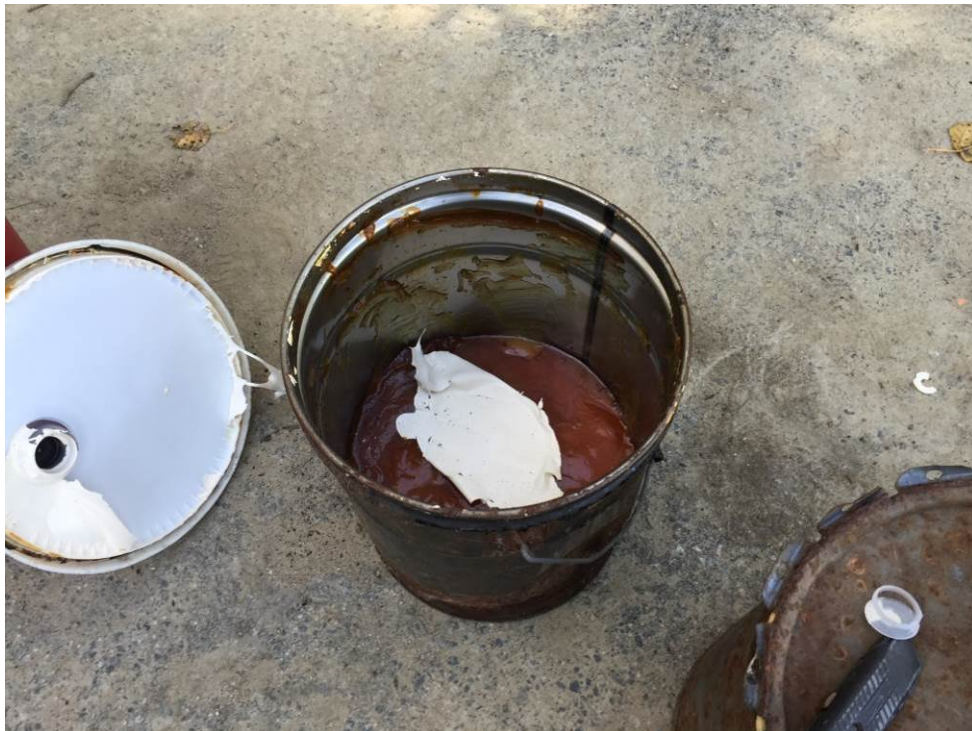
SCENE: View of the contents of Bucket No. 2.

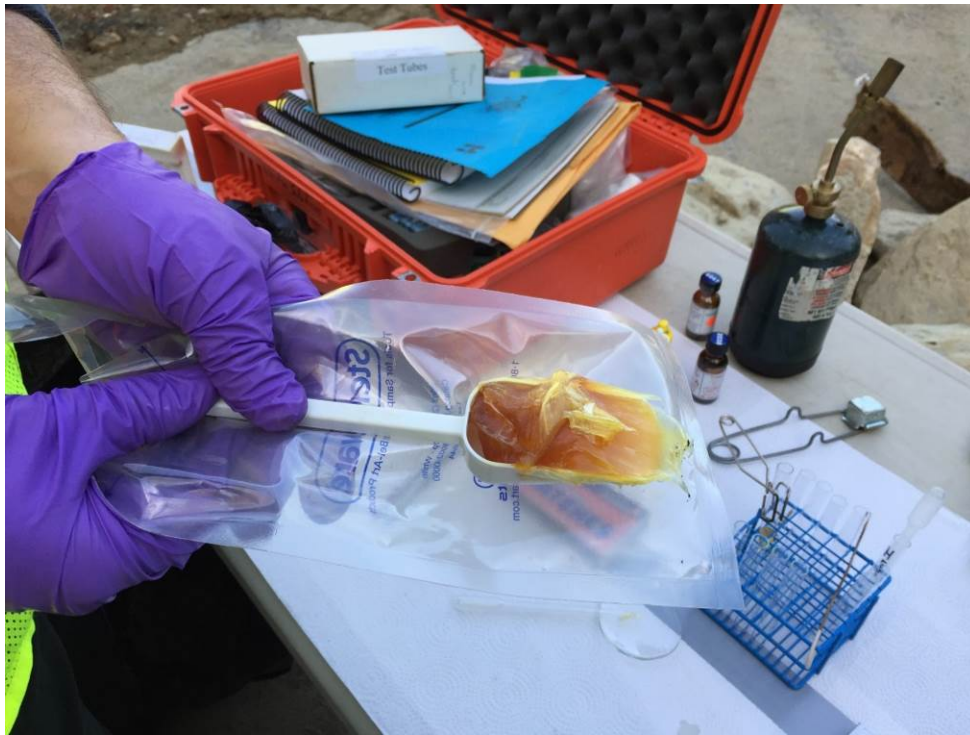
SCENE: View of the contents of Bucket No. 2 during hazcat activities.

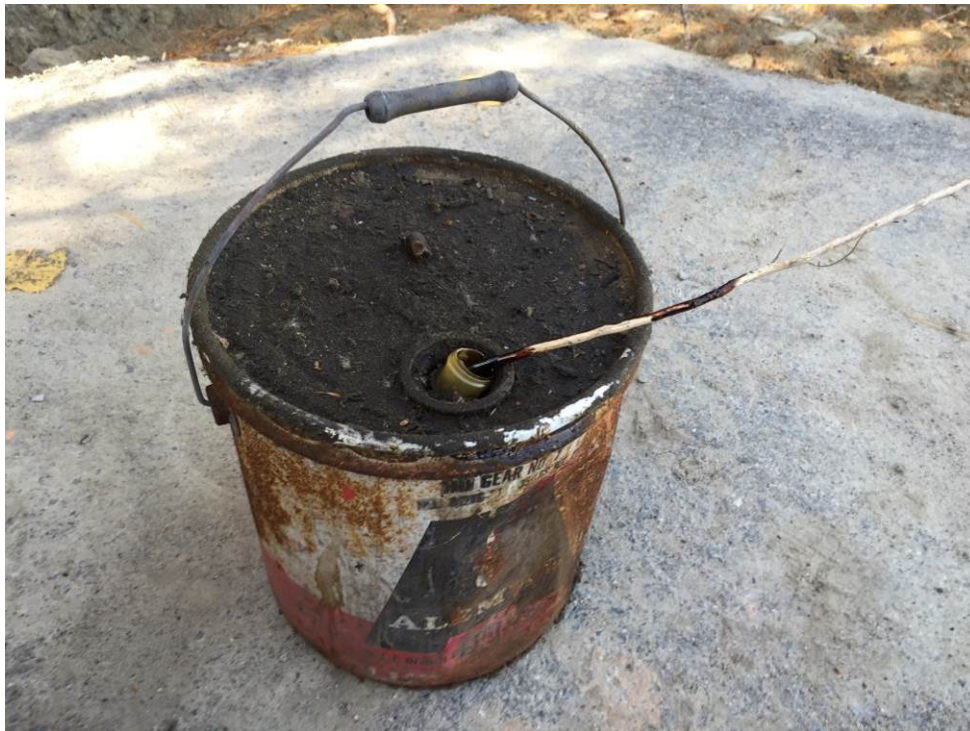
SCENE: View of the contents of Bucket No. 4 on the stick.

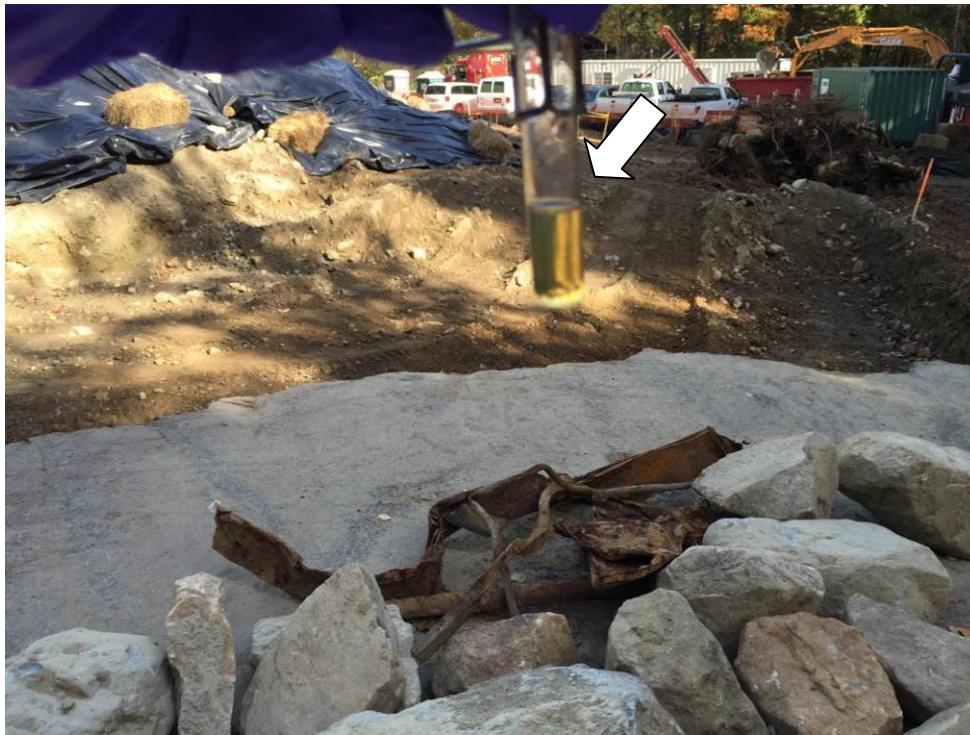
SCENE: View of the contents of Bucket No. 1 in test tube during hazcat activities.

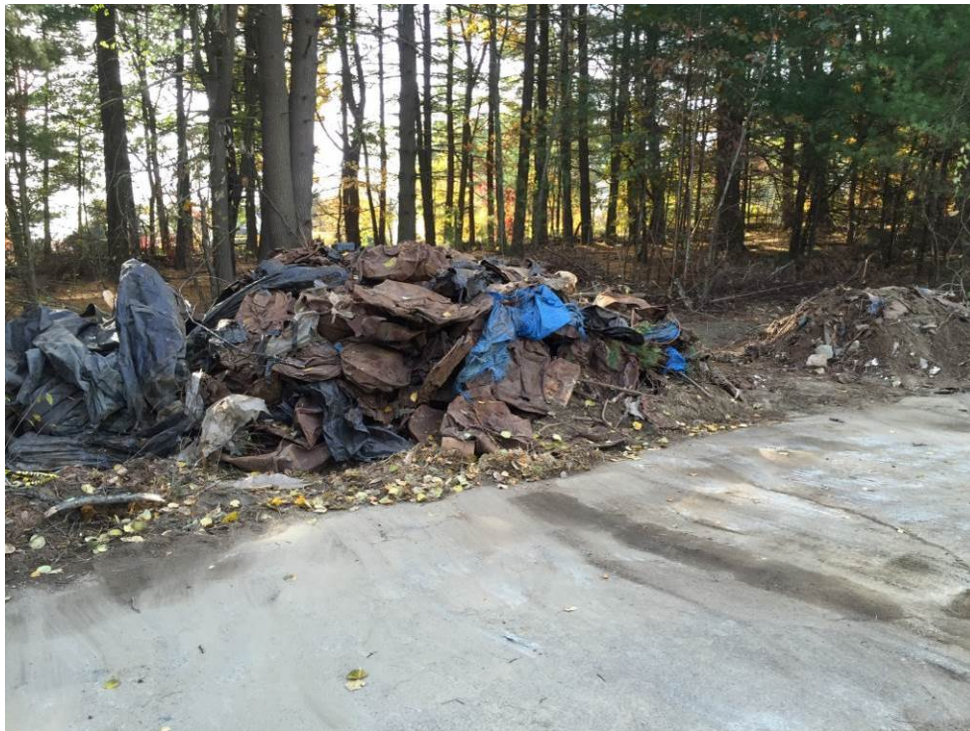
SCENE: View of the Resource Conservation and Recovery Act (RCRA)-contaminated drum carcass pile. Photograph taken facing south.

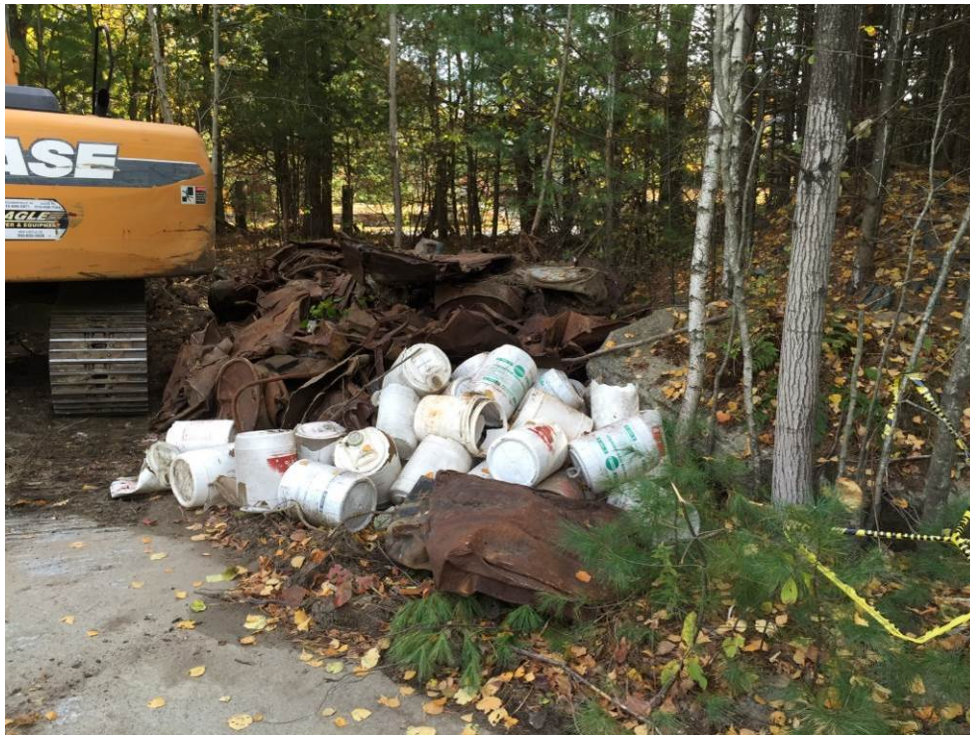
Lab test results of the drum sample were received. Based on the nearly complete absence of contaminants, the contents were added to the soil stockpile. The empty drum was crushed and added to the existing crushed drum pile categorized as non-hazardous waste based on testing performed during the site investigation.

SCENE: View of the non-hazardous drum carcasses and empty plastic containers collected from the site. Photograph taken facing southeast.

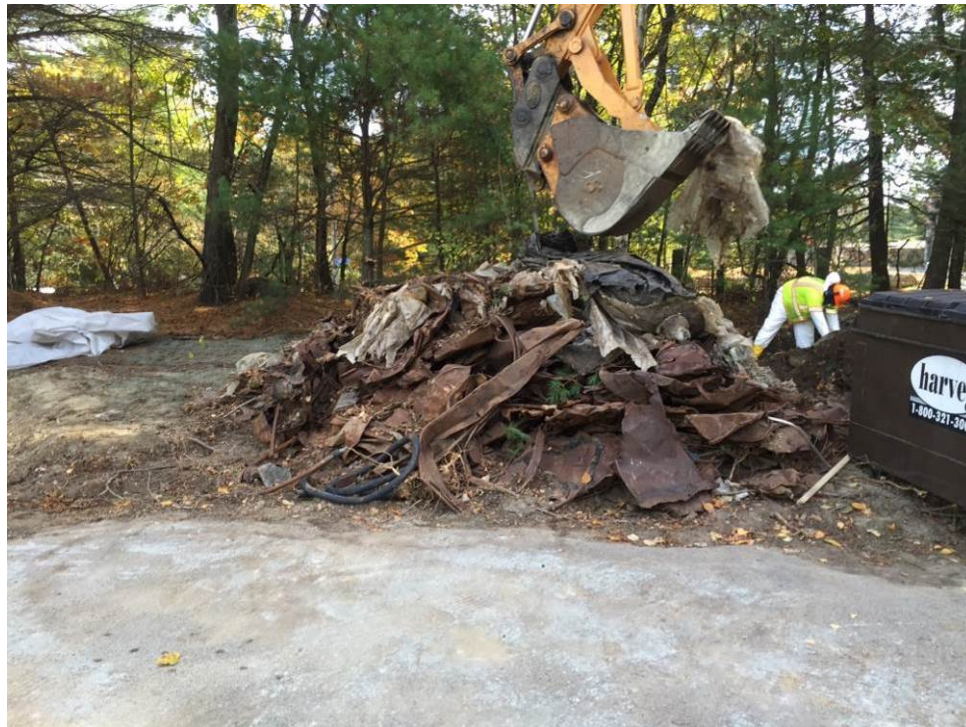
SCENE: View of the Toxic Substances Control Act (TSCA) drum carcass pile. Photograph taken facing east.

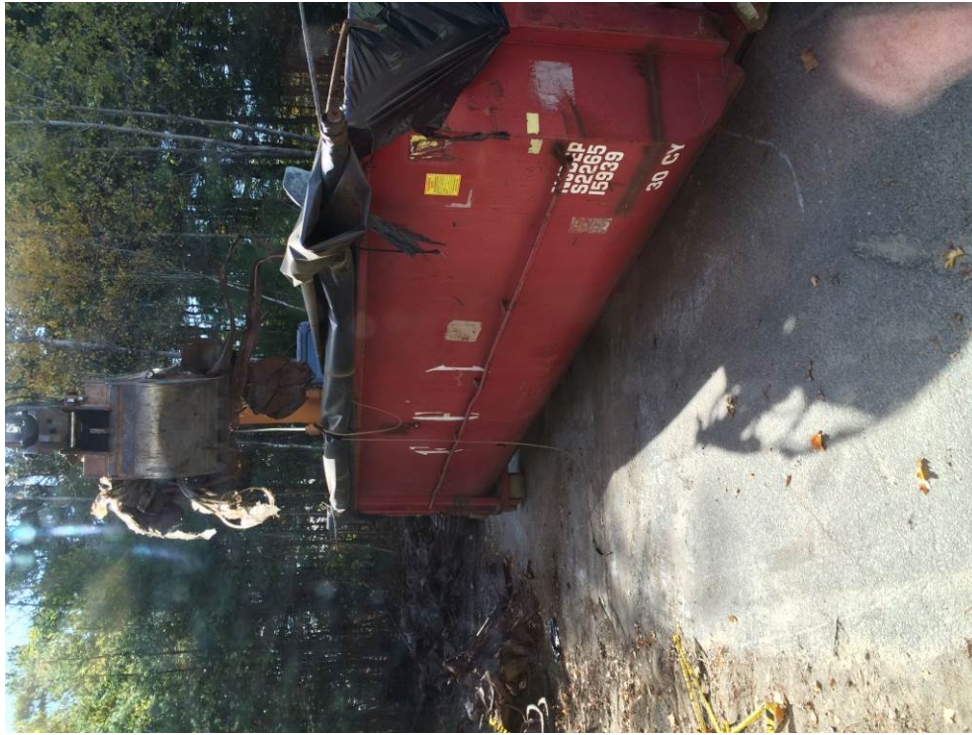
SCENE: View of the TSCA drum carcass pile being loaded into roll-off container for disposal. Photograph taken facing southeast.

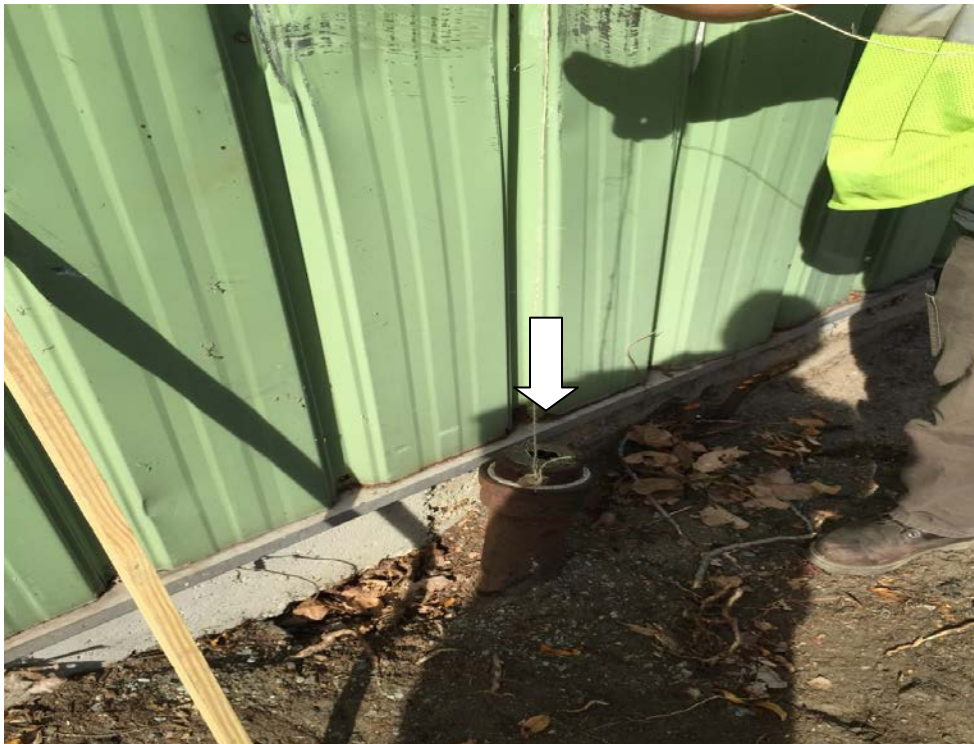
SCENE: View of the potential fill pipe along the southern side of the manufacturing building, with string used to attempt to measure depth. Photograph taken facing north.

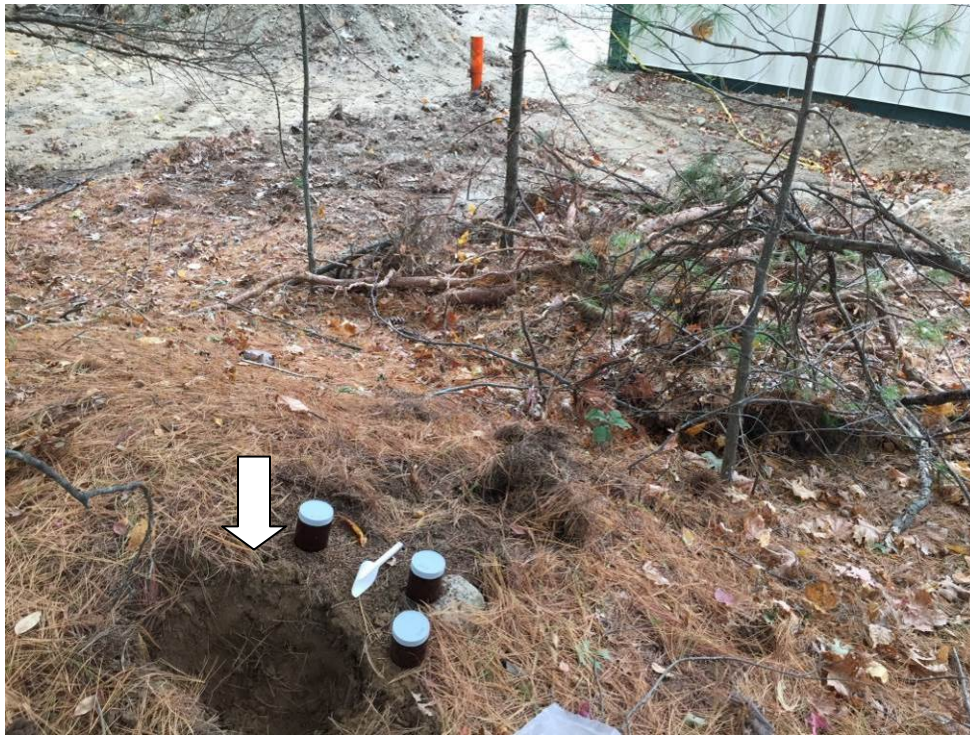
SCENE: View of sample RS33 from the soil pile east of the office trailer. Photograph taken facing west.

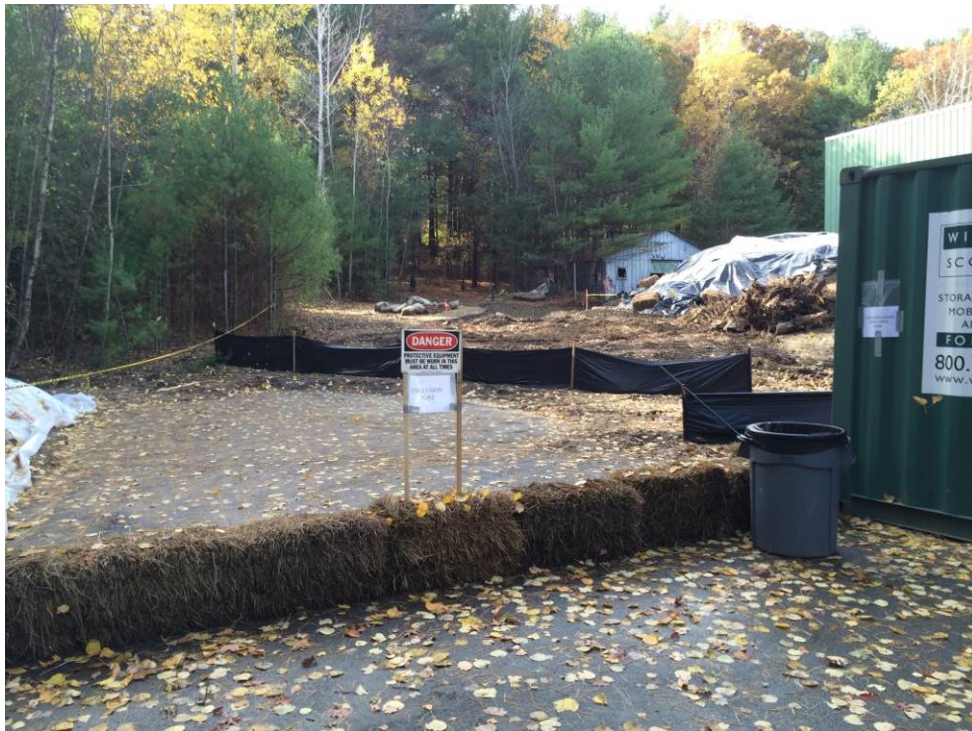
SCENE: View of hay bales and silt fencing installed for erosion control, with exclusion zone/contamination reduction zone signage. Photograph taken facing west.

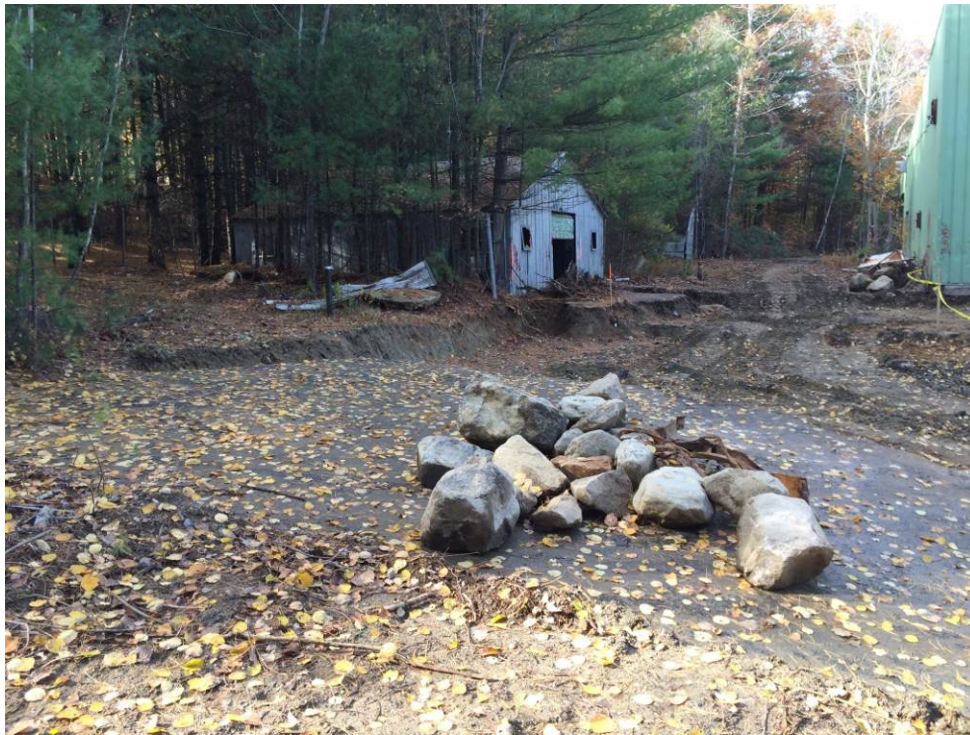
SCENE: View of stones and scrap metal removed from the excavation south of the manufacturing building and staged on an asphalt outcropping. Photograph taken facing northwest.

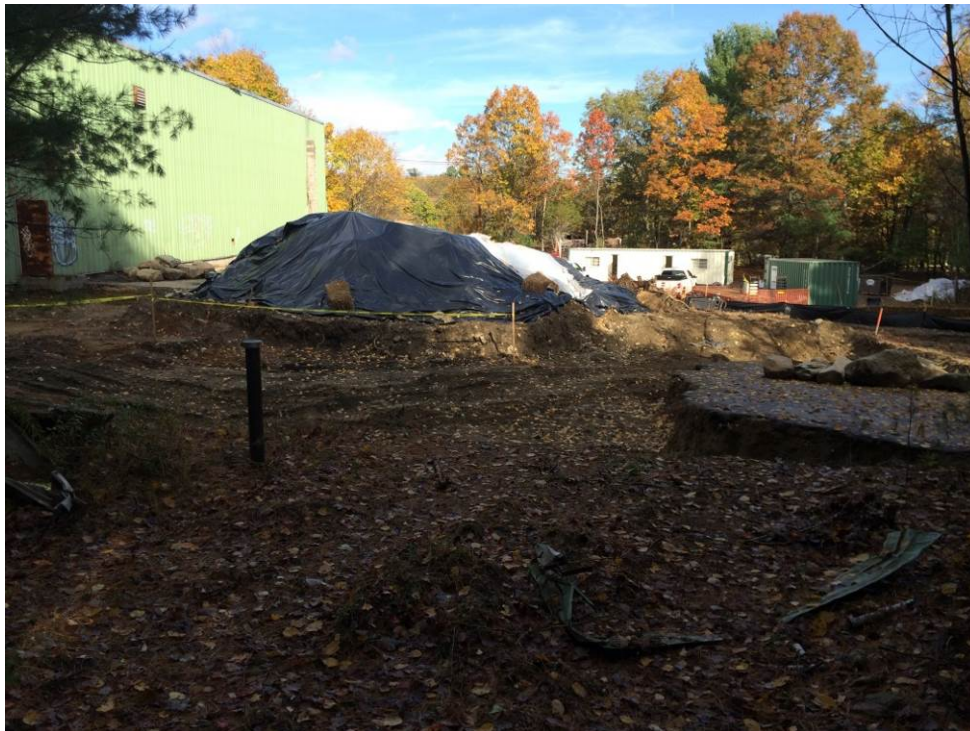
SCENE: View of the excavation around the covered contaminated soil stockpile south of the manufacturing building. Photograph taken facing northeast.

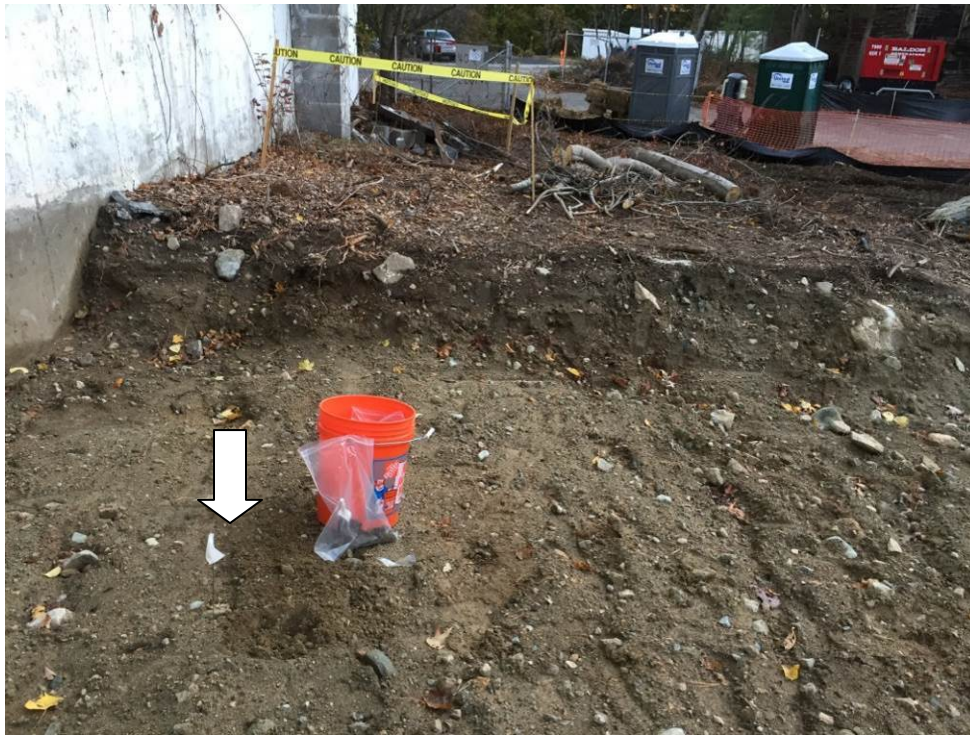
SCENE: View of one aliquot of sample RS34, a 3-point composite, collected from the northeastern end of the 2-foot excavation south of the manufacturing building. Photograph taken facing northeast.

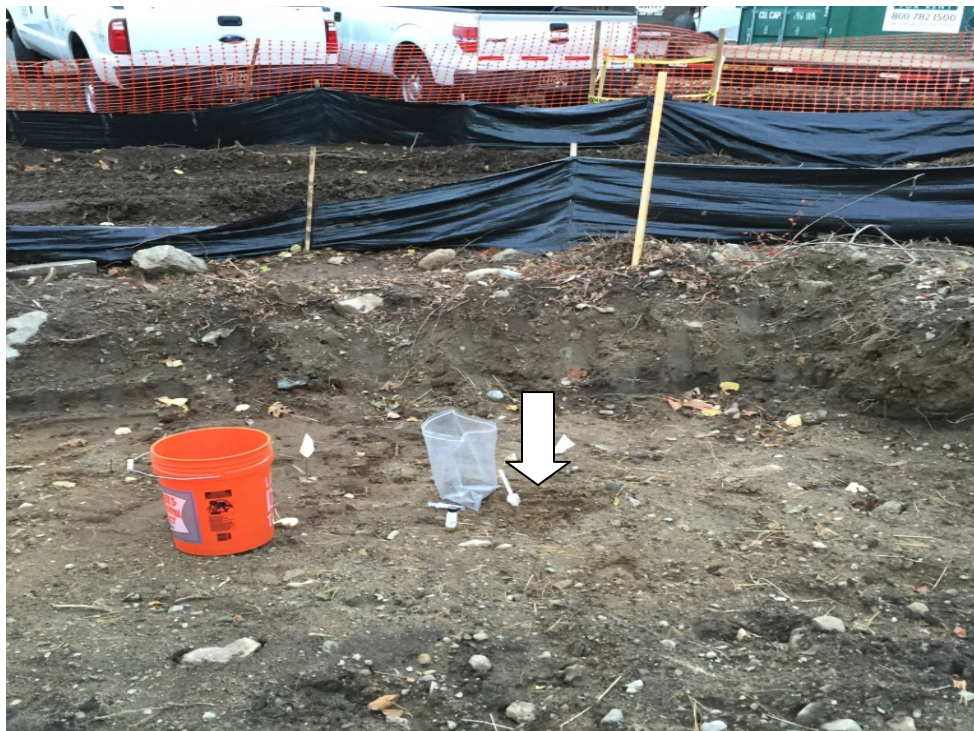
SCENE: View of one aliquot of sample RS34, a 3-point composite, collected from the southeastern end of the 2-foot excavation south of the manufacturing building. Photograph taken facing southeast.

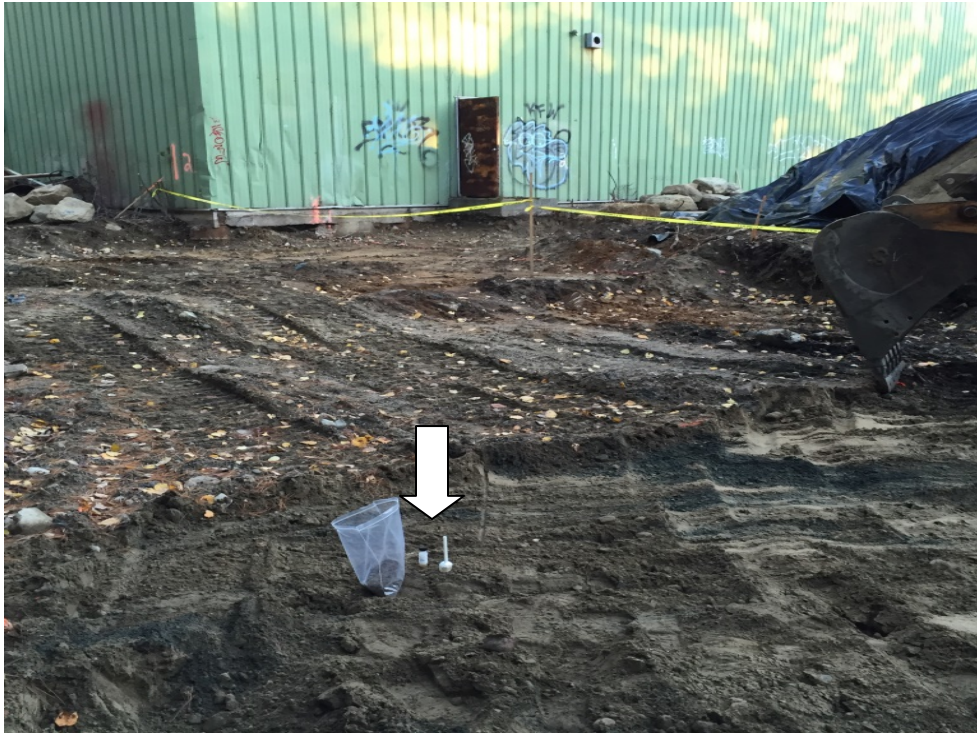
SCENE: View of one aliquot of sample RS34, a 3-point composite, collected from the 3-foot excavation south of the manufacturing building. Photograph taken facing north.

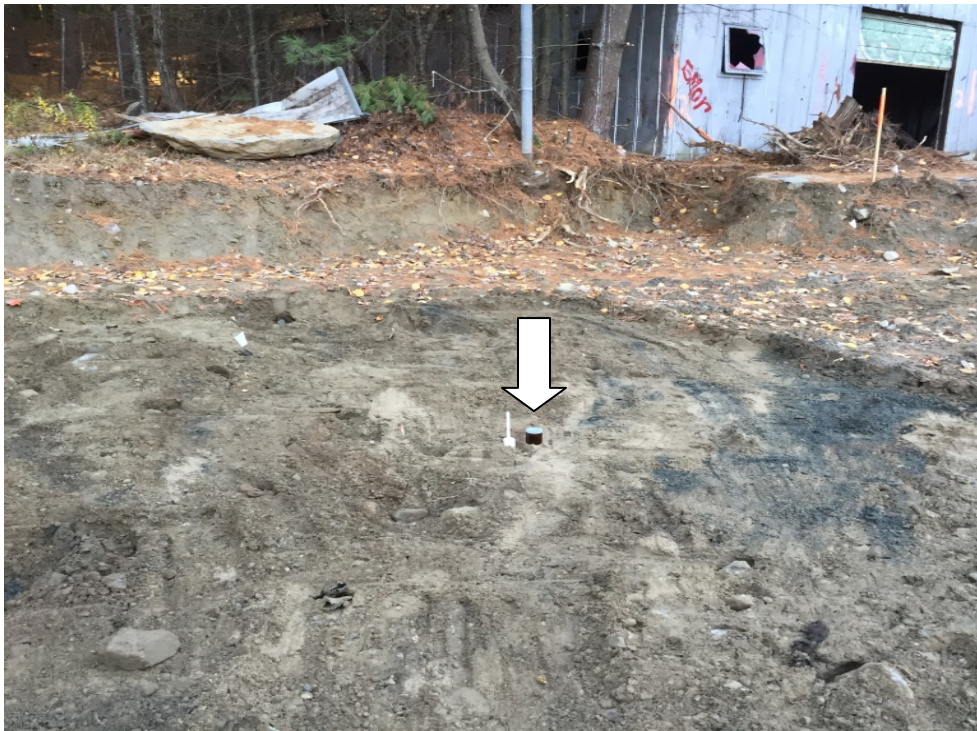
SCENE: View of sample RS35/SS-202, resampled after additional excavation in the 3-foot excavation south of the manufacturing building. Photograph taken facing northwest.
