**REMOVAL PROGRAM
AFTER ACTION REPORT
FOR THE
COLONIAL LACQUER & CHEMICAL CO. SITE
ASHLAND, MIDDLESEX COUNTY, MASSACHUSETTS
28 SEPTEMBER 2015 THROUGH 8 DECEMBER 2015**

Weston Solutions, Inc.
Superfund Technical Assessment and Response Team IV (START)
101 Billerica Avenue, Building 5, Suite 103
North Billerica, Massachusetts 01862

March 2016

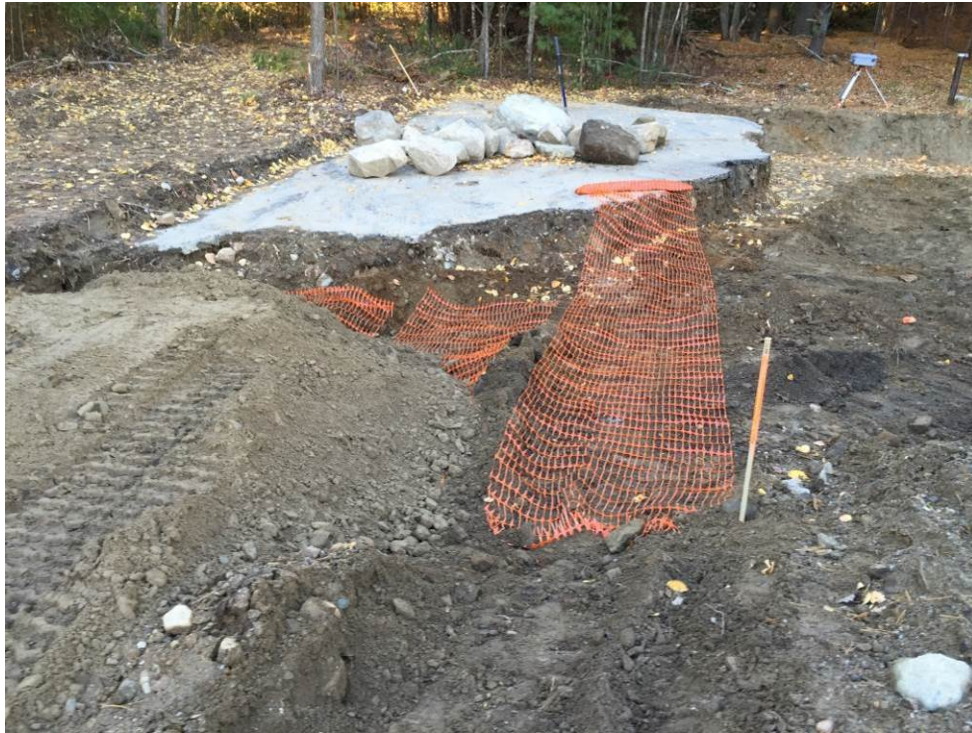
SCENE: View of the high-visibility fencing installed as a marker at the bottom of the excavation south of the manufacturing building prior to backfilling activities, and large rocks segregated from excavated soil and later returned to the excavated area. Photograph taken facing northwest.

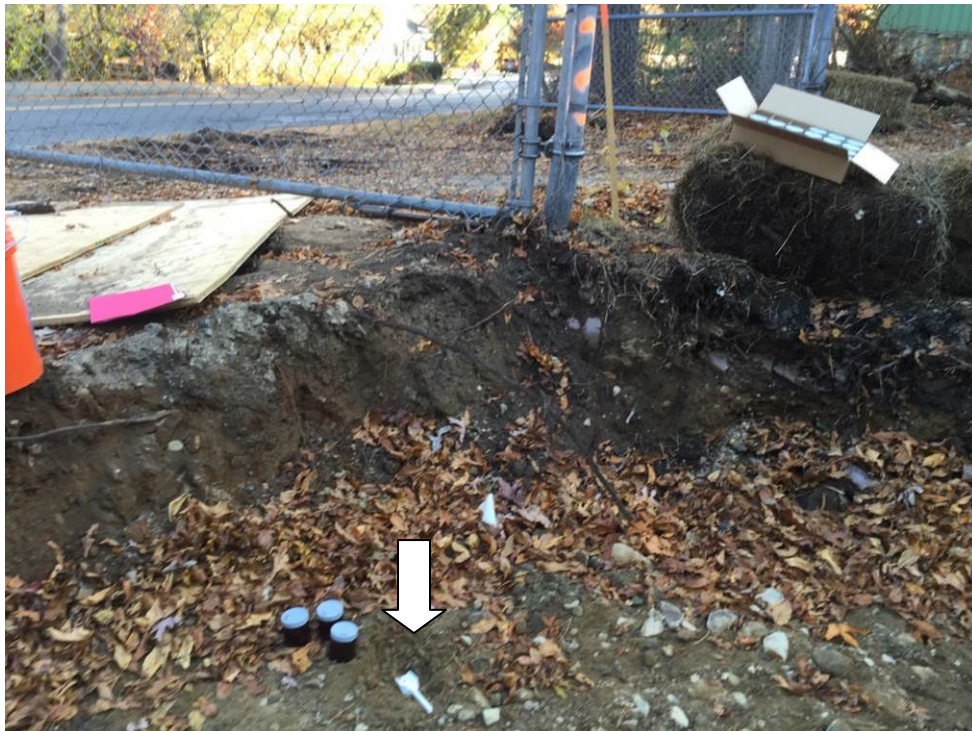
SCENE: View of sample RS36/SS-103 in the 3-foot excavation north of the lab building. Photograph taken facing east.

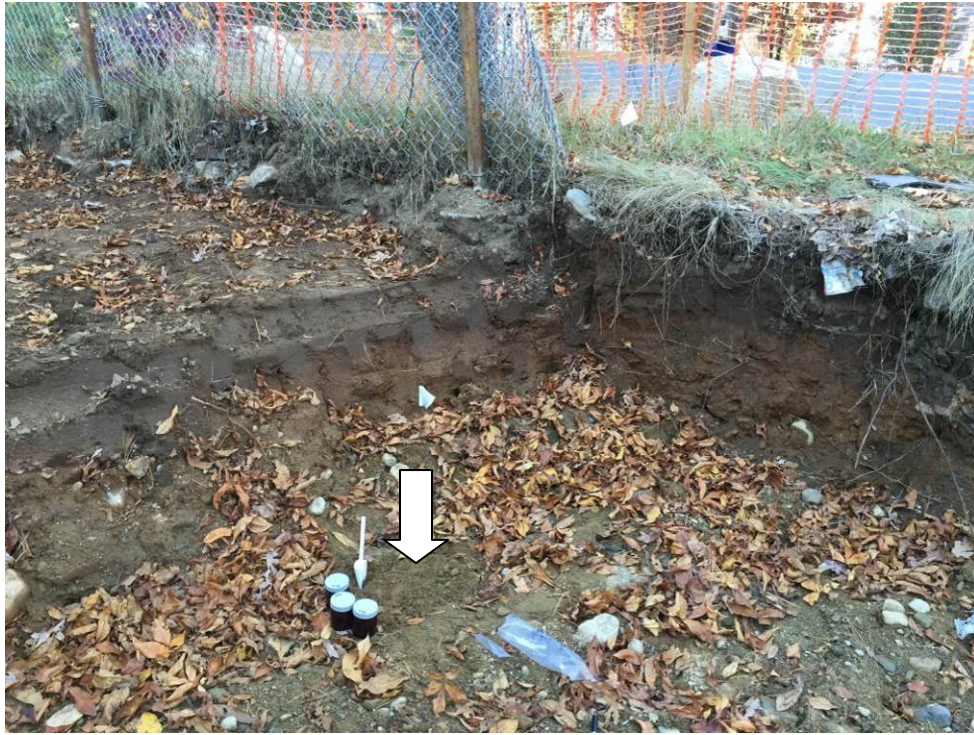
SCENE: View of sample RS37/SS-209 in the 3-foot excavation north of the lab building. Photograph taken facing northwest.

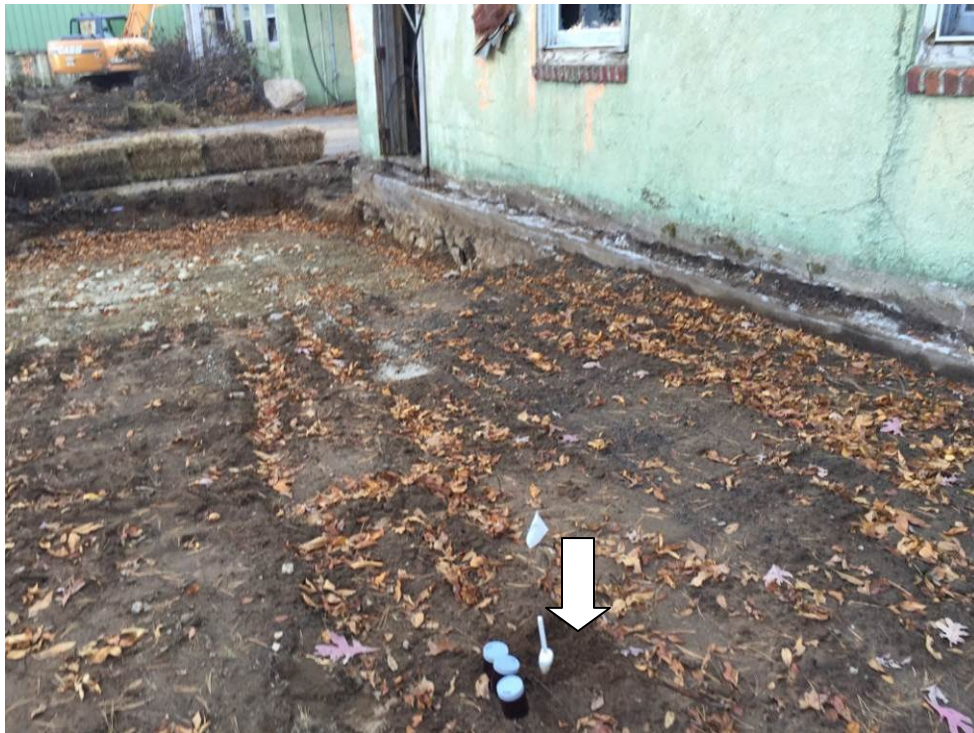
SCENE: View of sample RS38/SS-14/SS-27 in the 1-foot excavation north of the lab building. Photograph taken facing southeast.

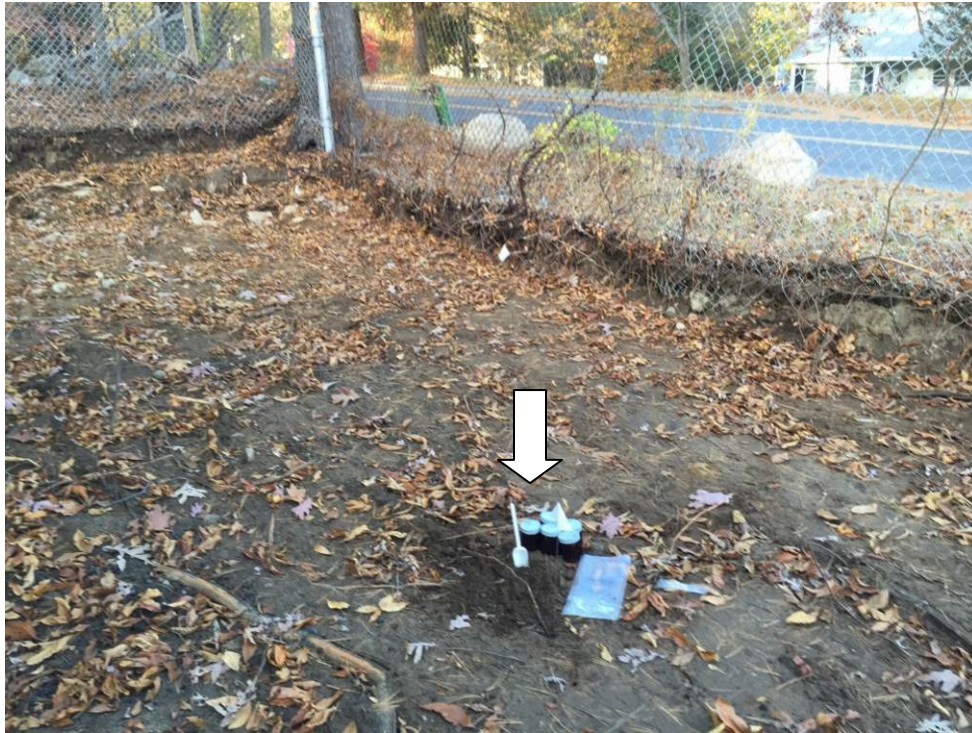
SCENE: View of sample RS39/SS-15 and RS46 (duplicate) in the 1-foot excavation north of the lab building. Photograph taken facing northwest.

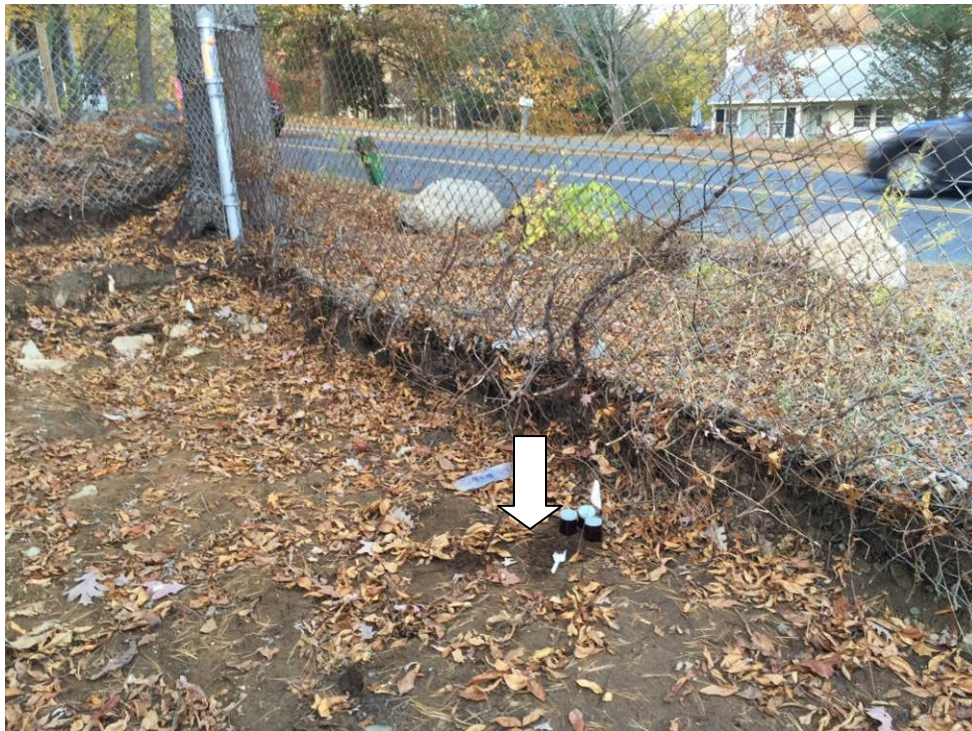
SCENE: View of sample RS40/SS-208 in the 1-foot excavation north of the lab building. Photograph taken facing northwest.

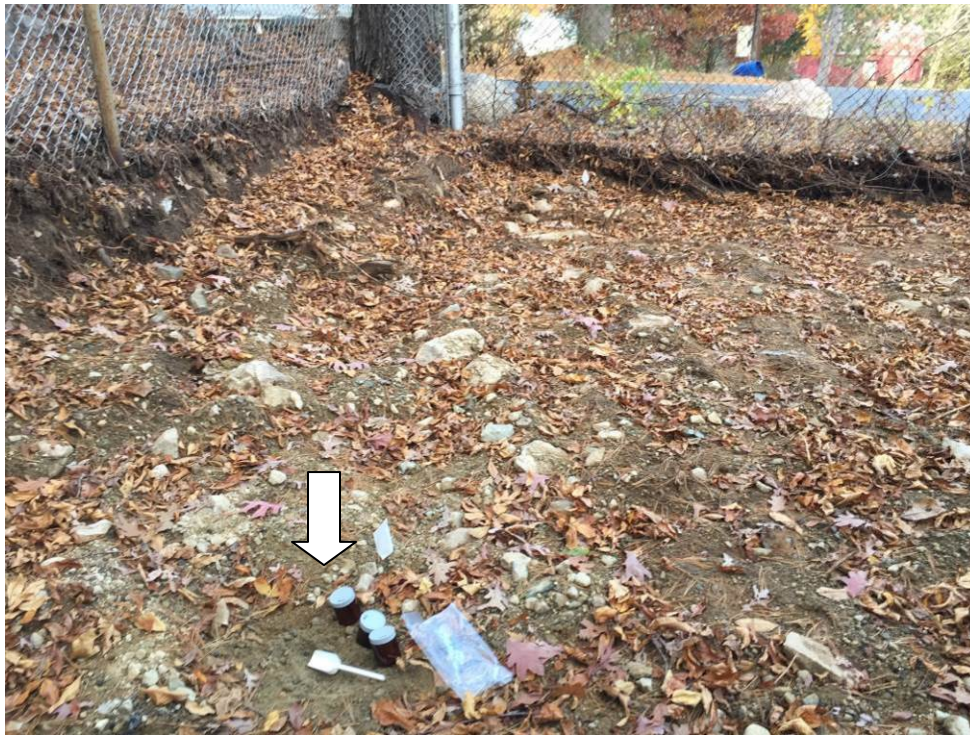
SCENE: View of sample RS41/SS-18 in the 1-foot excavation north of the lab building. Photograph taken facing northeast.

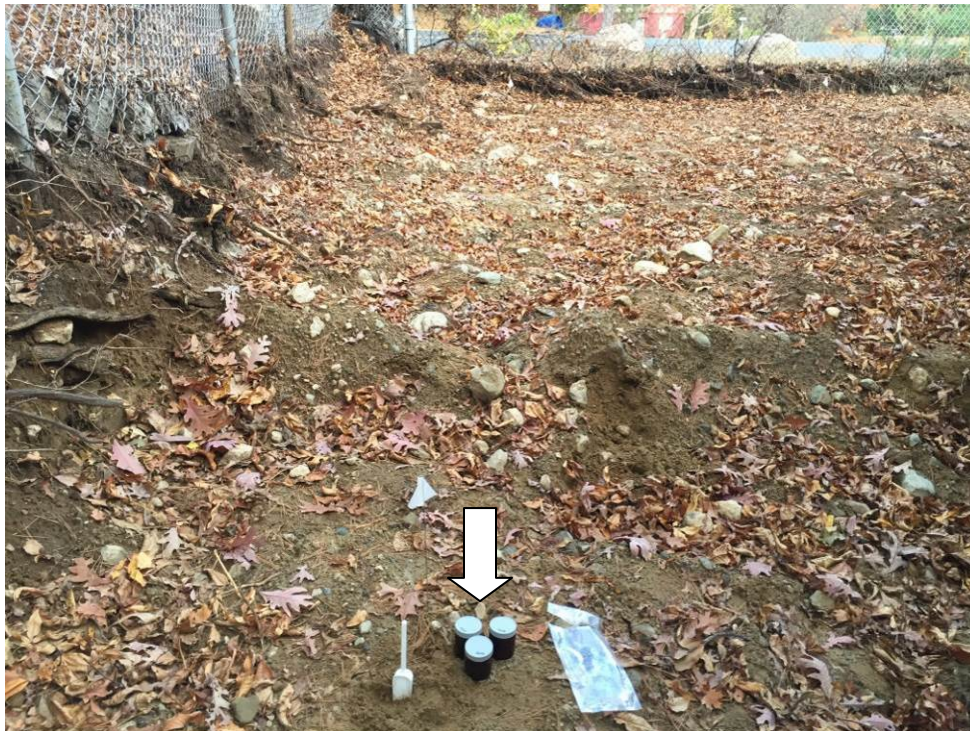
SCENE: View of sample RS42/SS-307 in the 2-foot excavation west of the lab building. Photograph taken facing northeast.

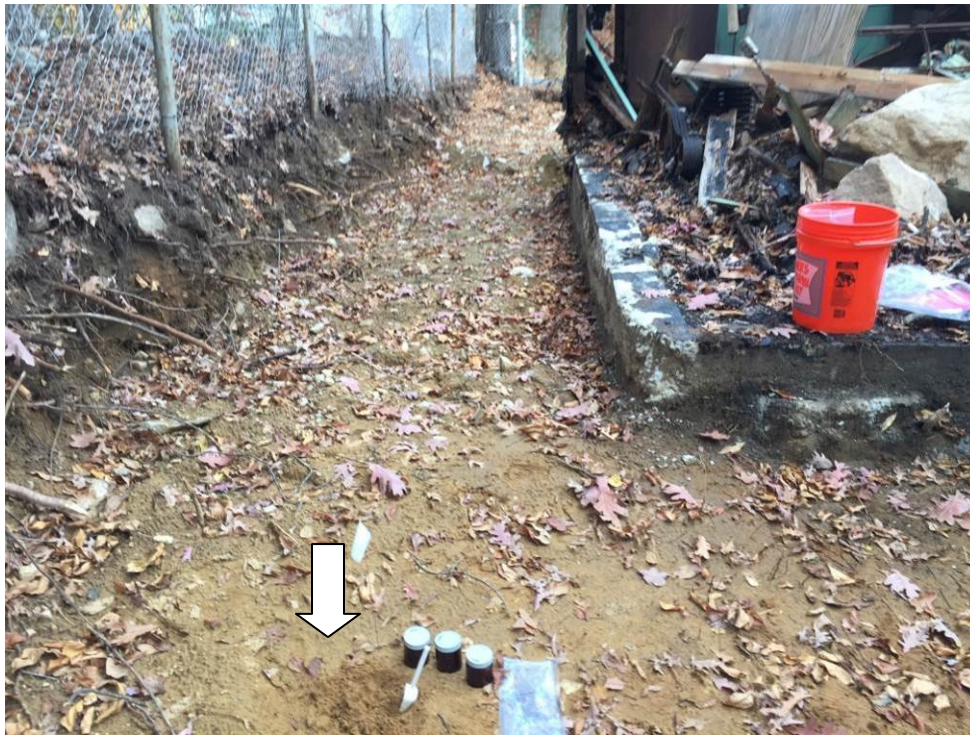
SCENE: View of sample RS43/SS-308 in the 2-foot excavation west of the lab building. Photograph taken facing northeast.

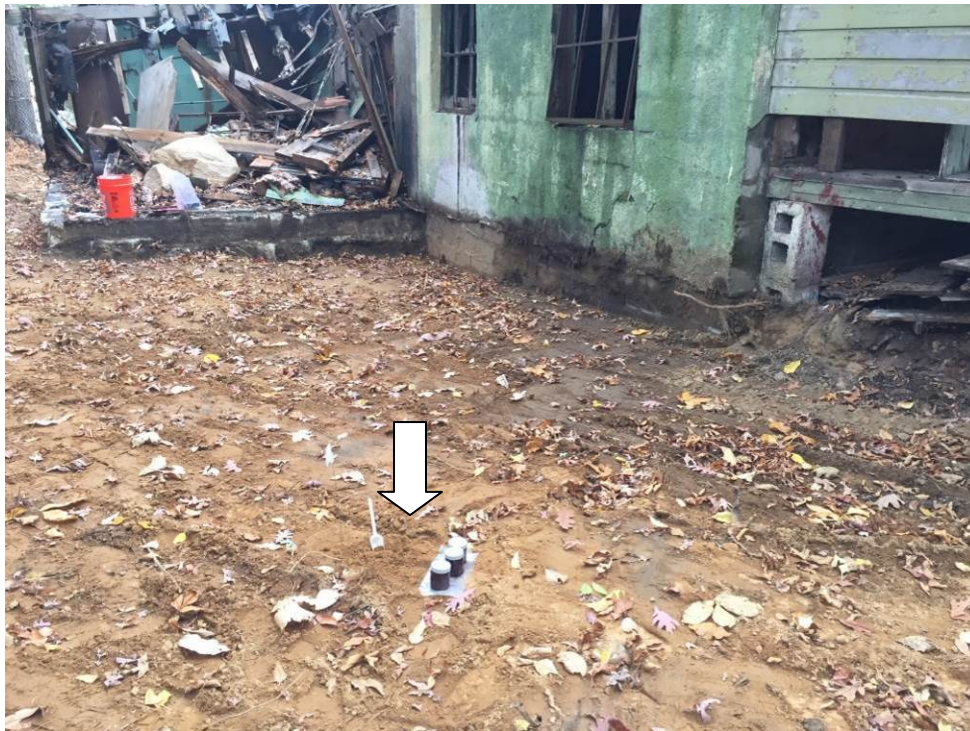
SCENE: View of sample RS44 in the 2-foot excavation west of the lab building. Photograph taken facing east.

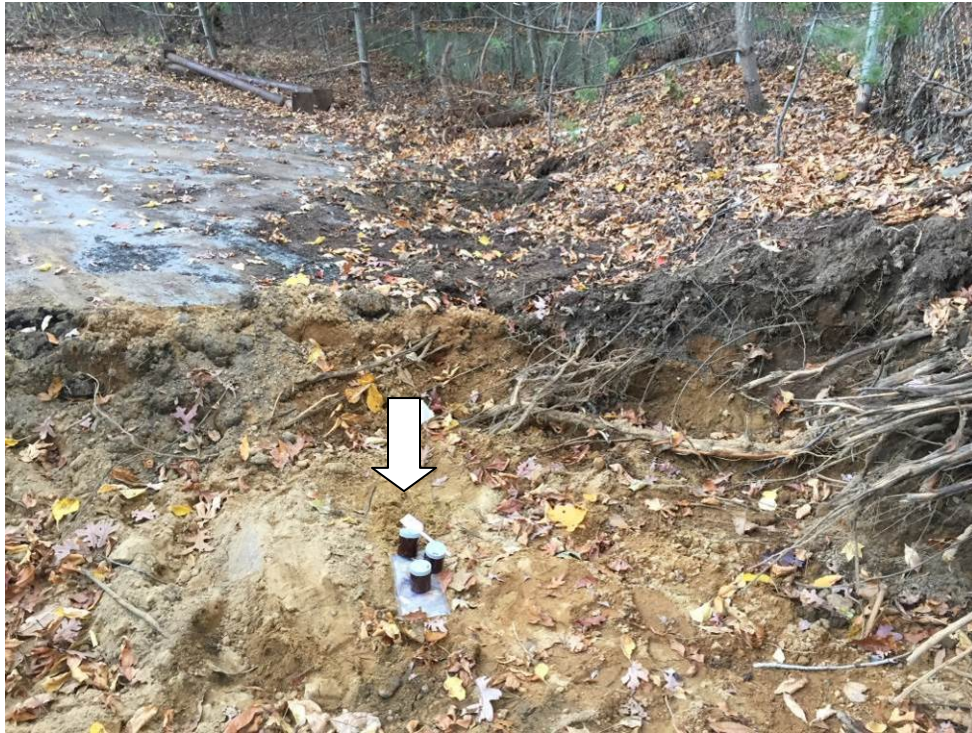
SCENE: View of sample RS45/SS-108 in the 2-foot excavation southwest of the lab building. Photograph taken facing southwest.

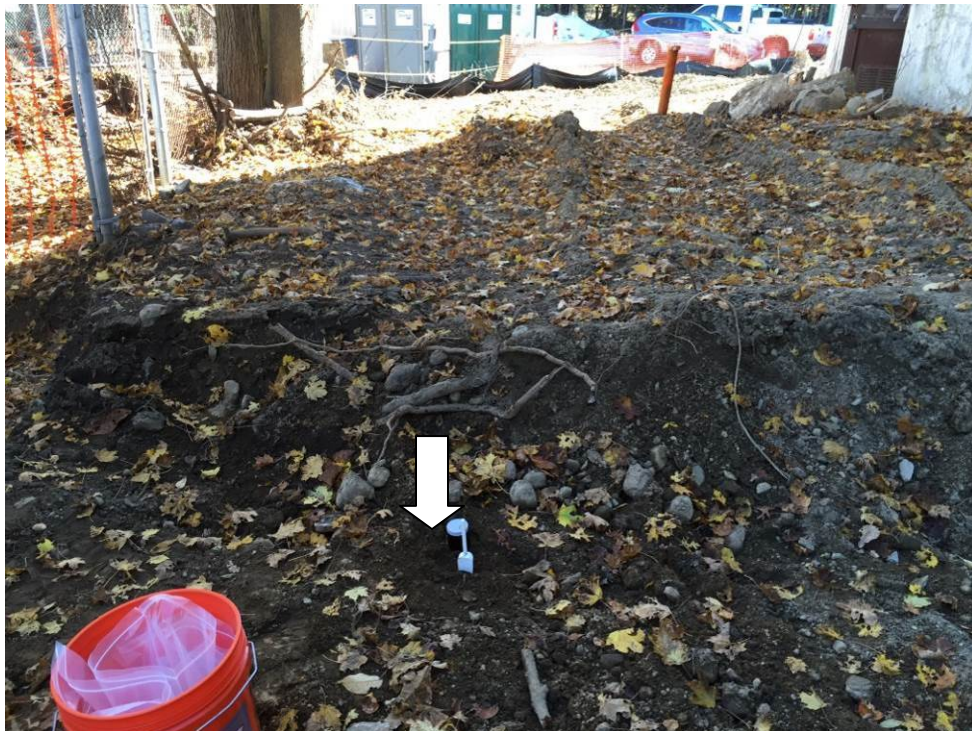
SCENE: View of sample RS47/SS-08 following additional excavation in the 2.5-foot excavation north of the manufacturing building. Photograph taken facing southeast.

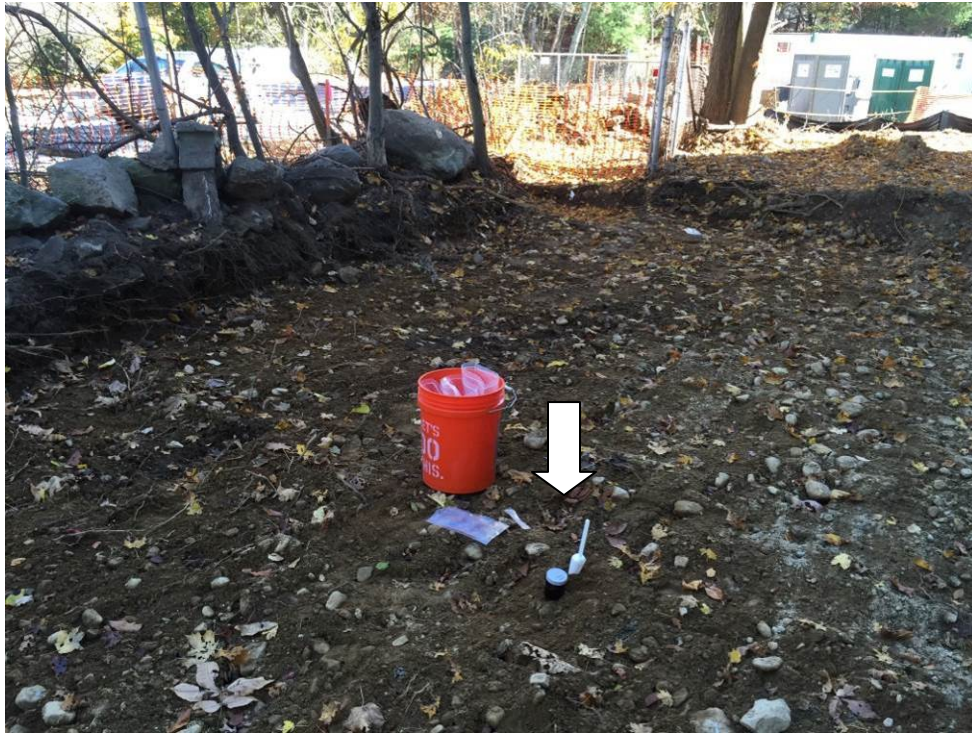
SCENE: View of sample RS49/SS-09 following additional excavation in the 2.5-foot excavation north of the manufacturing building. Photograph taken facing southeast.

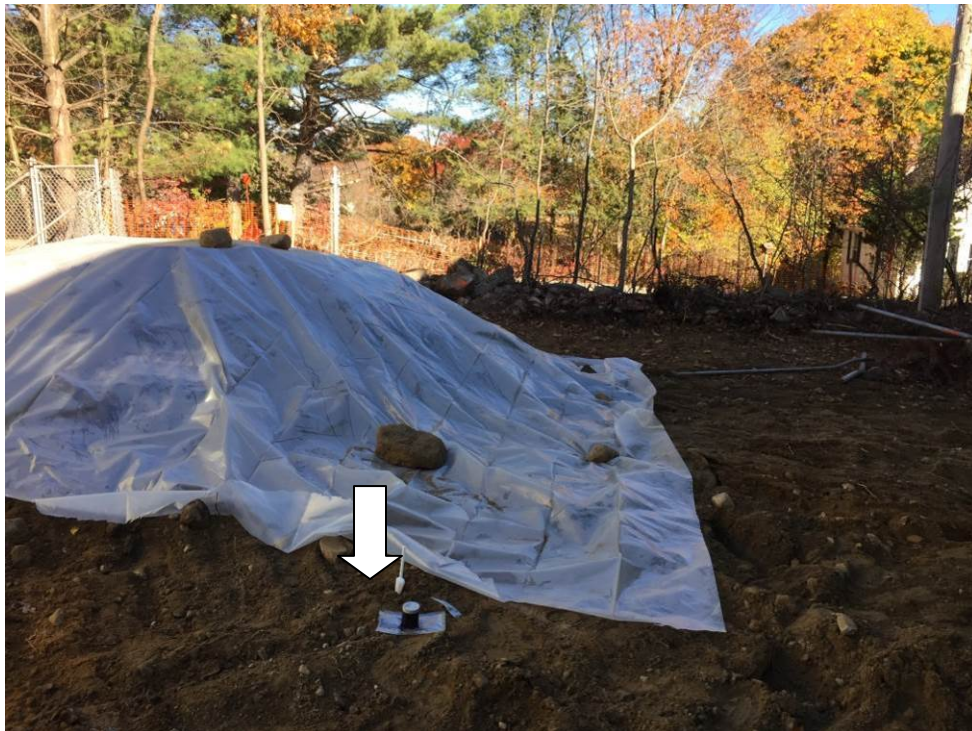
SCENE: View of sample RS48 following additional excavation in the 2-foot excavation between the manufacturing and office buildings, with stockpiled contaminated soil to the rear. Photograph taken facing north.

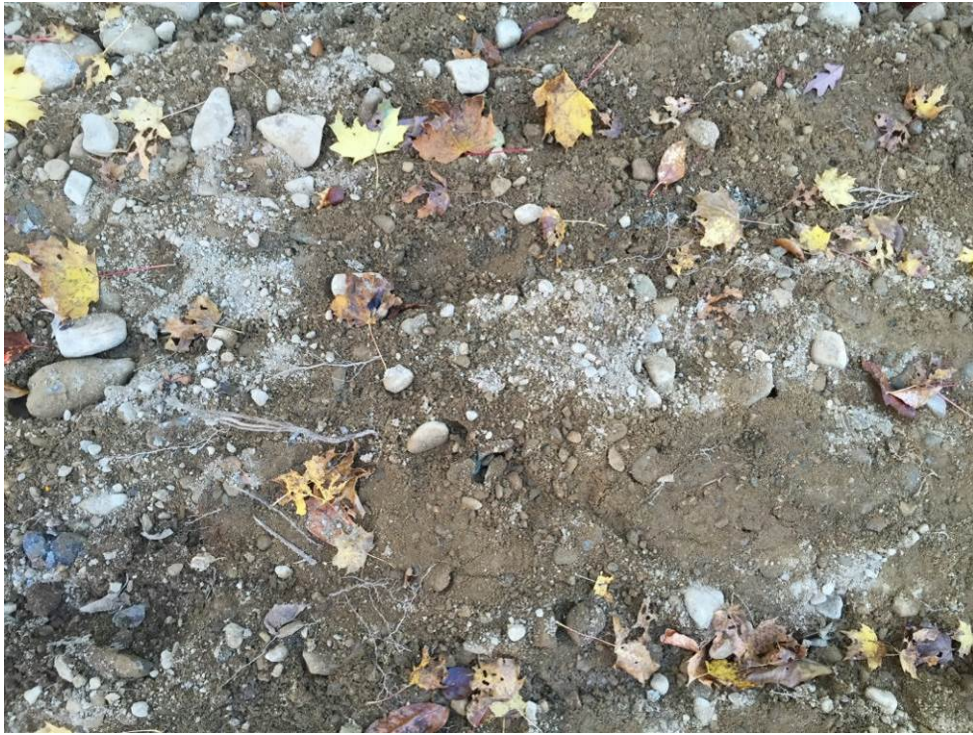
SCENE: View of the soil sampled for one aliquot of a 3-point composite (RS50) from the excavation northwest of the manufacturing building.

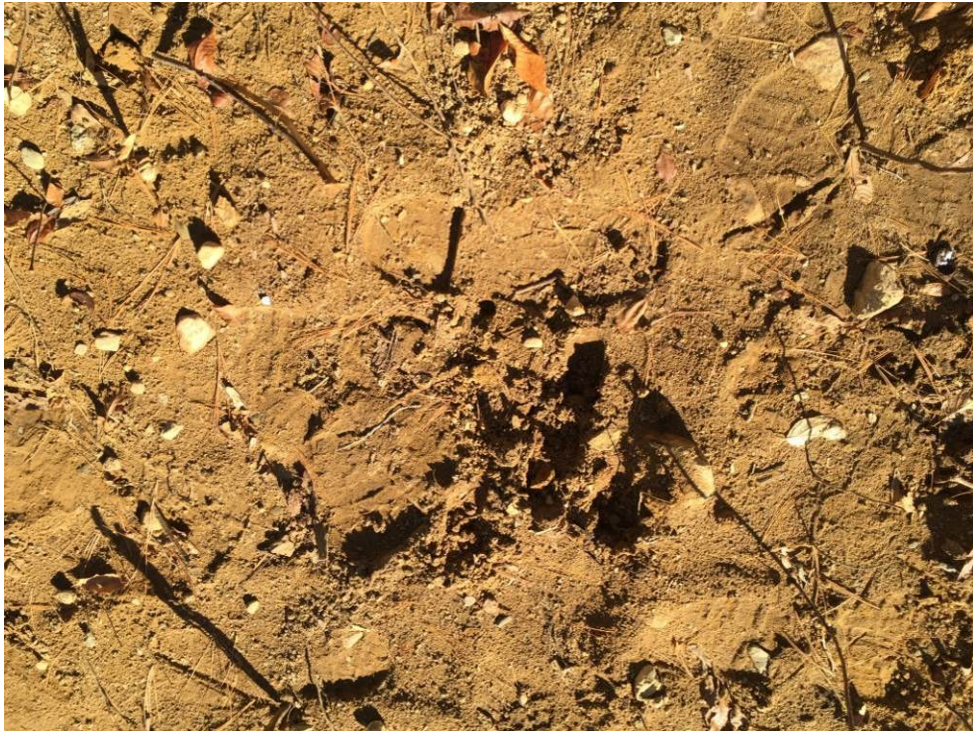
SCENE: View of the soil sampled for one aliquot of a 3-point composite (RS50) from the excavation northwest of the manufacturing building.

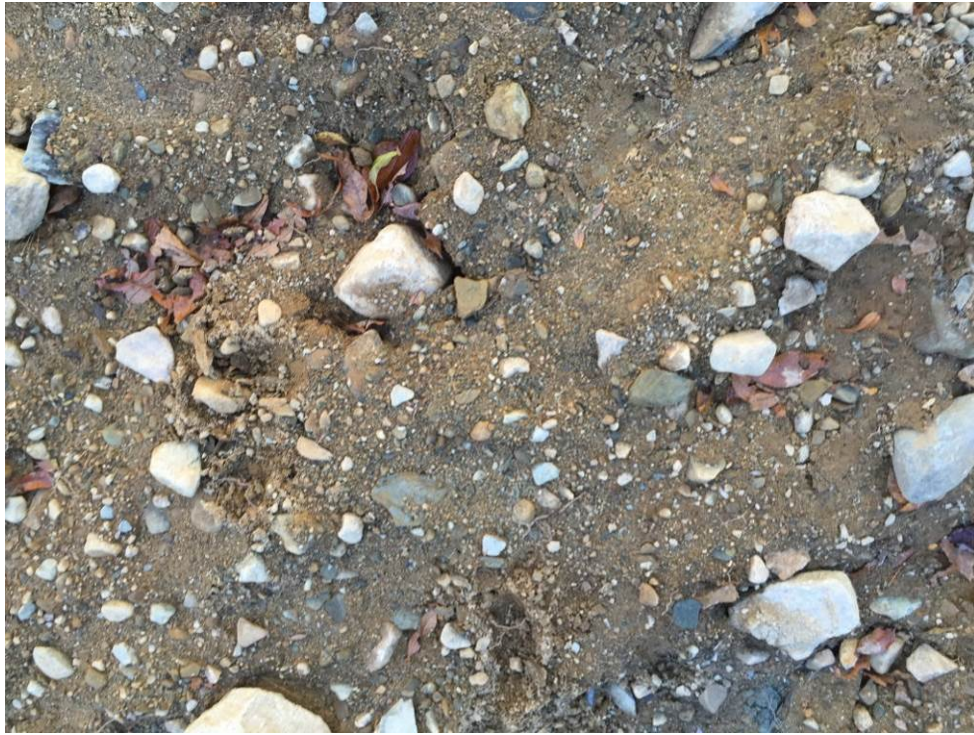
SCENE: View of the soil sampled for one aliquot of a 3-point composite (RS50) from the excavation northwest of the manufacturing building.

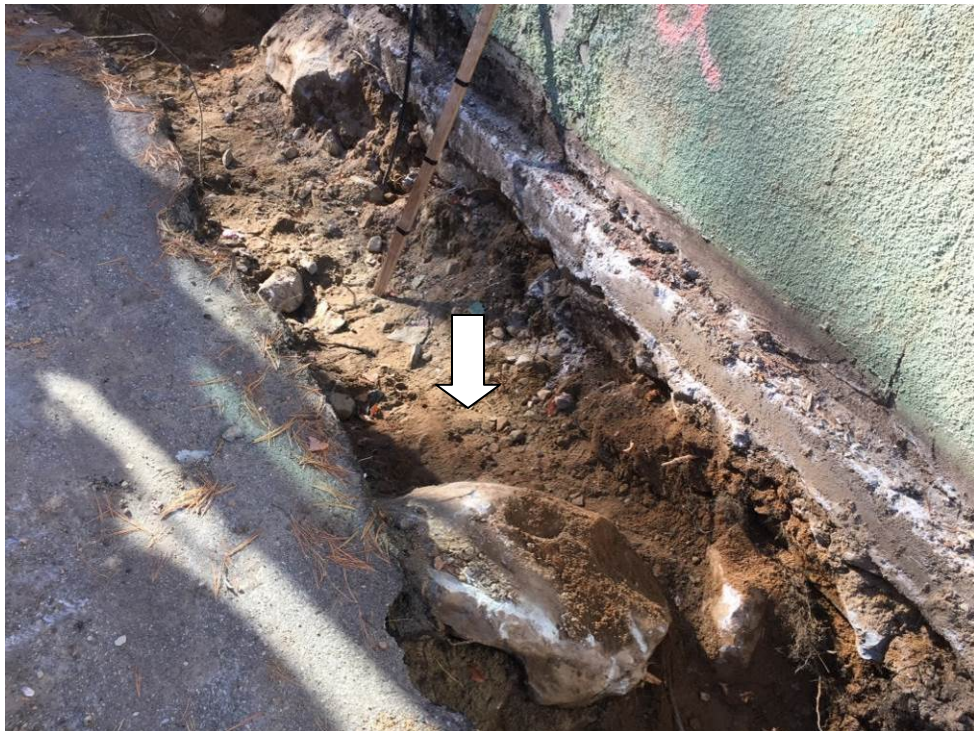
SCENE: View of sample RS52/NobisSS14 following additional excavation in the 3-foot excavation east of the lab building. Photograph taken facing west.

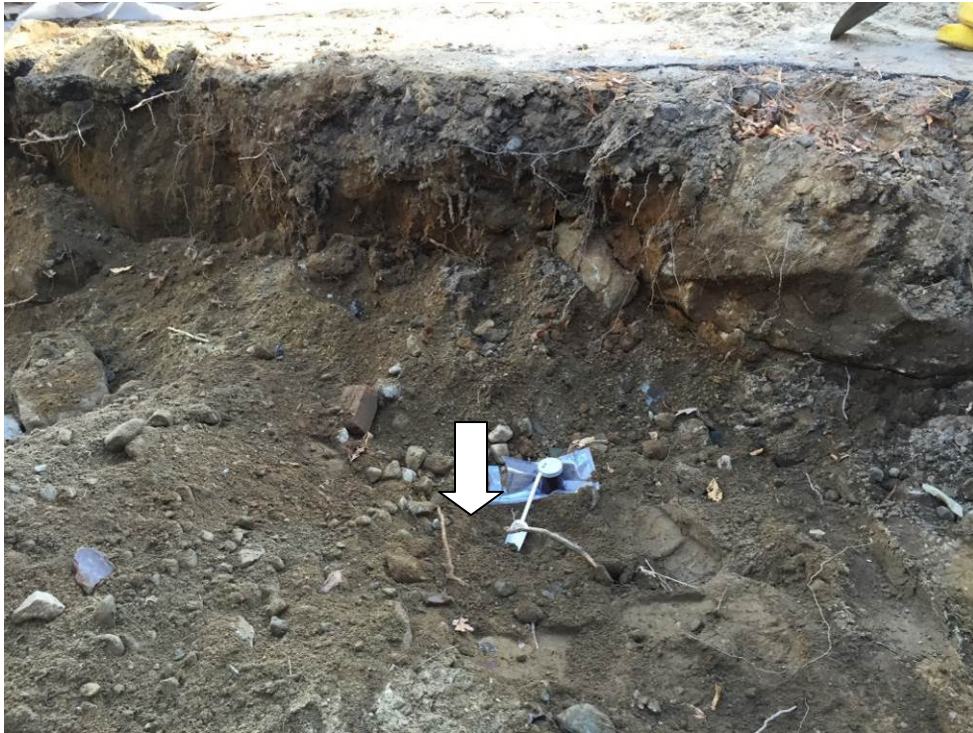
SCENE: View of sample RS51/SS-105 following additional excavation in the 3-foot excavation east of the lab building. Photograph taken facing southeast.

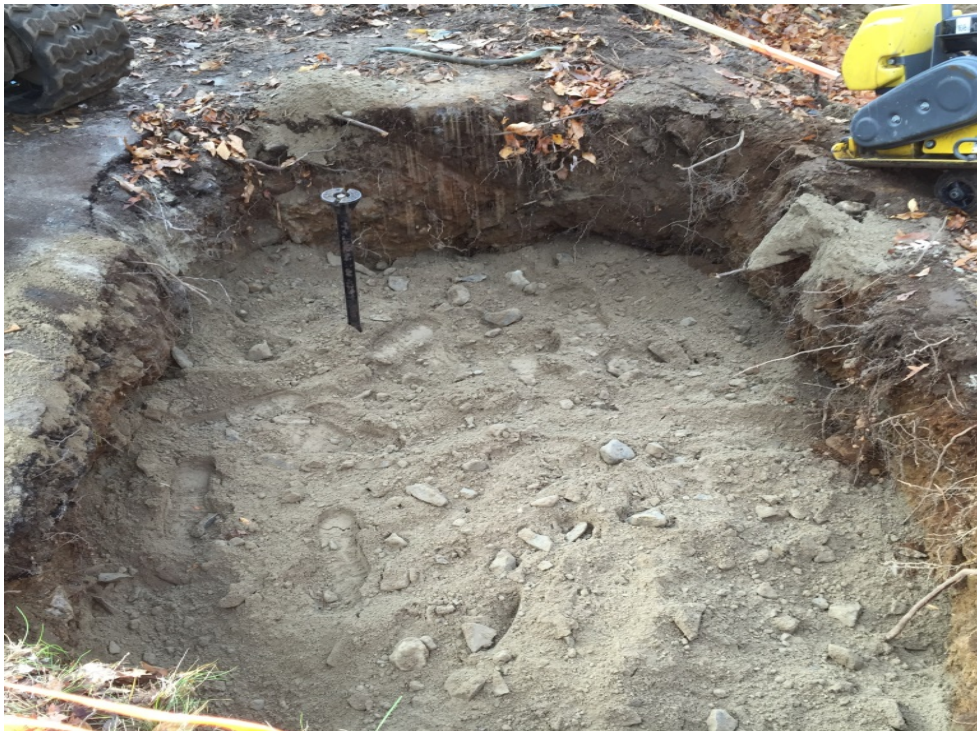
SCENE: View of the repaired water service line during backfilling activities. Photograph taken facing southwest.

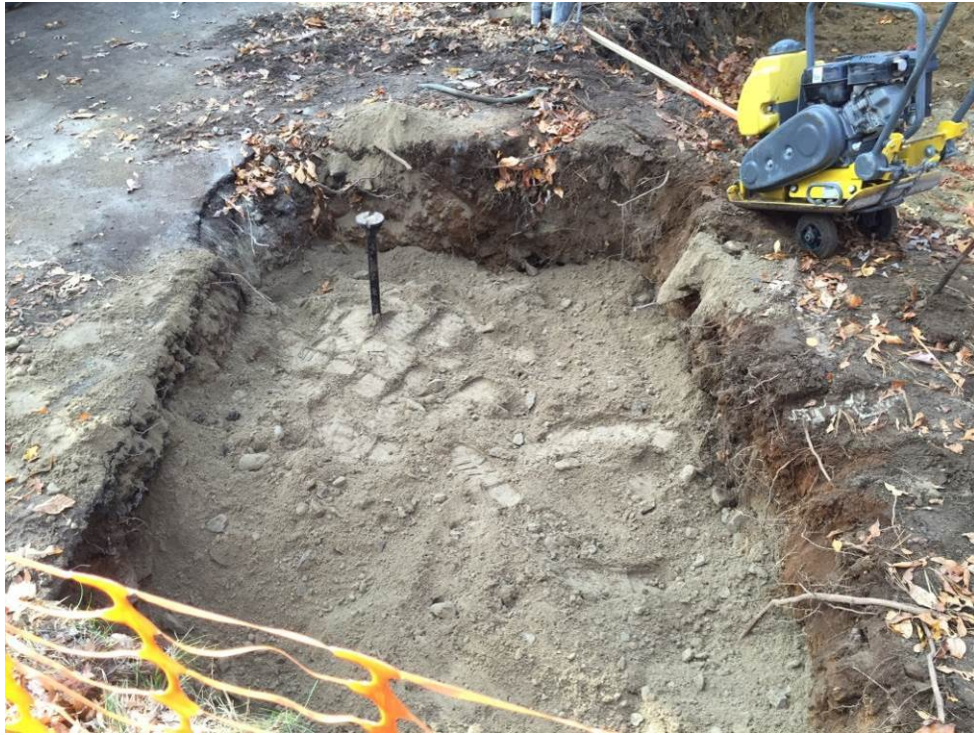
SCENE: View of the repaired water service line during backfilling and compaction activities. Photograph taken facing southwest.

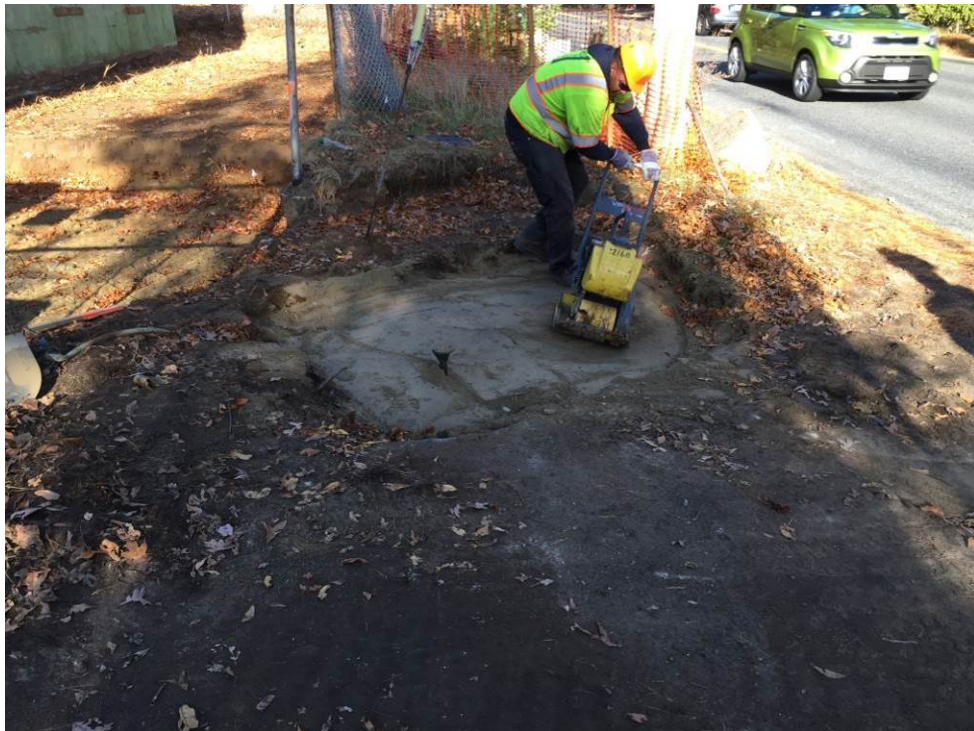
SCENE: View of the repaired water service line during compaction activities. Photograph taken facing northwest.

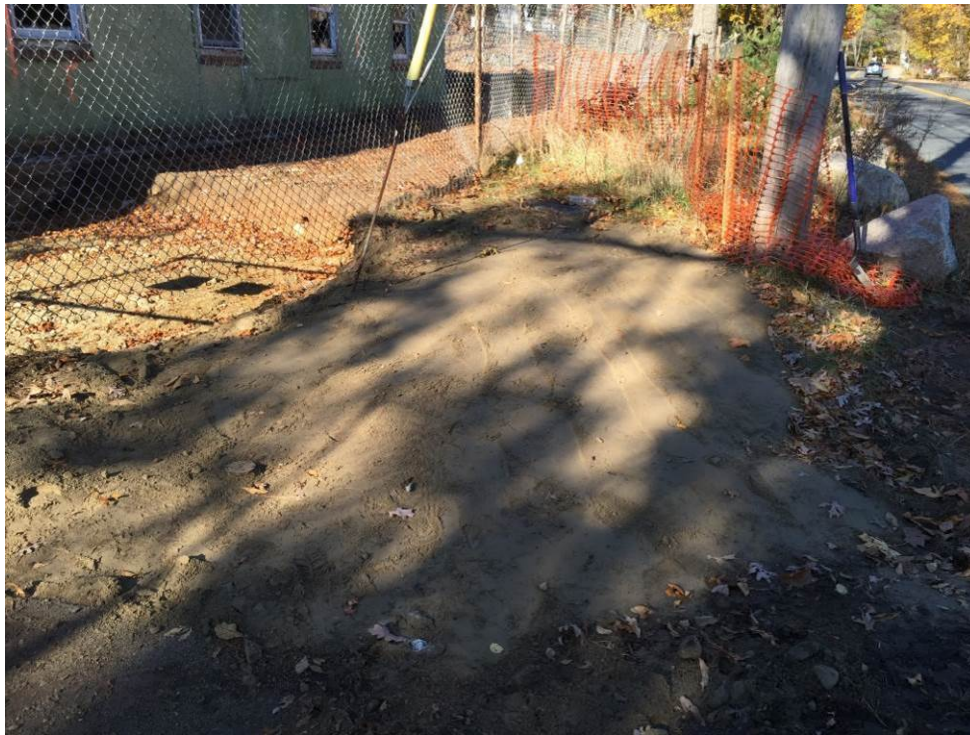
SCENE: View of the repaired water service line after backfilling and compaction activities. Photograph taken northwest.

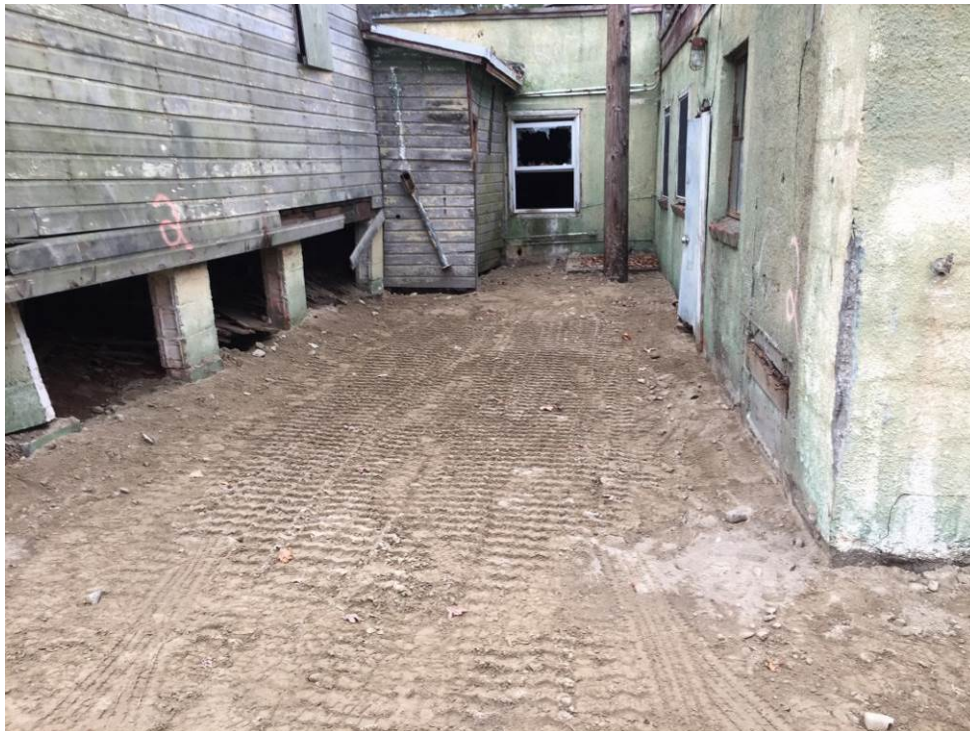
SCENE: View of the indented contaminated soil excavated area along the southeastern side of the lab building following backfilling activities. Photograph taken facing northwest.

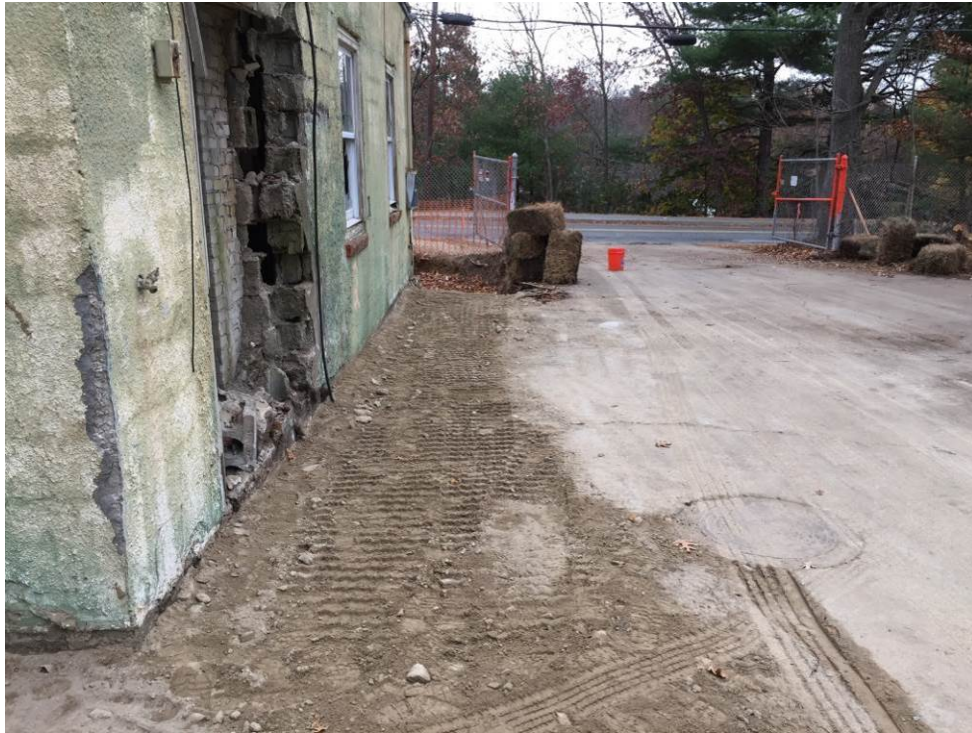
SCENE: View of the excavated area along the eastern side of the lab building following backfilling activities. Photograph taken facing northeast.

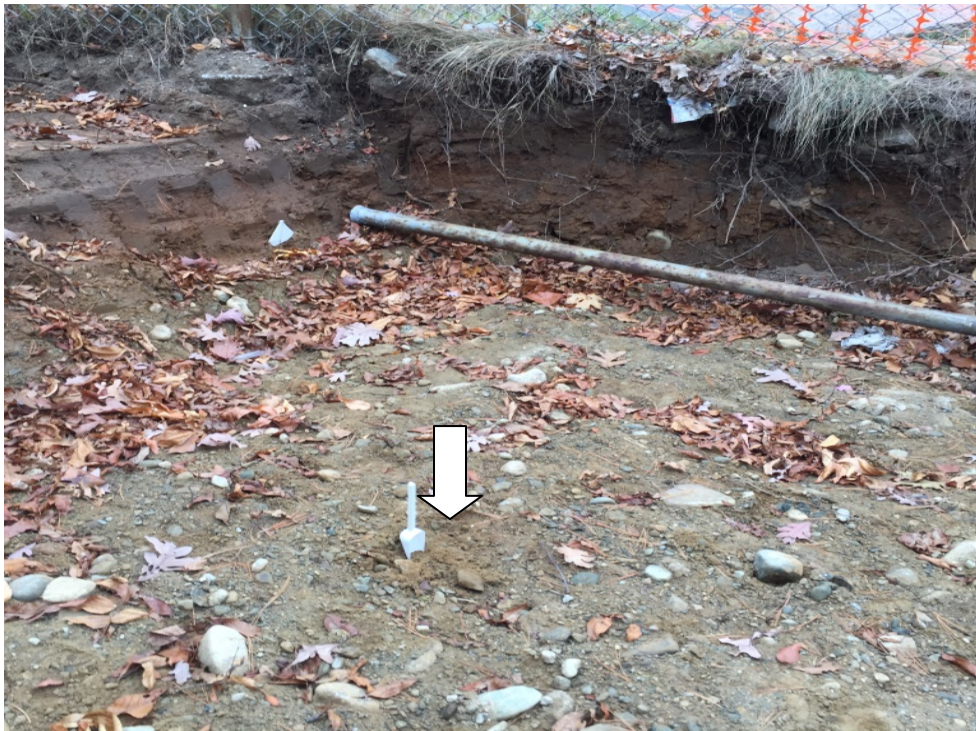
SCENE: View of one aliquot of sample RS53, a 3-point composite, collected from the 3-foot excavation north of the lab building. Photograph taken facing northwest.

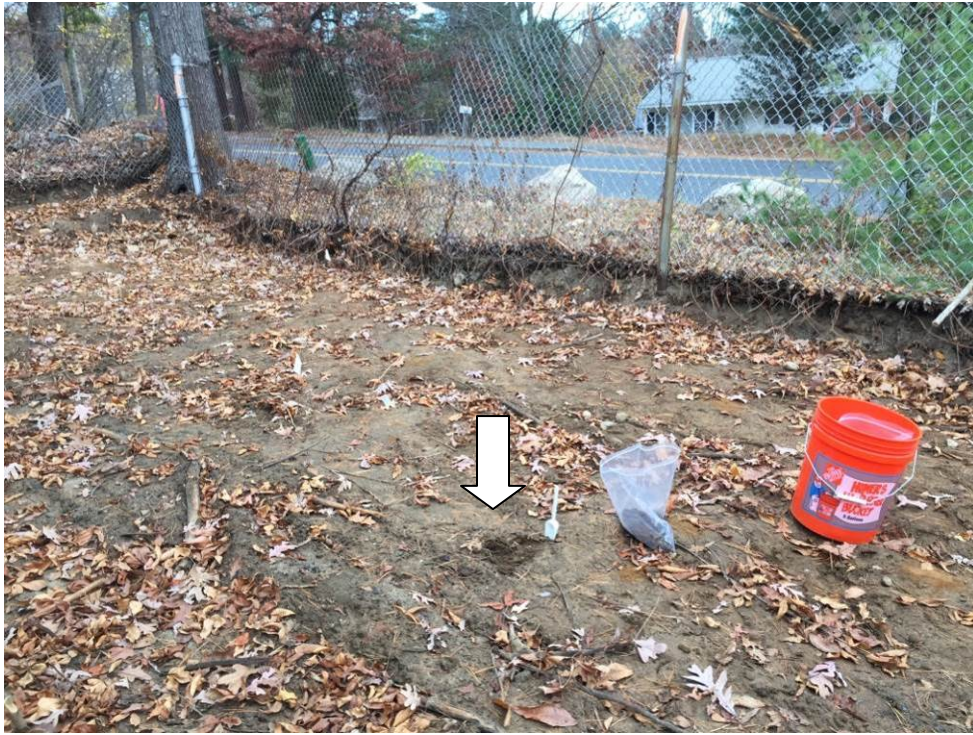
SCENE: View of one aliquot of sample RS53, a 3-point composite, collected from the 1-foot excavation north of the lab building. Photograph taken facing northwest.

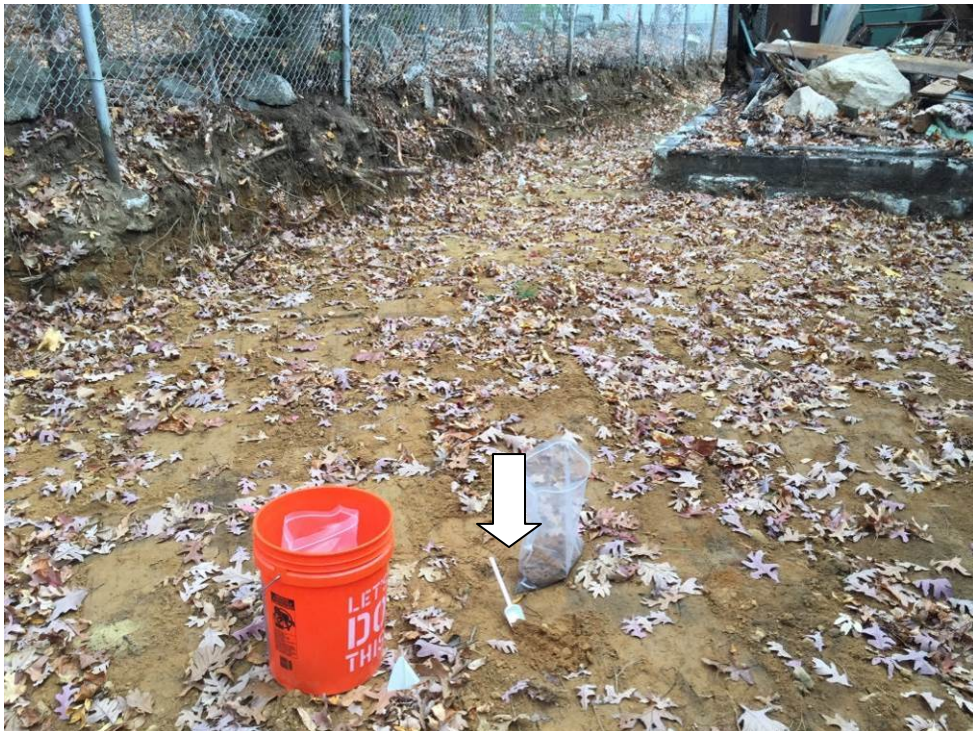
SCENE: View of one aliquot of sample RS53, a 3-point composite, collected from the 2-foot excavation west of the lab building. Photograph taken facing north.

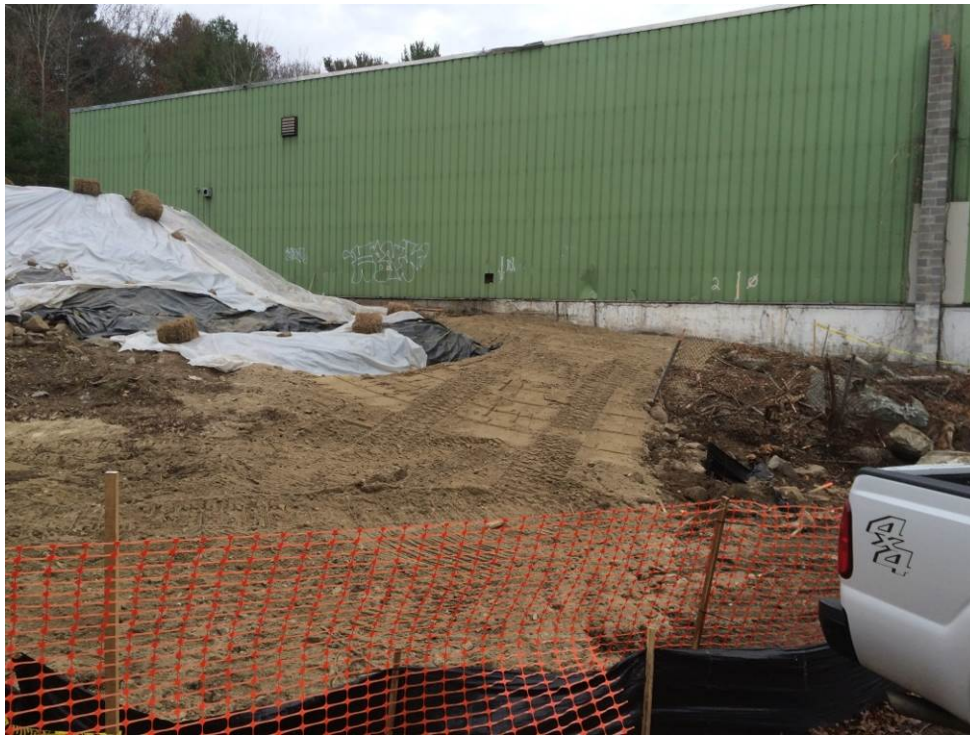
SCENE: View of the covered contaminated soil stockpile south of the manufacturing building, surrounded by excavated and backfilled areas. Photograph taken facing west.

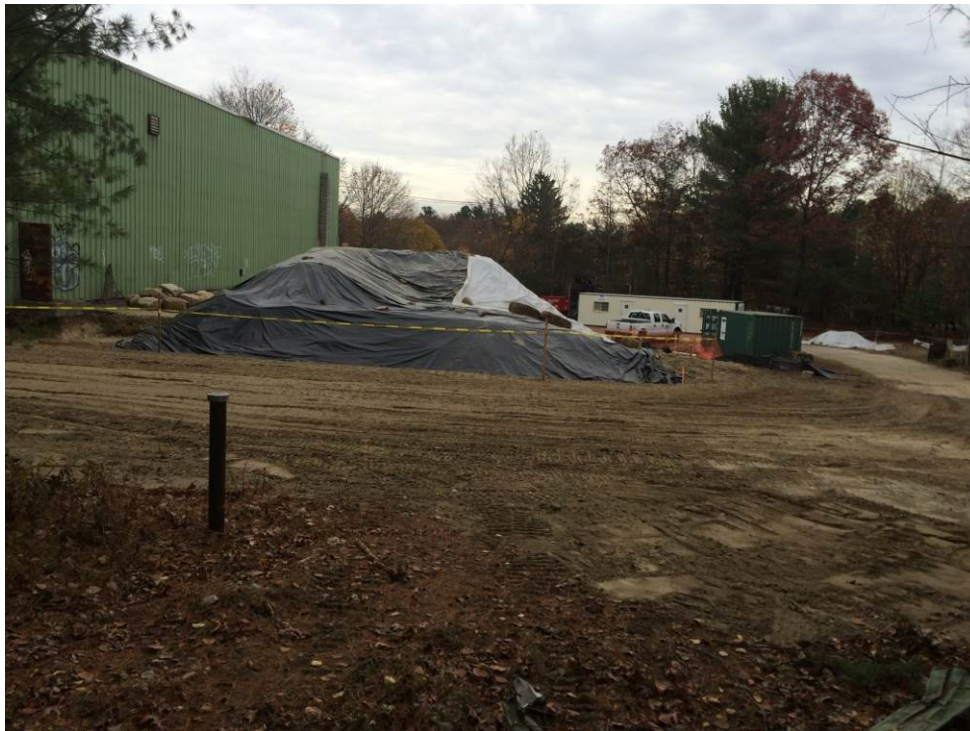
SCENE: View of covered contaminated soil stockpile south of the manufacturing building, surrounded by excavated and backfilled areas. Photograph taken facing northeast.
