**REMOVAL PROGRAM
AFTER ACTION REPORT
FOR THE
COLONIAL LACQUER & CHEMICAL CO. SITE
ASHLAND, MIDDLESEX COUNTY, MASSACHUSETTS
28 SEPTEMBER 2015 THROUGH 8 DECEMBER 2015**

Weston Solutions, Inc.
Superfund Technical Assessment and Response Team IV (START)
101 Billerica Avenue, Building 5, Suite 103
North Billerica, Massachusetts 01862

March 2016

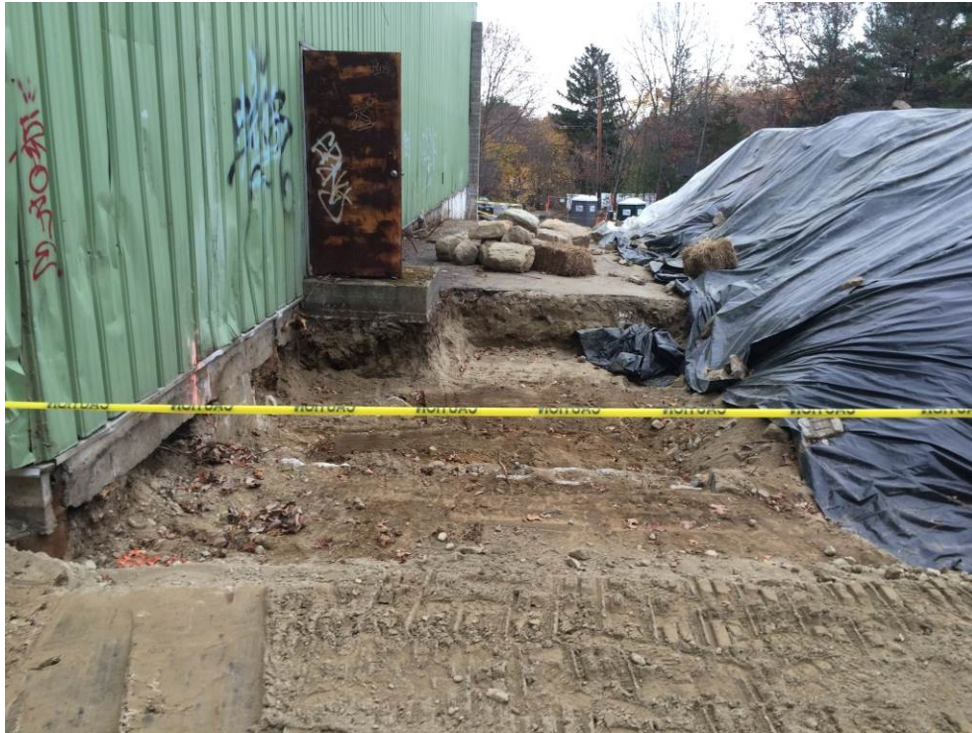
SCENE: View of the northwest corner of the excavated area south of the manufacturing building, with an excavated and backfilled area in foreground, an asphalt outcropping to rear, and the covered contaminated soil stockpile to the right. Photograph taken facing northeast.

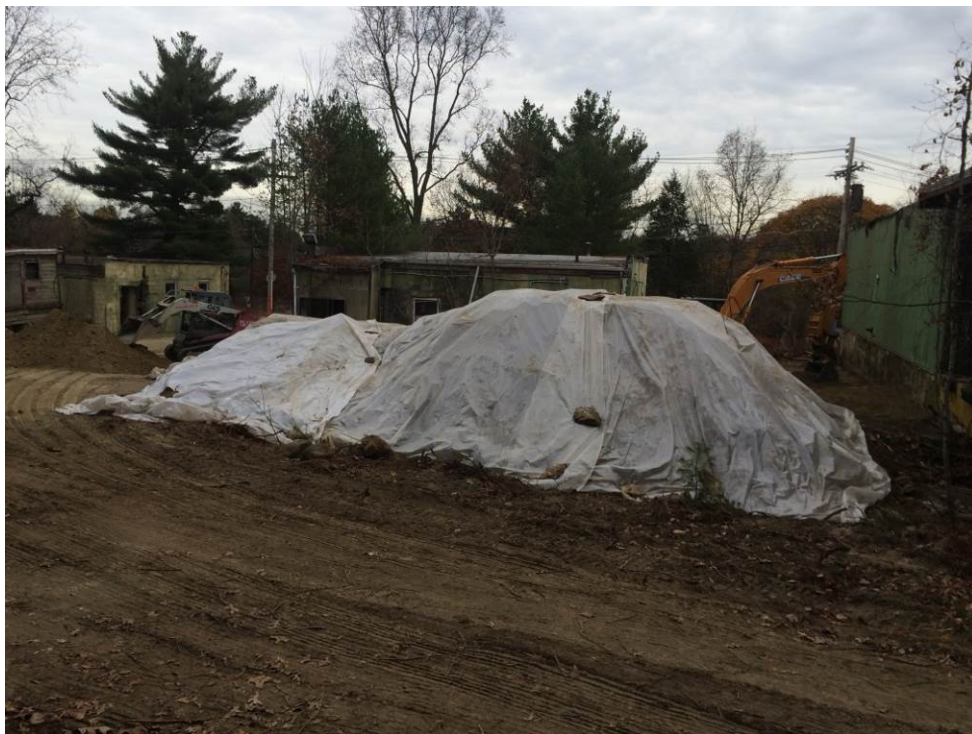
SCENE: View of the covered contaminated soil stockpile in second location on the paved pad south of the office building. Photograph taken facing northeast.

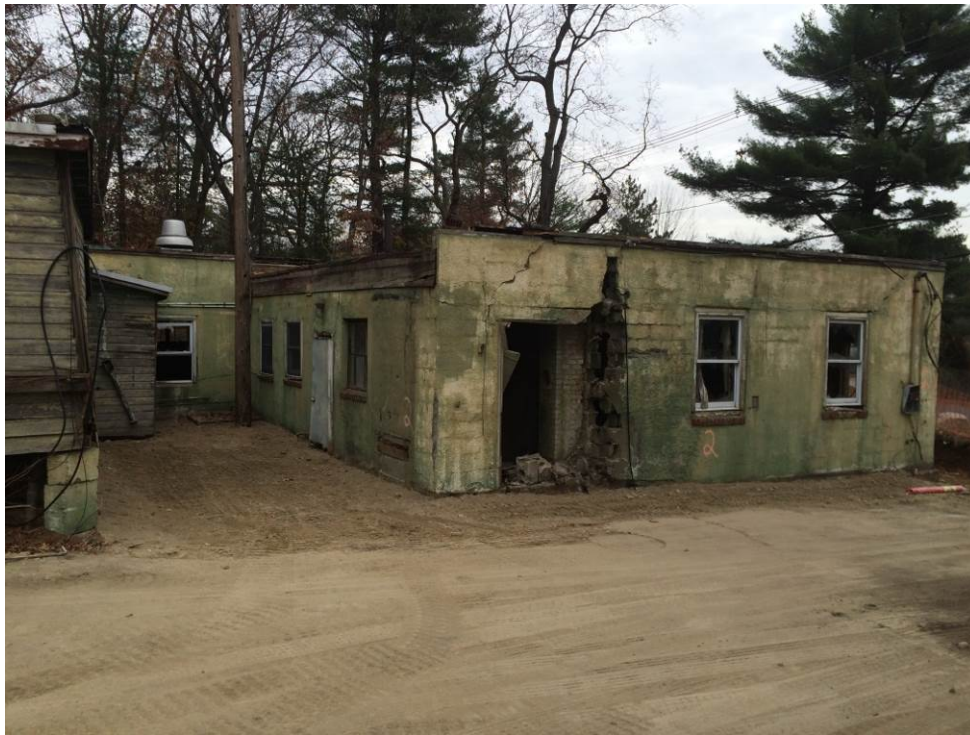
SCENE: View of the indented area on the southeast side of the lab building following excavation and backfilling. Photograph taken facing north.

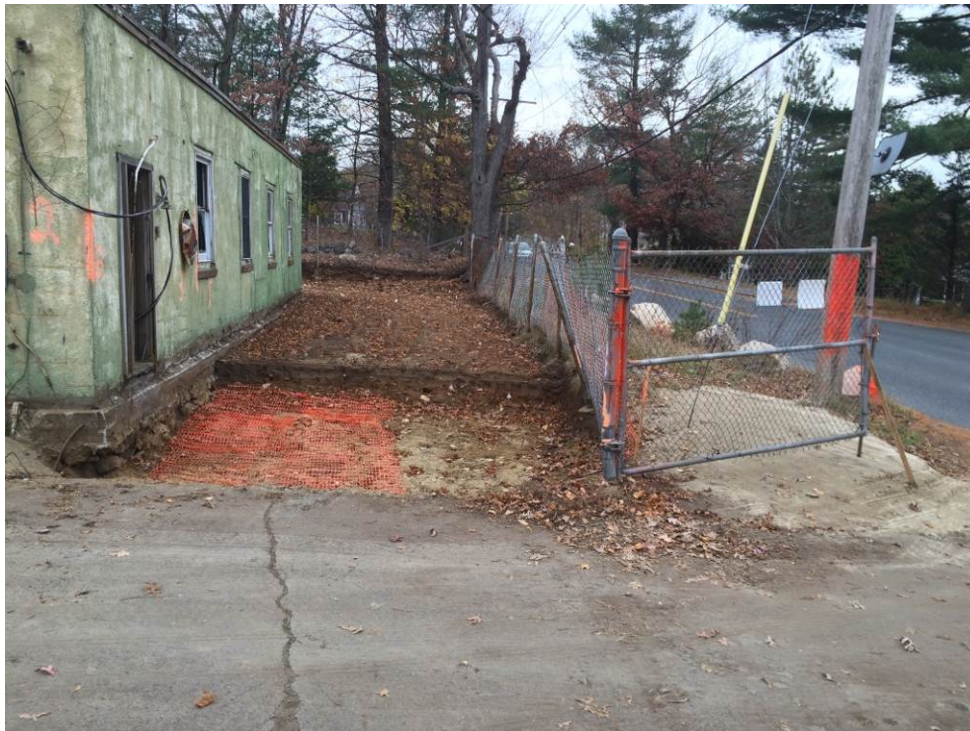
SCENE: View of the excavated area north of the lab building prior to backfilling. Photograph taken facing northwest.

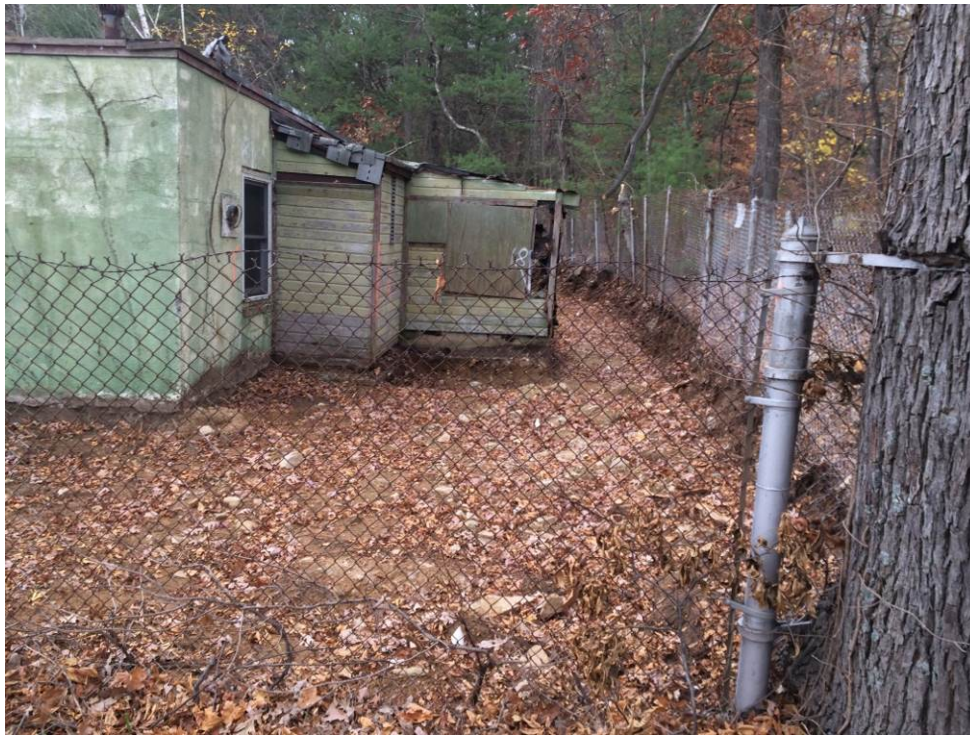
SCENE: View of the excavated area west of the lab building prior to backfilling. Photograph taken facing southwest.

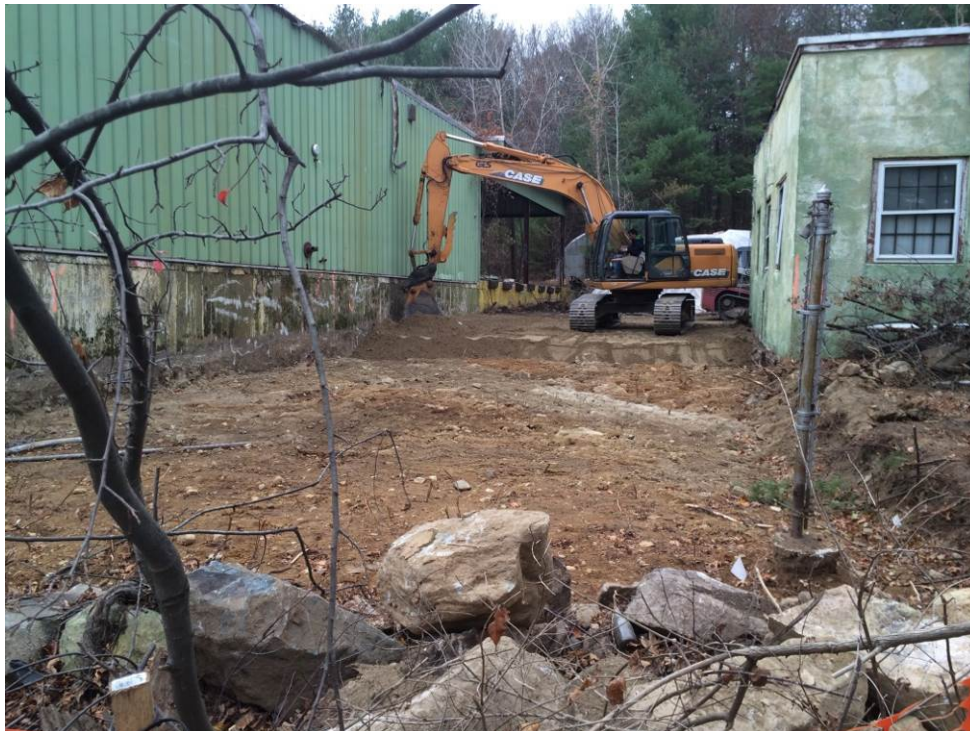
SCENE: View of excavation being conducted between the manufacturing and office buildings. Photograph taken facing southwest.

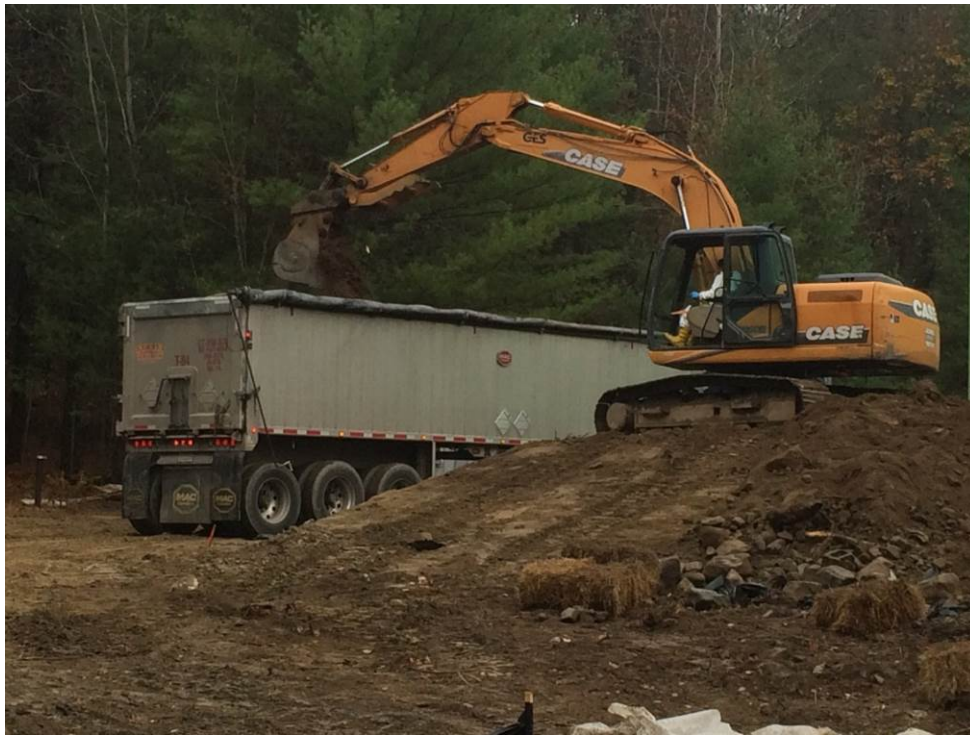
SCENE: View of contaminated soil load-out being conducted south of the manufacturing building. Photograph taken facing southwest.

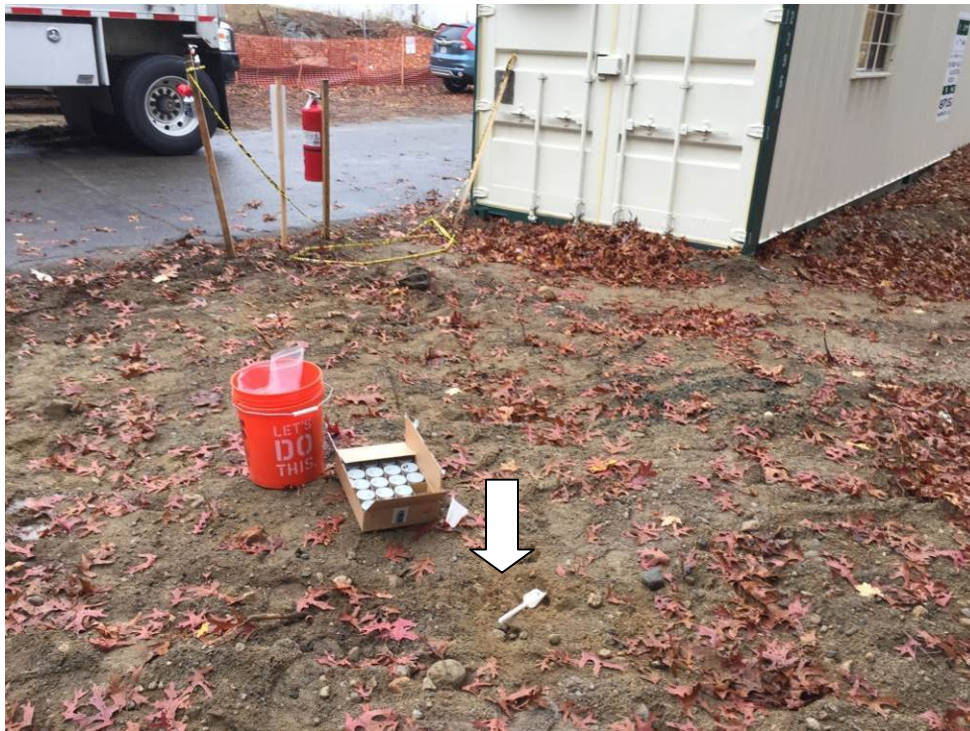
SCENE: View of sample RS54 collected from the northeastern end of the former location of the TSCA drum carcass pile. Photograph taken facing north.

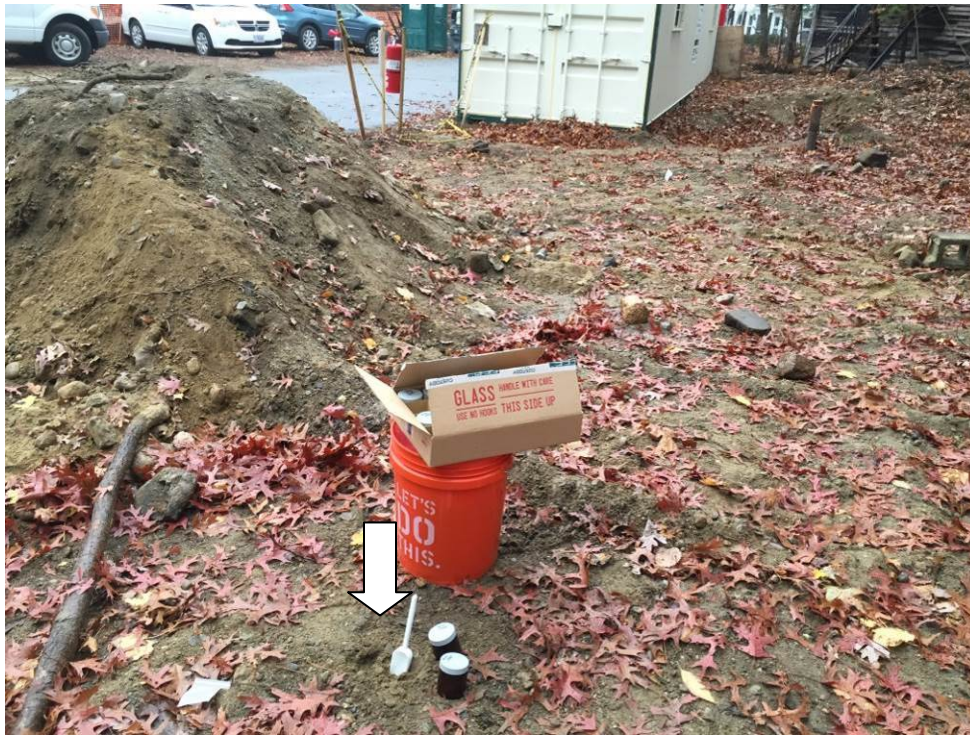
SCENE: View of sample RS55 collected from the southwestern end of the former location of the TSCA drum carcass pile. Photograph taken facing north.

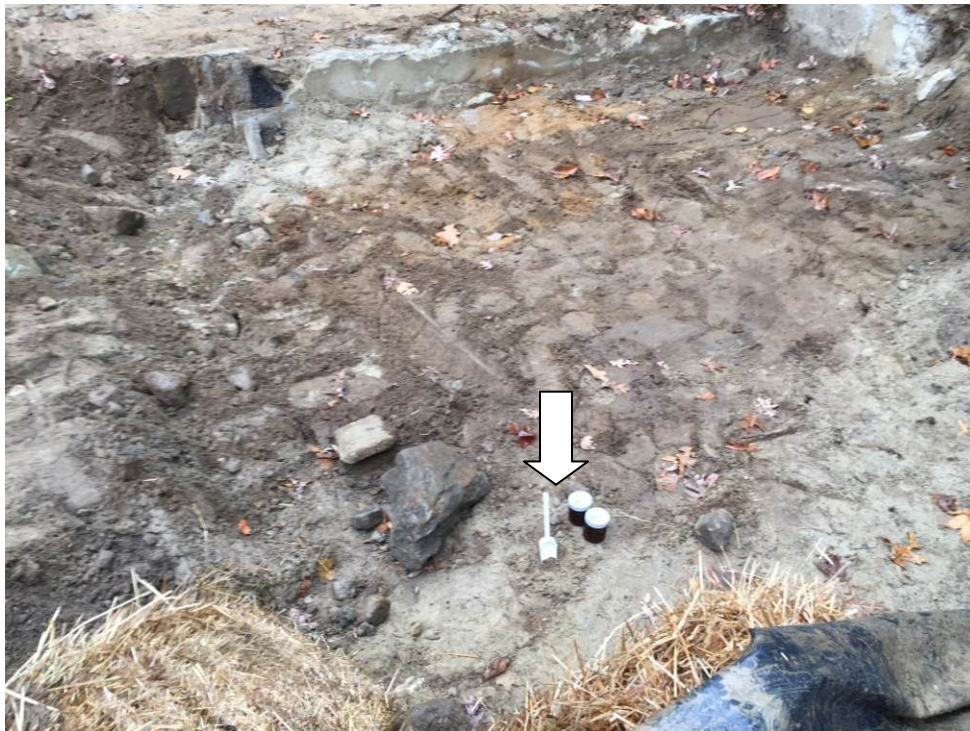
SCENE: View of sample RS59/SS-06 collected following additional excavation in the 3-foot excavation south of the manufacturing building. Photograph taken facing southwest.

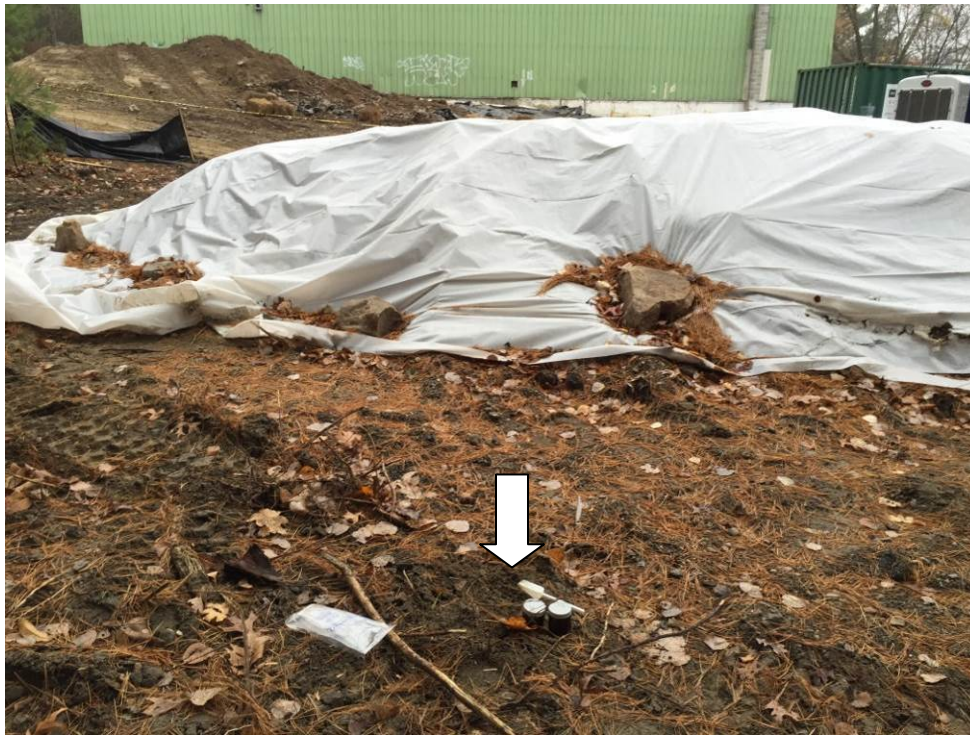
RS58	01LK-0067	11/12/2015	1025	N/A	ND	---	---	Under western end of former location of hazardous (lead) drum carcass pile at 0 to 3 inches.

SCENE: View of sample RS58 collected from the western end of the former location of the RCRA-contaminated drum carcass pile. Photograph taken facing north.

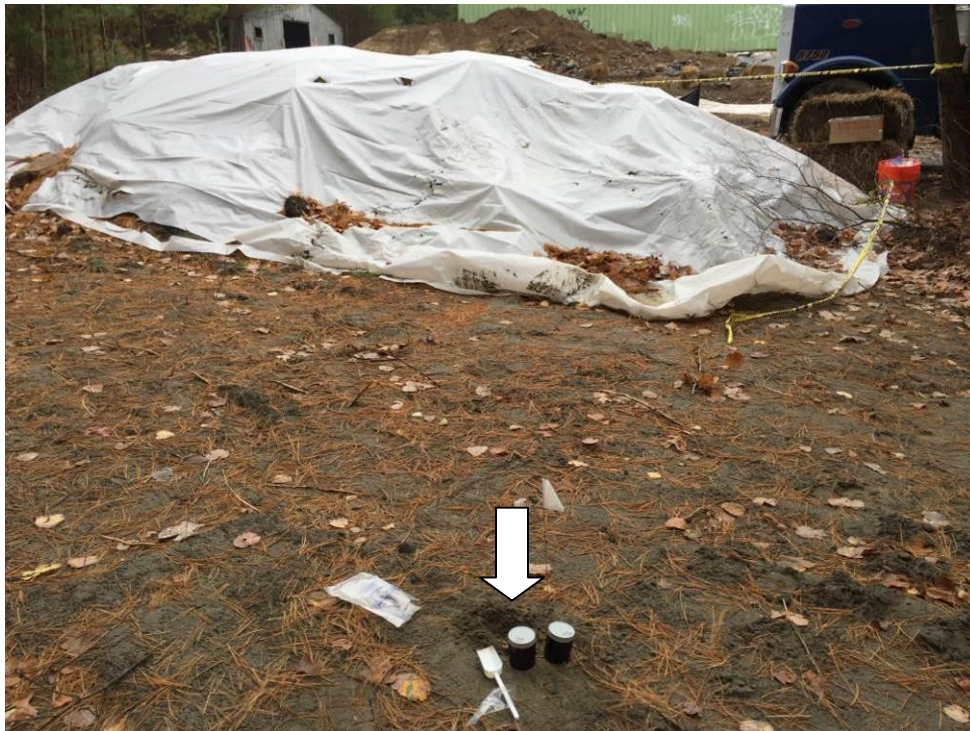
SCENE: View of sample RS57 collected at the eastern end of the former location of the RCRA-contaminated drum carcass pile. Photograph taken facing northwest.

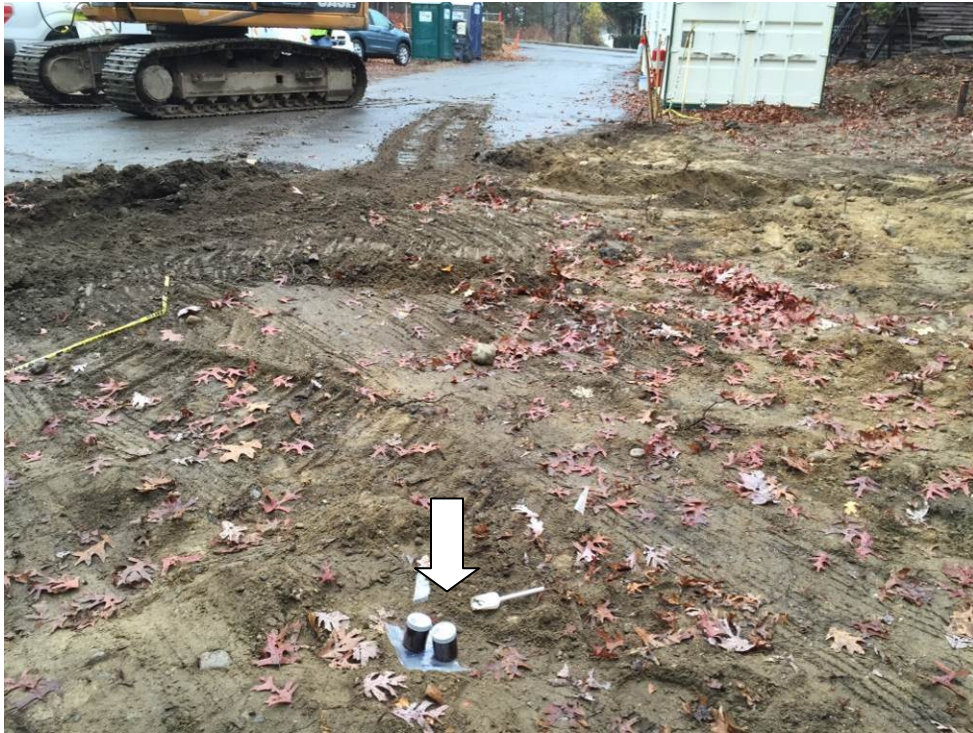
SCENE: View of sample RS56 collected from the former location of the non-hazardous drum carcass pile. Photograph taken facing north.

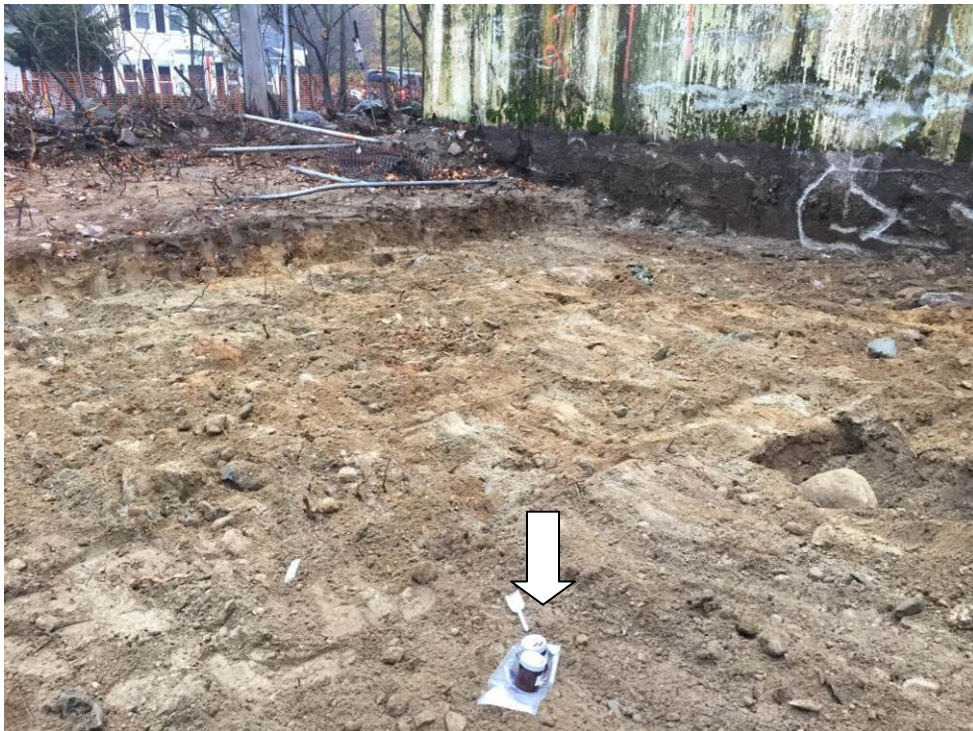
SCENE: View of sample RS60 following additional excavation in the 3-foot excavation between the manufacturing and office buildings. Photograph taken facing east.

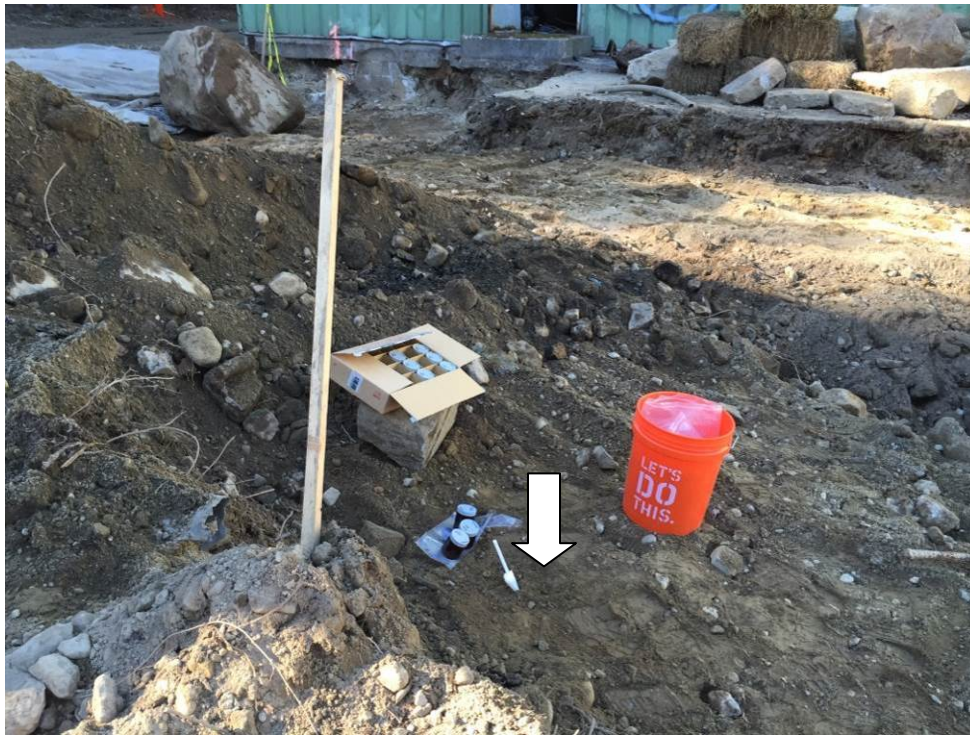
SCENE: View of sample RS61/SS-101 collected in the 3-foot excavation south of the manufacturing building. Photograph taken facing northwest.

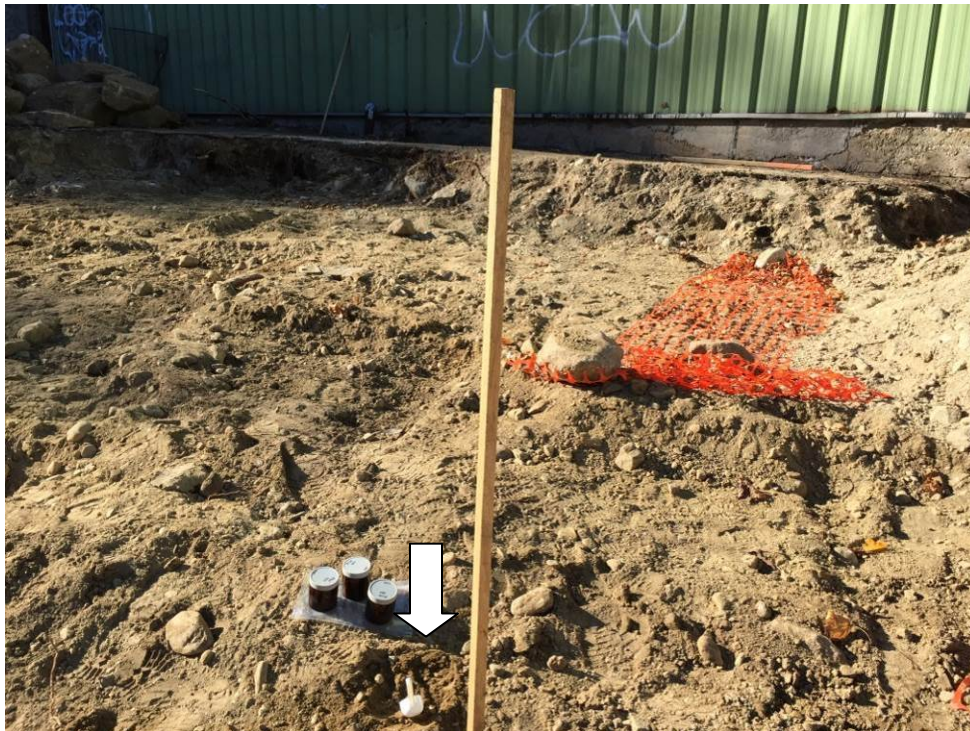
SCENE: View of sample RS62/SS-204/SS-211 collected in the 2-foot excavation south of the manufacturing building. Photograph taken facing northwest.

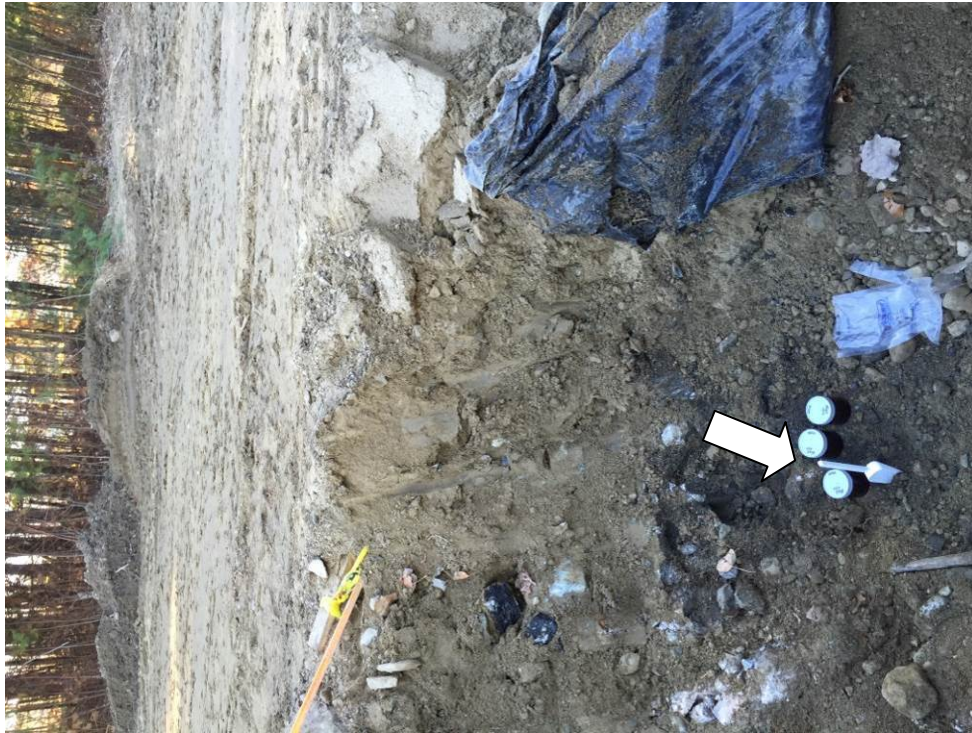
SCENE: View of sample RS63/SS-300 collected in the 3-foot excavation south of the manufacturing building. Photograph taken facing south.

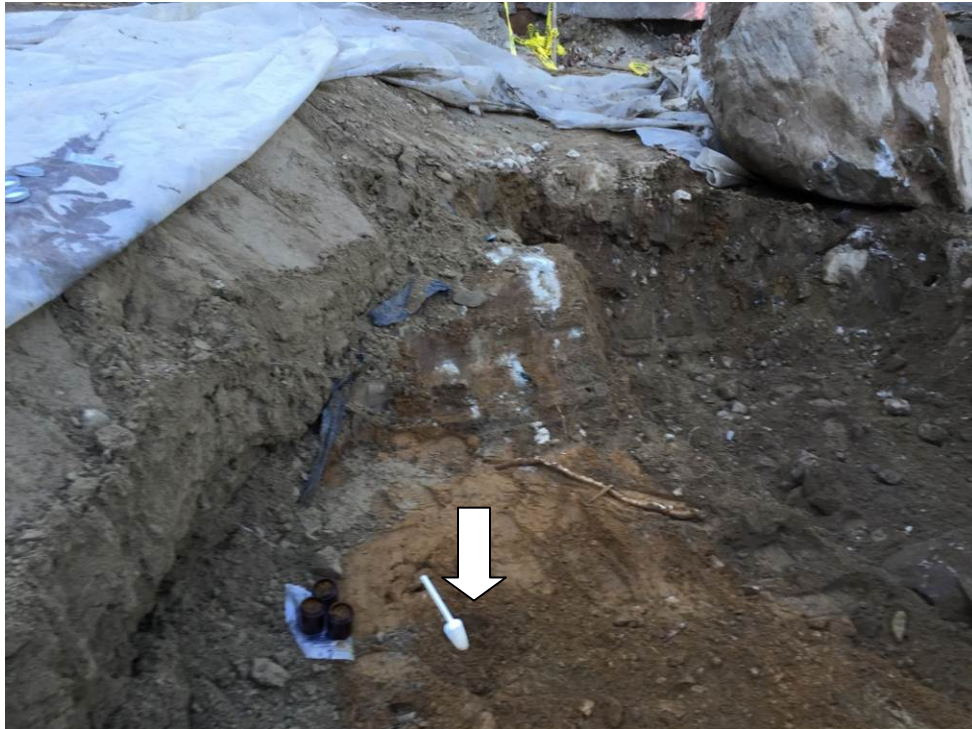
SCENE: View of sample RS64/SS-100 collected in the 3-foot excavation south of the manufacturing building. Photograph taken facing north.

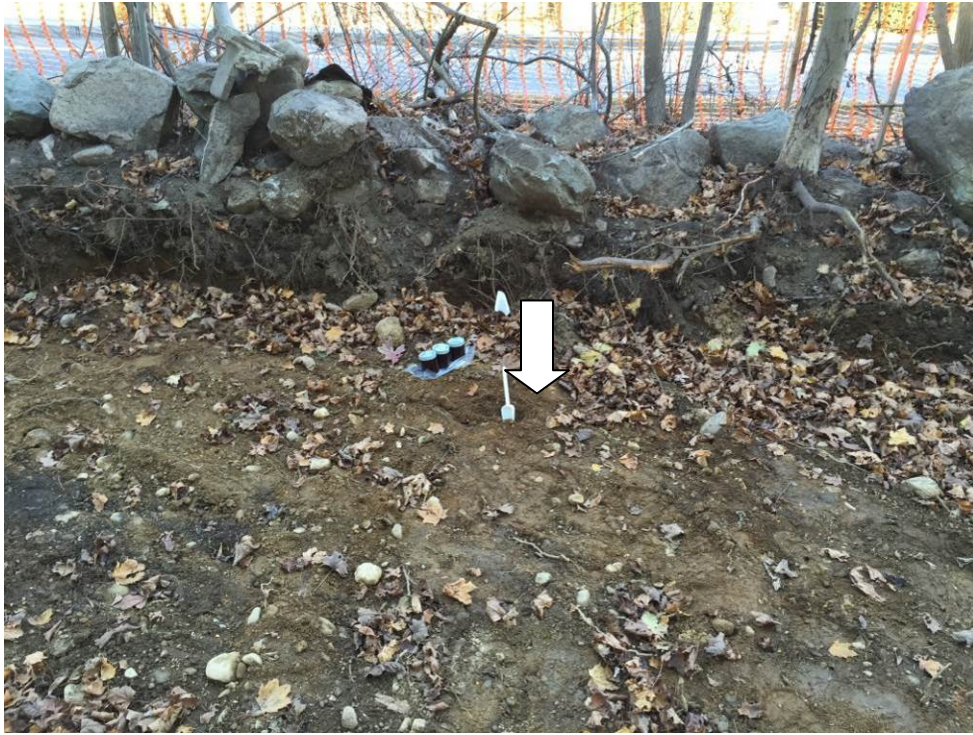
SCENE: View of sample RS65/SS-402 following additional excavation in the 2.5-foot excavation north of the manufacturing building. Photograph taken facing north.

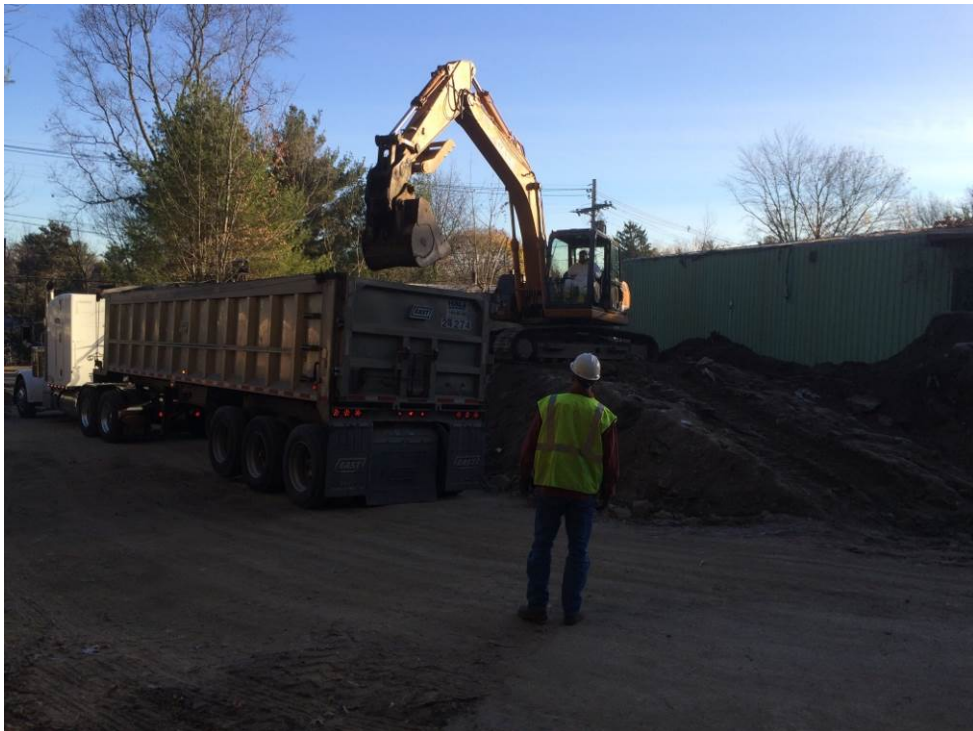
SCENE: View of contaminated soil load-out being conducted south of the office building. Photograph taken facing east.

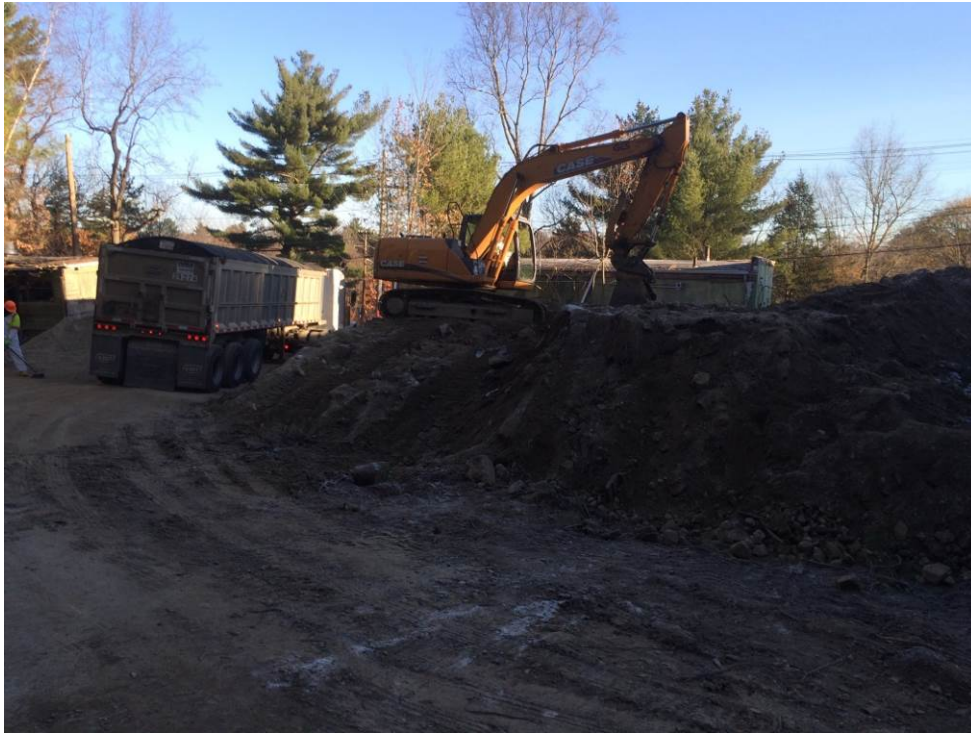
SCENE: View of contaminated soil load-out being conducted south of the office building. Photograph taken facing northeast.

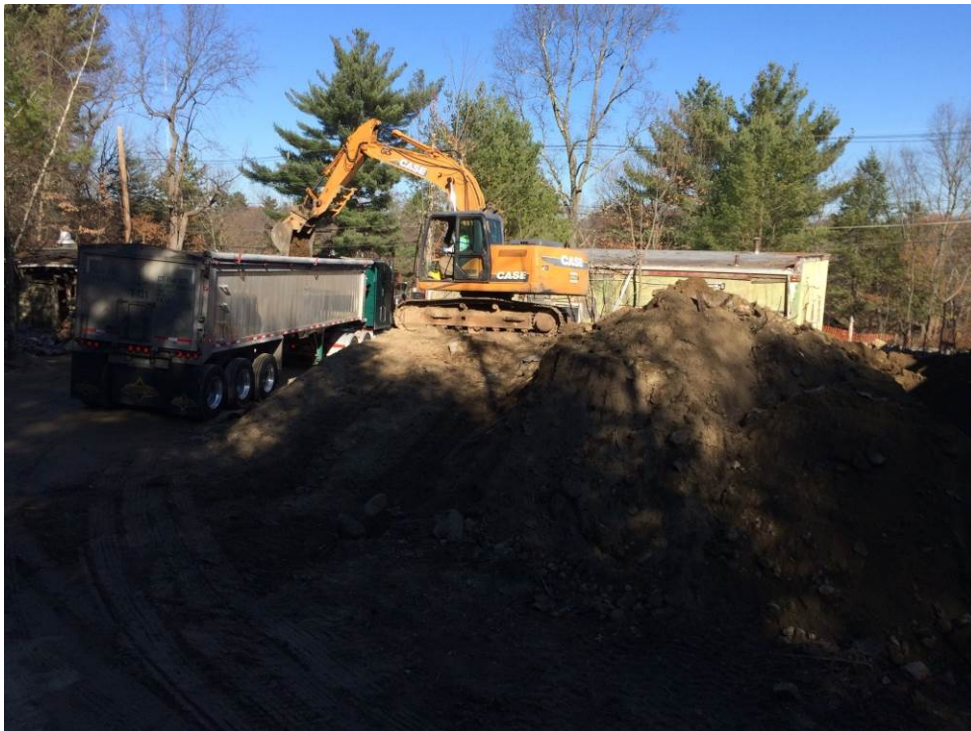
SCENE: View of contaminated soil load-out being conducted south of the office building. Photograph taken facing northeast.

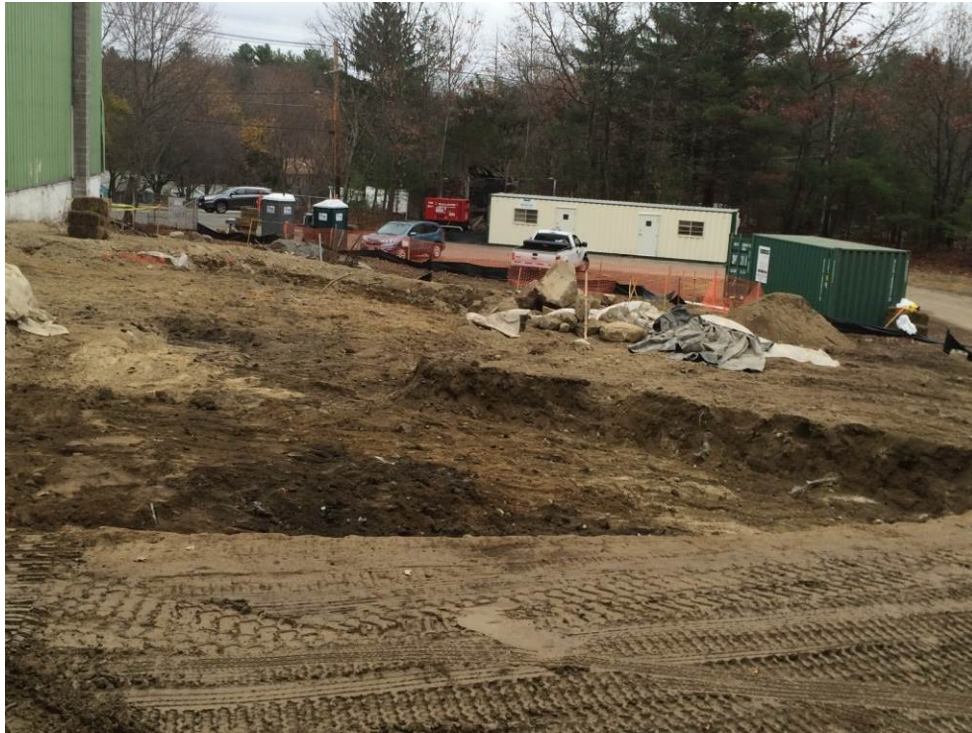
SCENE: View of the excavation south of the manufacturing building after removal of and excavation under the contaminated soil stockpile. Photograph taken facing northeast.

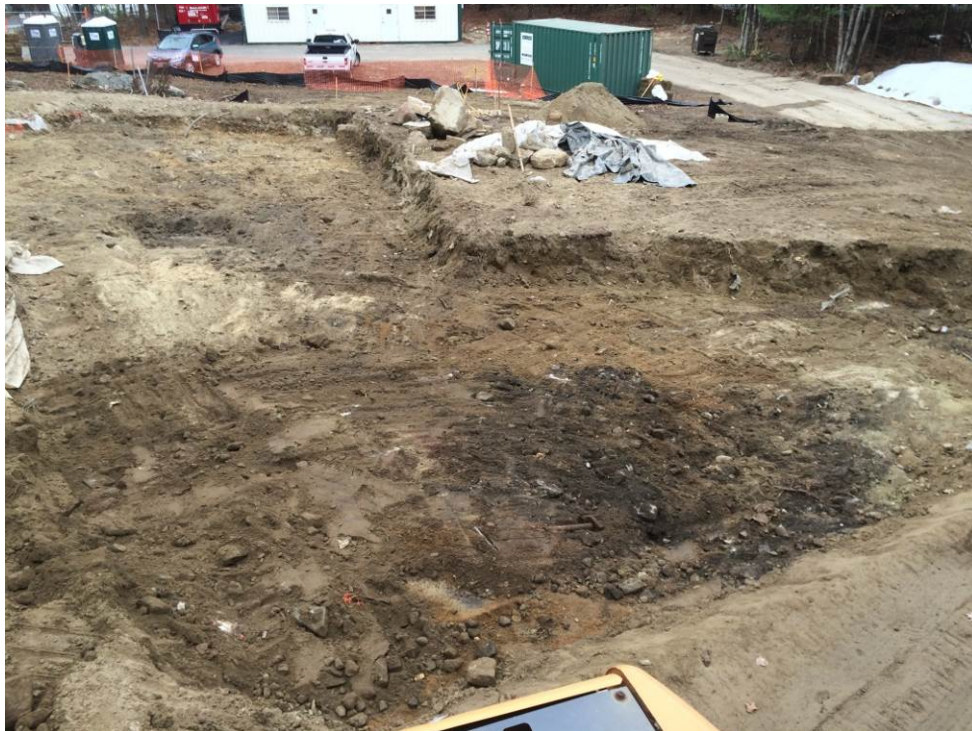
SCENE: View of the excavation south of the manufacturing building after removal of and excavation under the contaminated soil stockpile, showing darker soil mixed with debris. Photograph taken facing east.

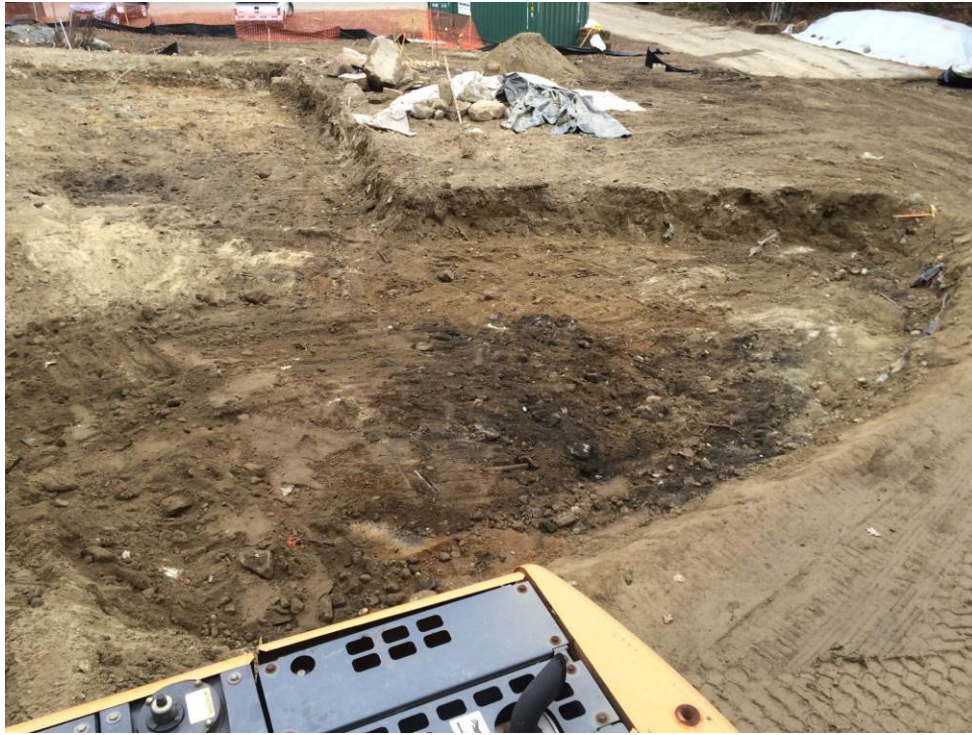
SCENE: View of the excavation south of the manufacturing building after removal of and excavation under the contaminated soil stockpile, showing darker soil mixed with debris. Photograph taken facing east.

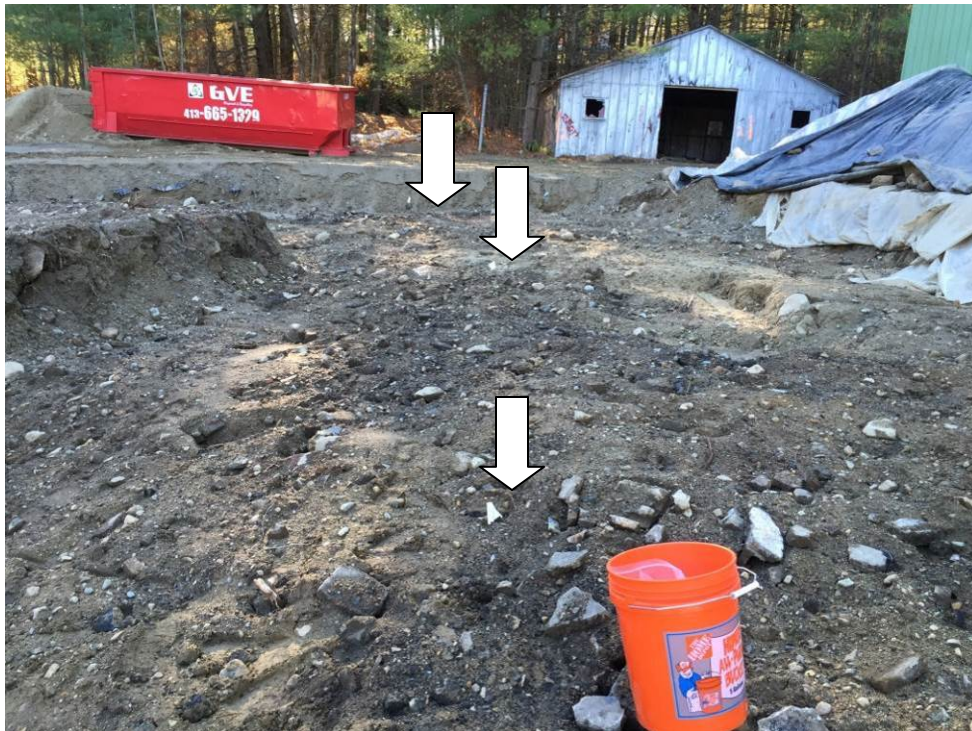
SCENE: View of sample RS70 collected as a 3-point composite in the 3-foot excavation south of the manufacturing building. On the right is soil excavated from 2 to 3 feet during the week of 16 November 2015, and stockpiled within the excavation area on an asphalt outcropping while awaiting analytical results. Photograph taken facing southwest.

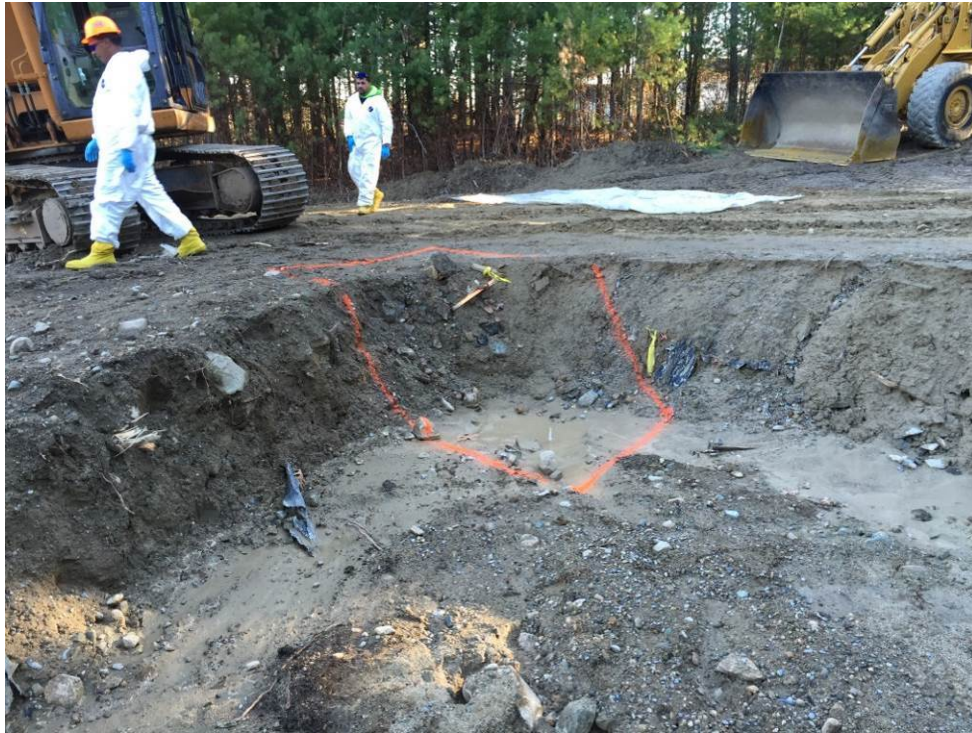
SCENE: View of the area marked for additional excavation south of sample RS63/SS-300, south of the manufacturing building. Photograph taken facing south.

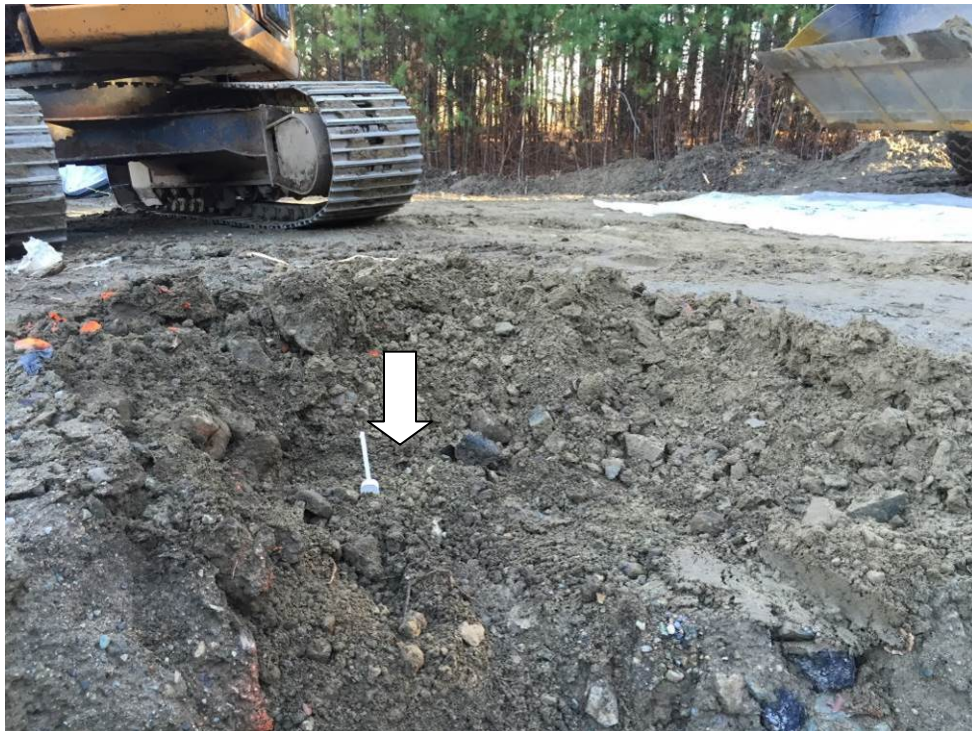
SCENE: View of sample RS66 in the additional excavated area south of sample RS63/SS-300 at the 1-foot depth. Photograph taken facing southeast.

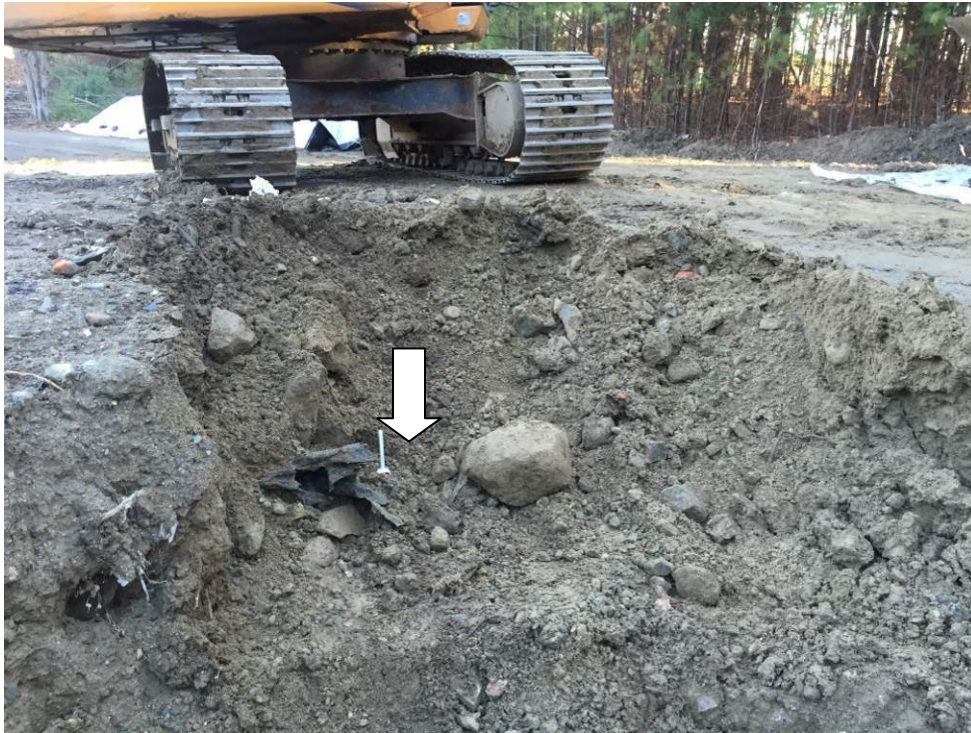
SCENE: View of sample RS67 in the additional excavated area south of sample RS63/SS-300 at the 2-foot depth. Photograph taken facing southeast.

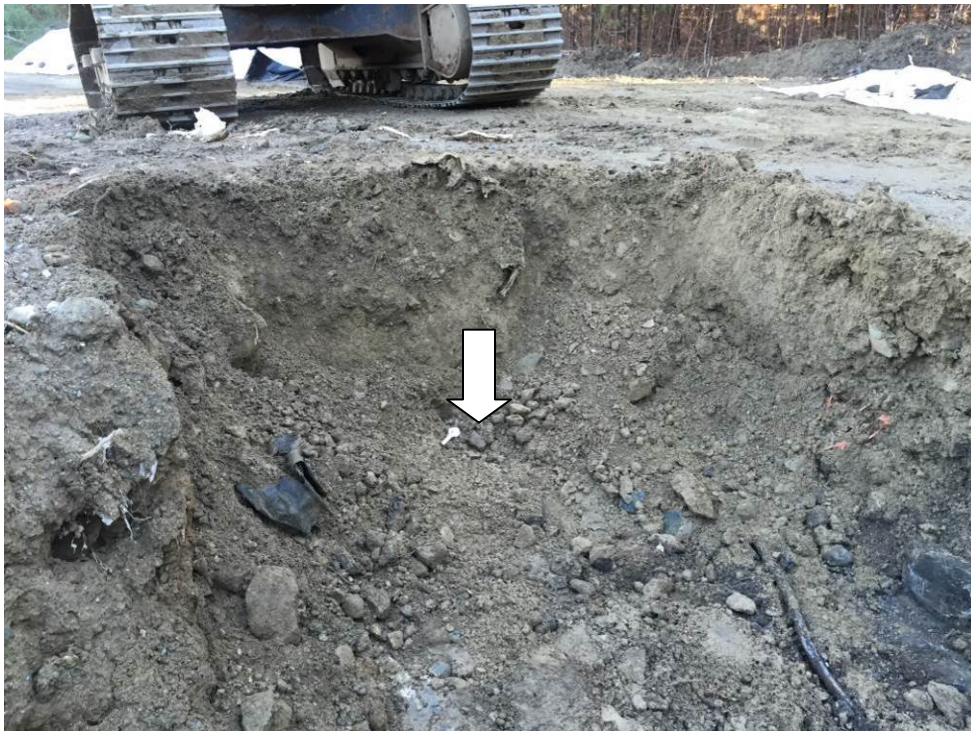
SCENE: View of sample RS68 in the additional excavated area south of sample RS63/SS-300 at the 3-foot depth. Photograph taken facing southeast.
