**REMOVAL PROGRAM
AFTER ACTION REPORT
FOR THE
COLONIAL LACQUER & CHEMICAL CO. SITE
ASHLAND, MIDDLESEX COUNTY, MASSACHUSETTS
28 SEPTEMBER 2015 THROUGH 8 DECEMBER 2015**

Weston Solutions, Inc.
Superfund Technical Assessment and Response Team IV (START)
101 Billerica Avenue, Building 5, Suite 103
North Billerica, Massachusetts 01862

March 2016

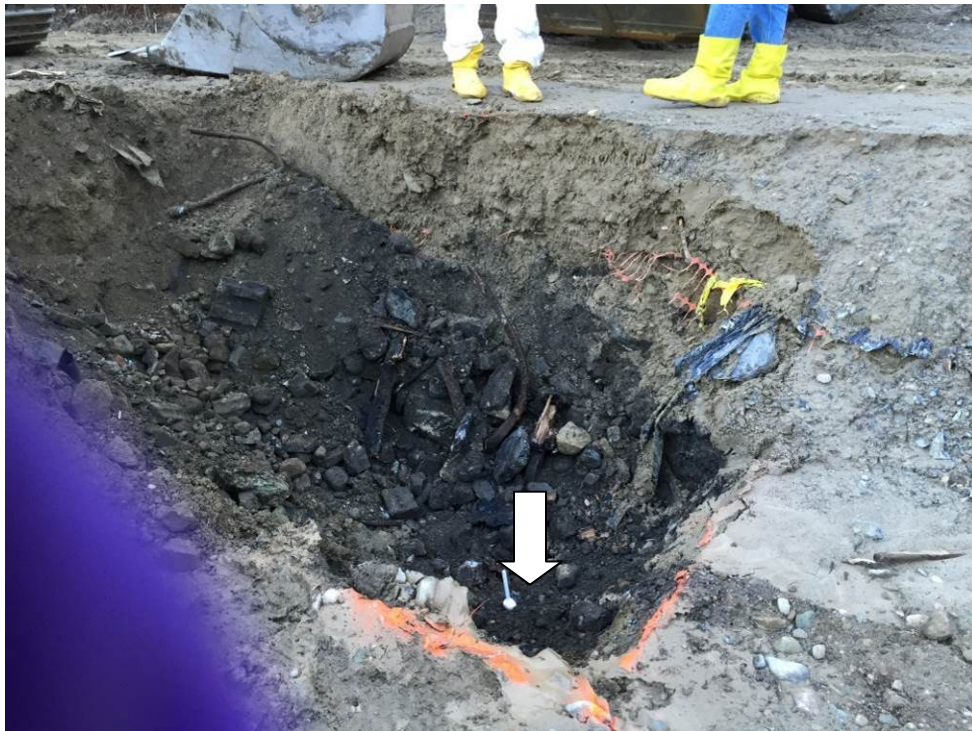
SCENE: View of sample RS69 in the additional excavated area near sample RS63/SS-300 at the 4.5-foot depth.

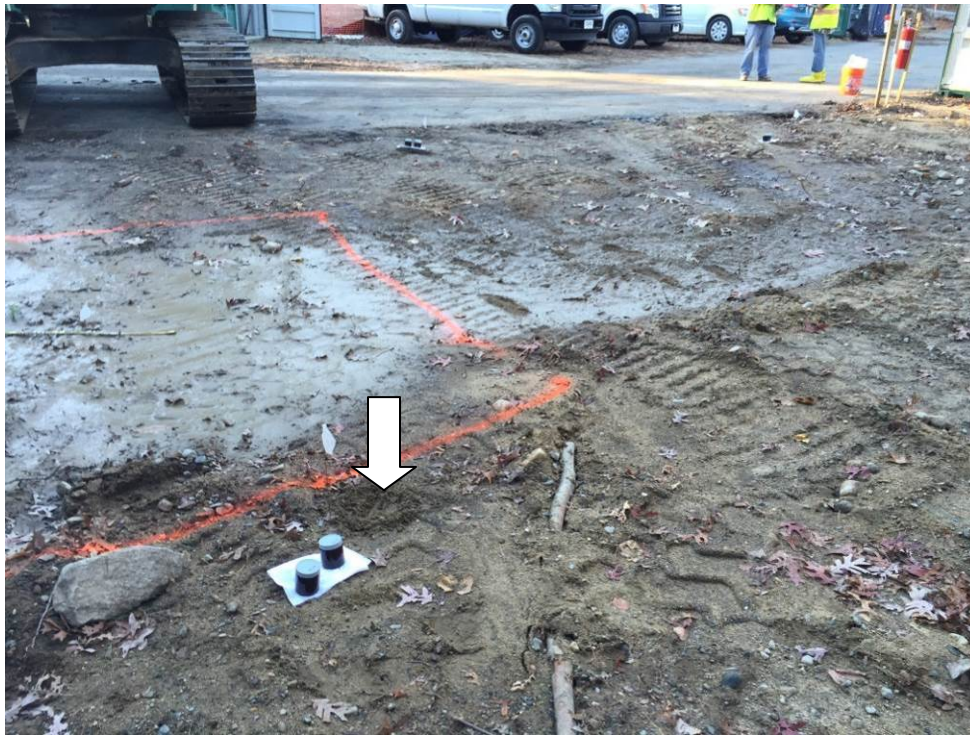
SCENE: View of sample RS73 east of the former location of the non-hazardous drum carcass pile at the 0-3 inch depth, with area around location of RS56 outlined in spray paint for additional excavation. Photograph taken facing northwest.

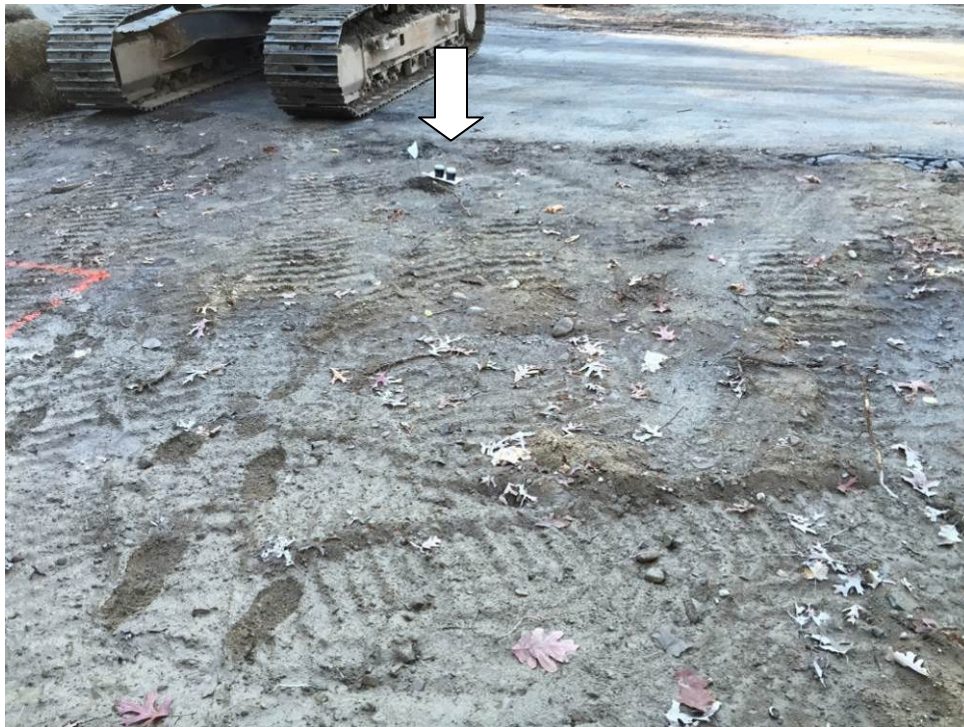
Sample Location No.	Scribe Sample No.	Date	Time	Corresponding PA/SI or Removal Action Sample No.	Total PCBs (mg/Kg)			Sample Location/Description
					NERL ¹	ERRS ²	CLP ³	
RS72	01LK-0082	11/20/2015	1408	near RS56	---	---	0.15	North of former location of non-hazardous drum carcass pile at 0 to 3 inch depth.
RS73	01LK-0083	11/20/2015	1413	near RS56	---	---	0.91	East of former location of non-hazardous drum carcass pile at 0 to 3 inch depth.
RS74	01LK-0084	11/20/2015	1458	RS56	---	---	---	Under former non-hazardous drum carcass pile at 6-inch depth after excavation. NOTE: SAMPLE NOT ANALYZED, REPLACED BY RS75 AND RS76.
RS75	01LK-0085	11/23/2015	1315	RS56	---	---	0.33	Under former non-hazardous drum carcass pile at 6-inch depth after excavation.
RS76	01LK-0086	11/23/2015	1315	RS56	---	---	0.14	Under former location of non-hazardous drum carcass pile at 6-inch depth after excavation - duplicate of RS75.

SCENE: View of sample RS72 north of the former location of the non-hazardous drum carcass pile at the 0-3 inch depth, with area around location of RS56 outlined in spray paint for additional excavation. Photograph taken facing west.

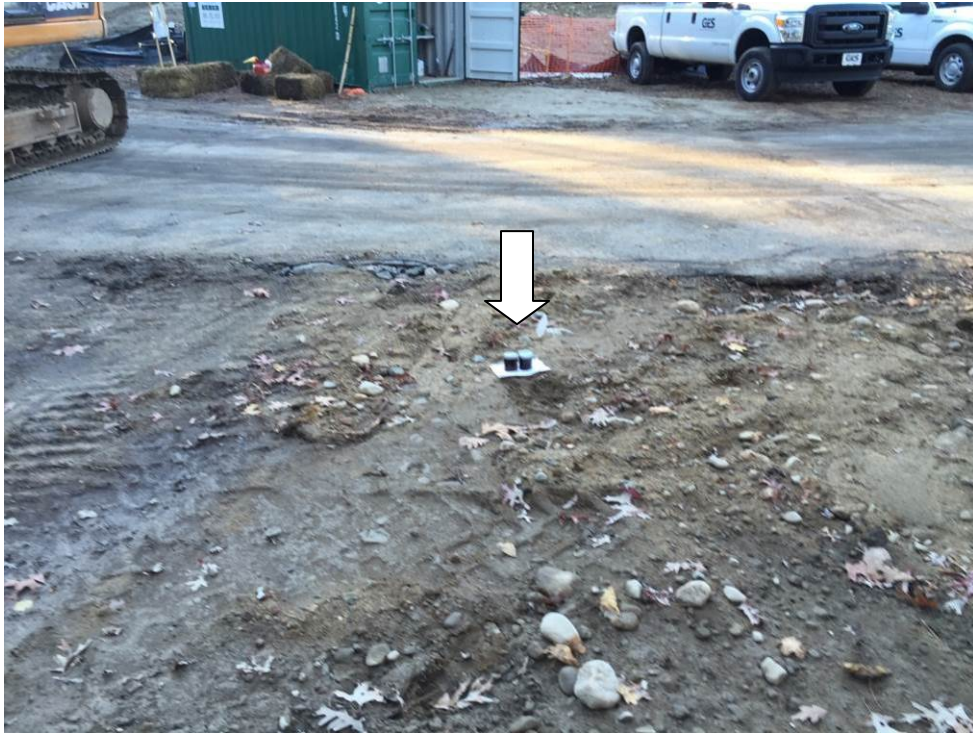
SCENE: View of sample RS71 northeast of the former location of the non-hazardous drum carcass pile at the 0-3 inch depth. Photograph taken facing northwest.

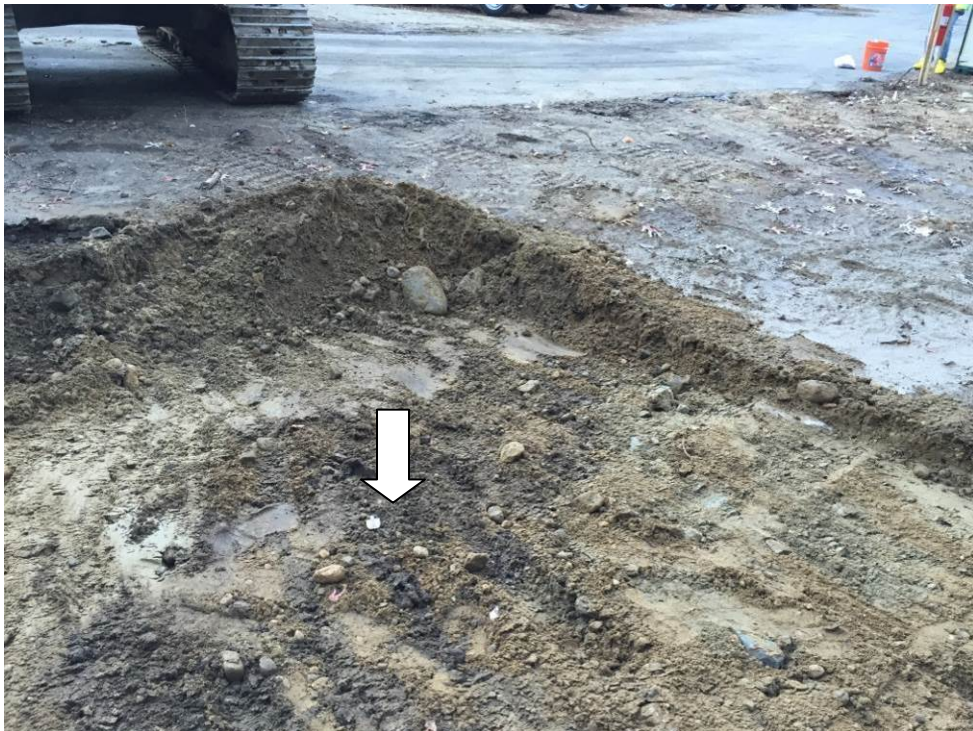
SCENE: View of sample RS74 at the former location of the non-hazardous drum carcass pile near sample RS56, after the 6-inch excavation. Photograph taken facing northwest.

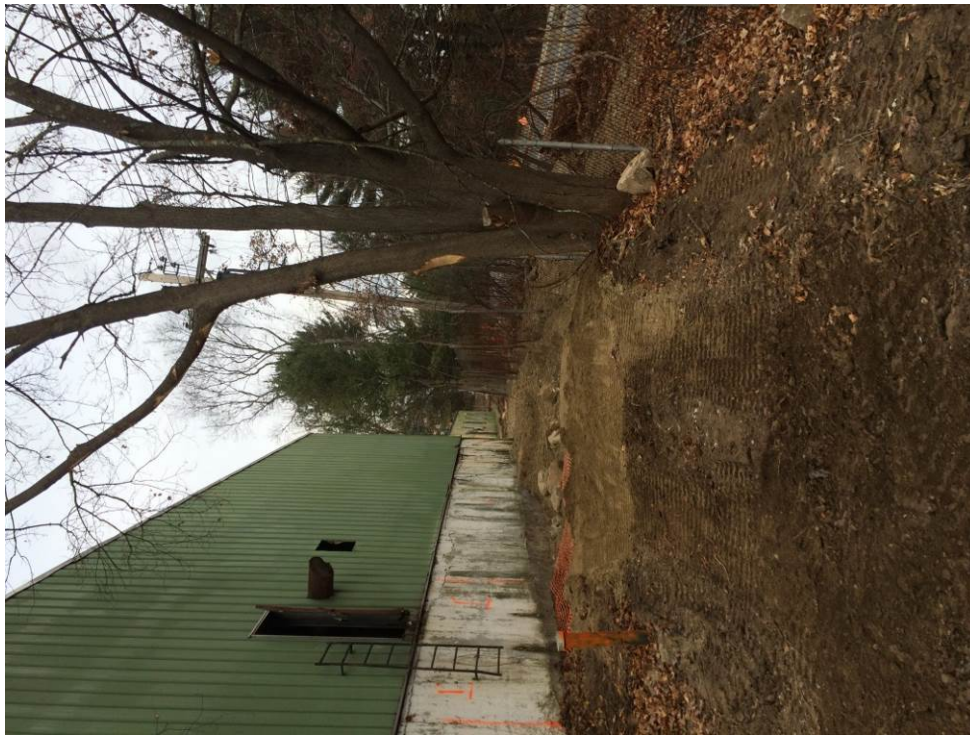
SCENE: View of the excavated area north of the manufacturing building during backfilling, showing high-visibility fencing installed as a marker at the bottom of the excavation, and large rocks returned to the excavation as part of backfilling. Photograph taken facing northwest.

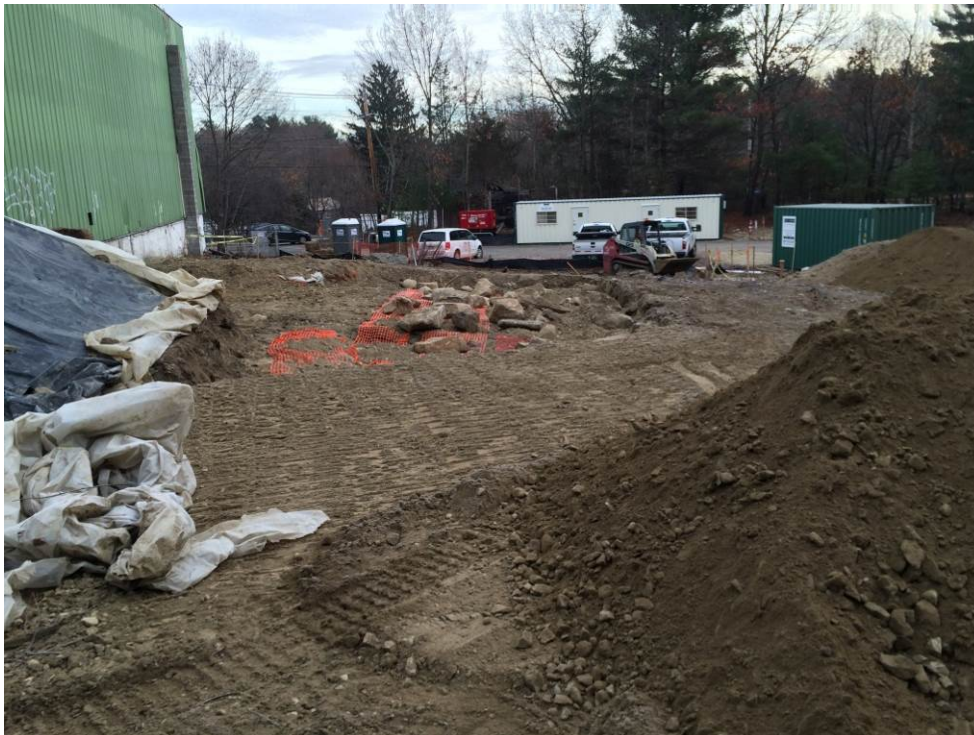
SCENE: View of the excavated area south of the manufacturing building during backfilling, showing high-visibility fencing installed as a marker at the bottom of the excavation, and large rocks returned to the excavation as part of backfilling, with piles of clean backfill to the right. Photograph taken facing northeast.

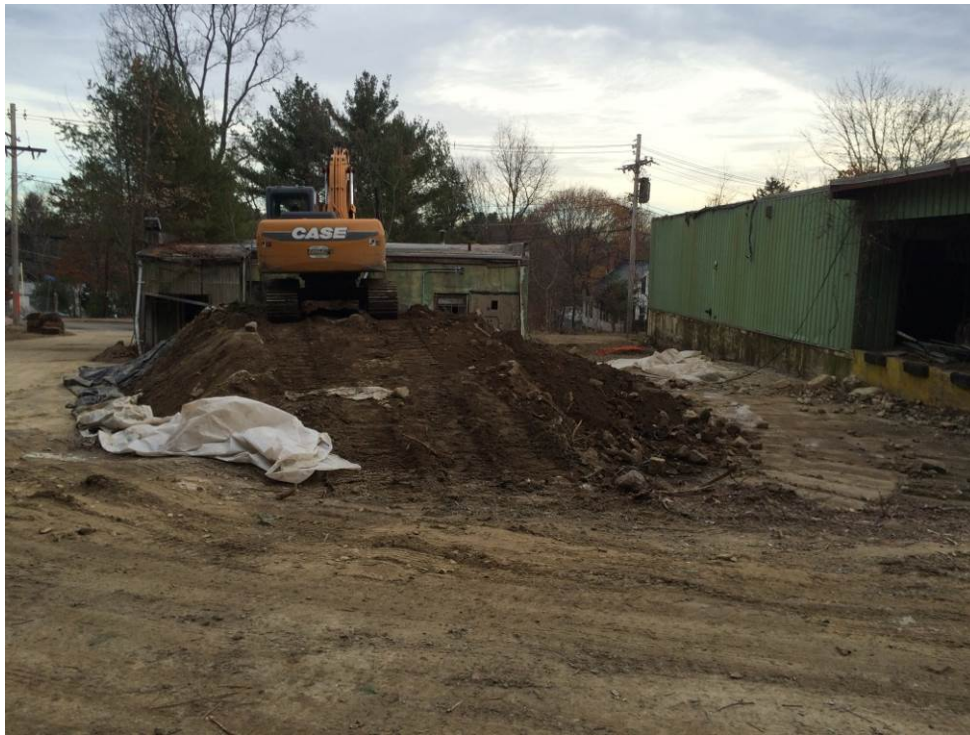
SCENE: View of the second contaminated soil stockpile south of the office building during load-out. Photograph taken facing northeast.

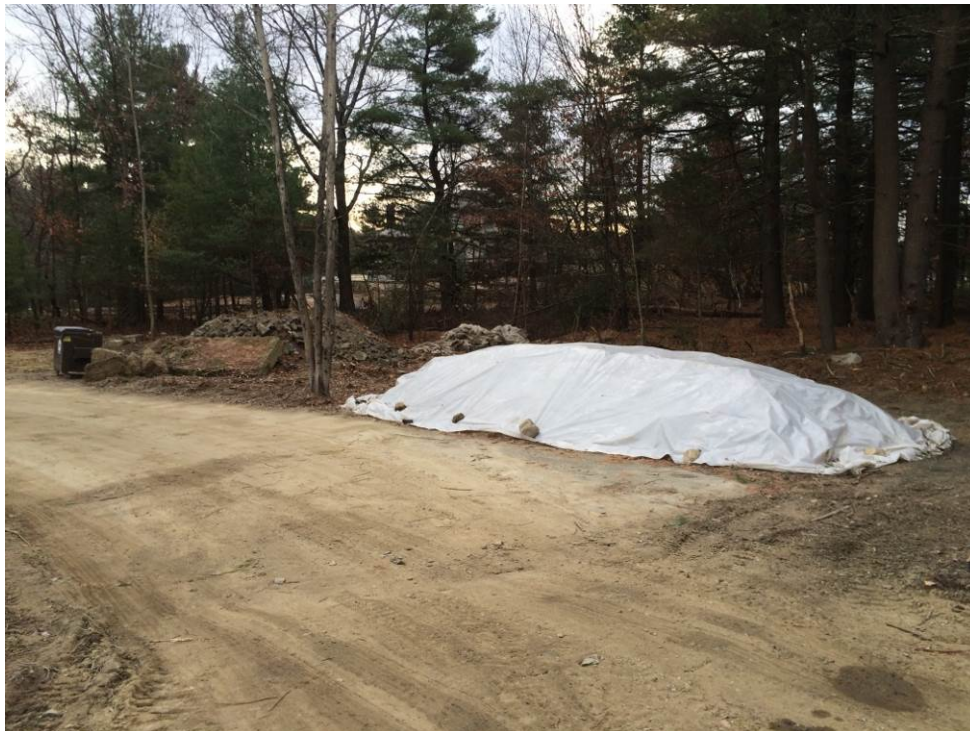
SCENE: View of the covered RCRA drum carcass pile prior to load-out. Photograph taken facing southeast.

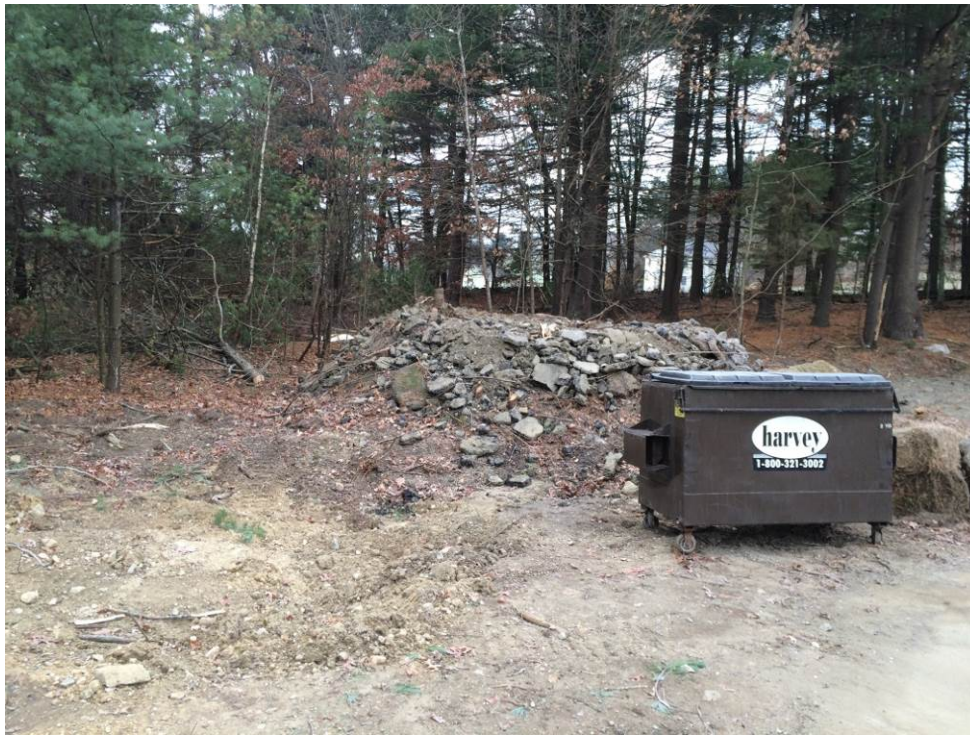
SCENE: View of the former location of non-hazardous drum carcass pile to the left following load-out, and the pre-existing pile of soil mixed with asphalt in center. Photograph taken facing south.

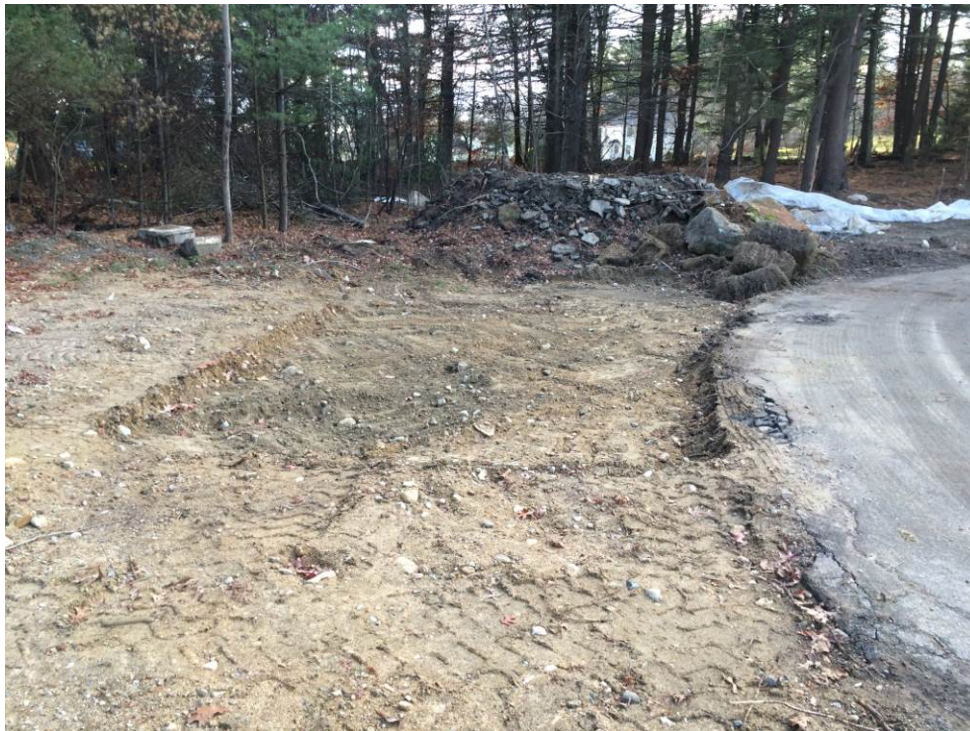
SCENE: View of the former location of non-hazardous drum carcass pile after load-out and 6-inch excavation. Photograph taken facing south.

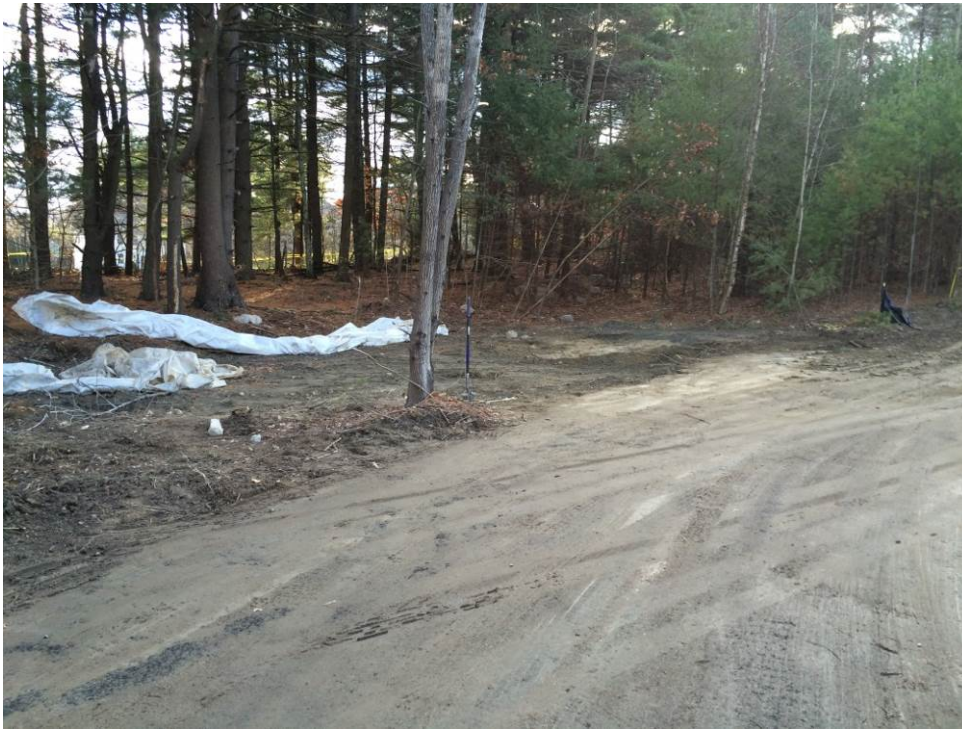
SCENE: View of the former location of RCRA drum carcass pile following load-out. Photograph taken south.

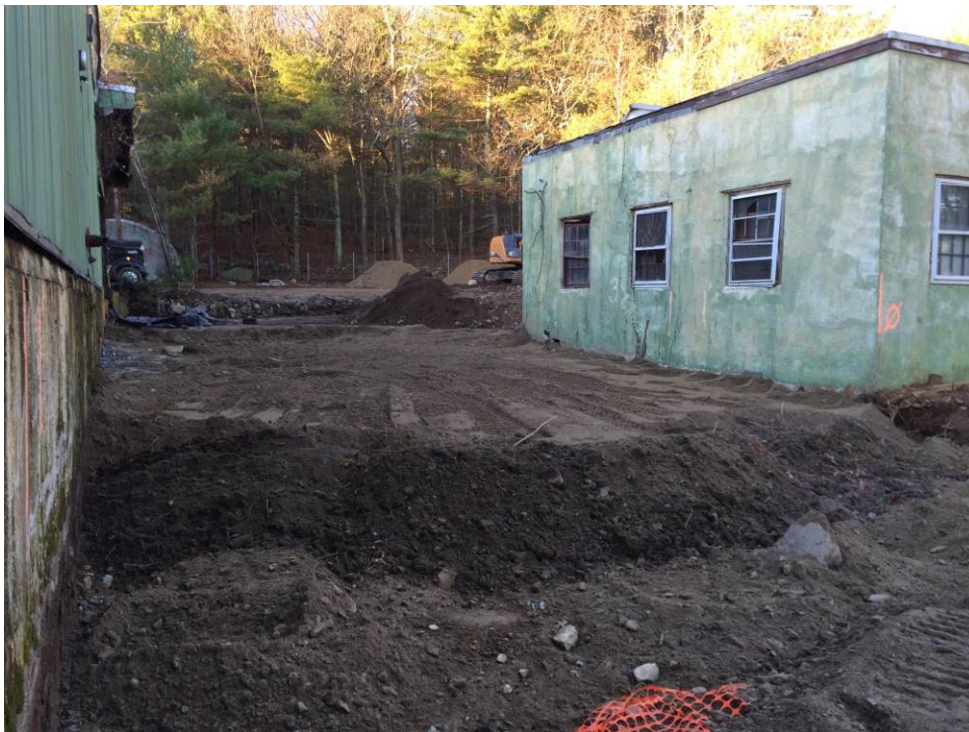
SCENE: View of the area between manufacturing and office buildings during backfilling. Photograph taken facing southwest.

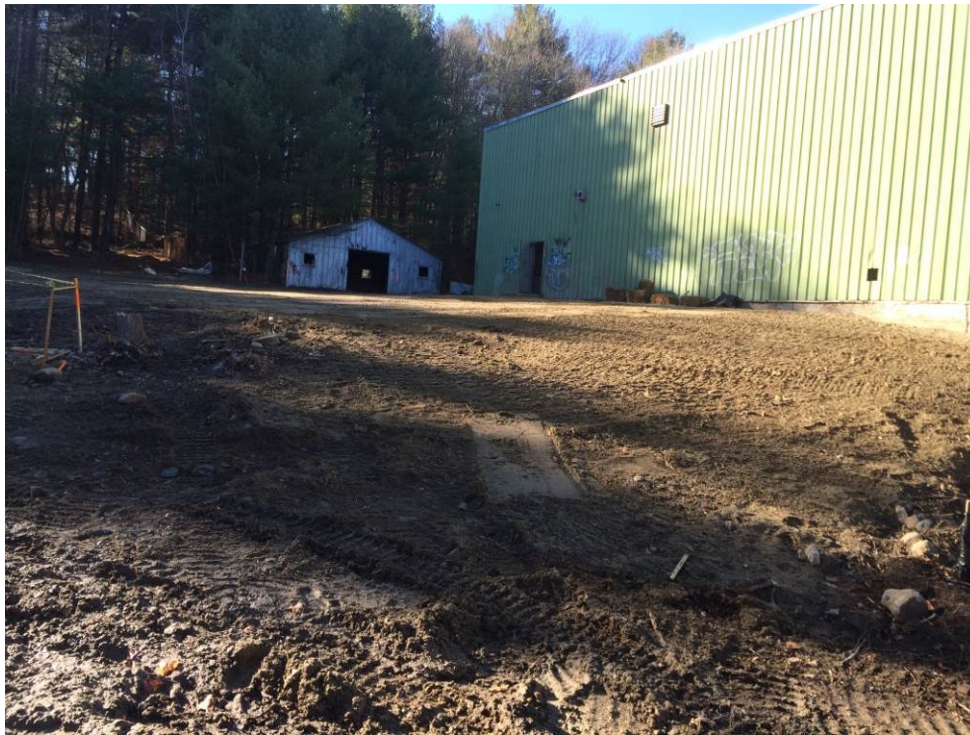
SCENE: View of the area south of manufacturing building following backfilling. Photograph taken facing west.

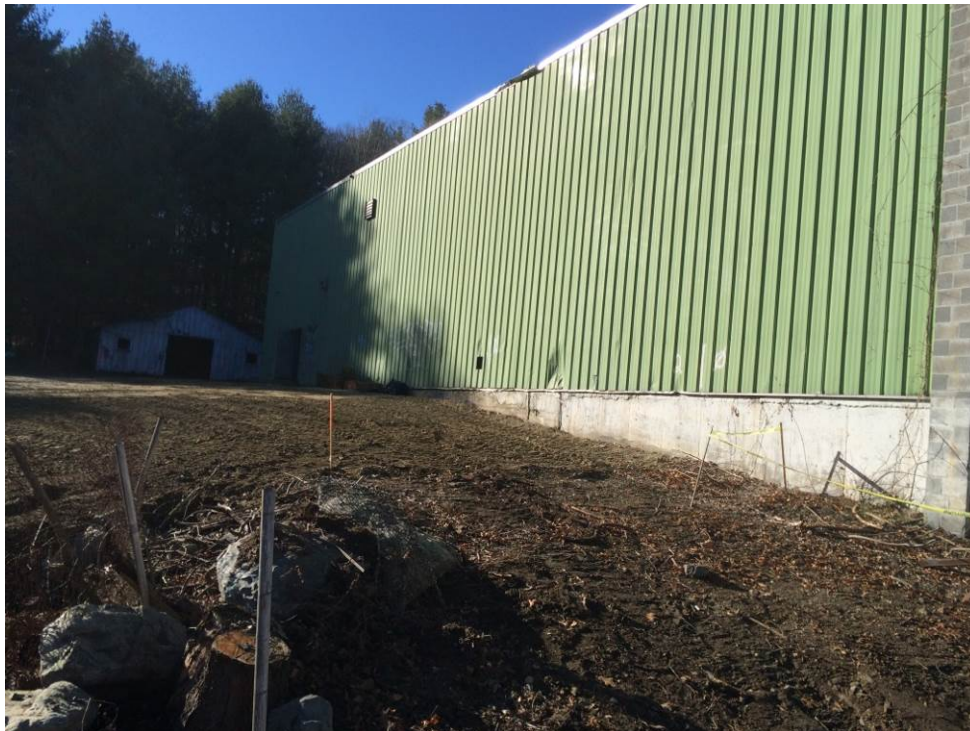
SCENE: View of the area south of manufacturing building following backfilling. Photograph taken facing west.

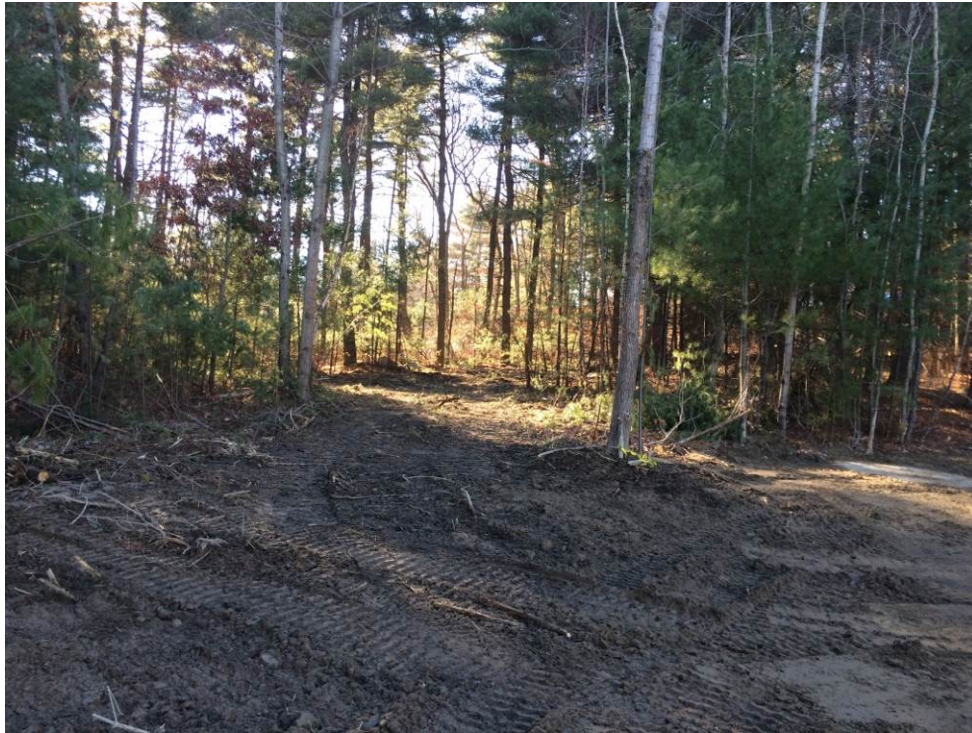
SCENE: View of final site conditions toward southern end of site, after completion of felled tree removal. Photograph taken facing southwest.

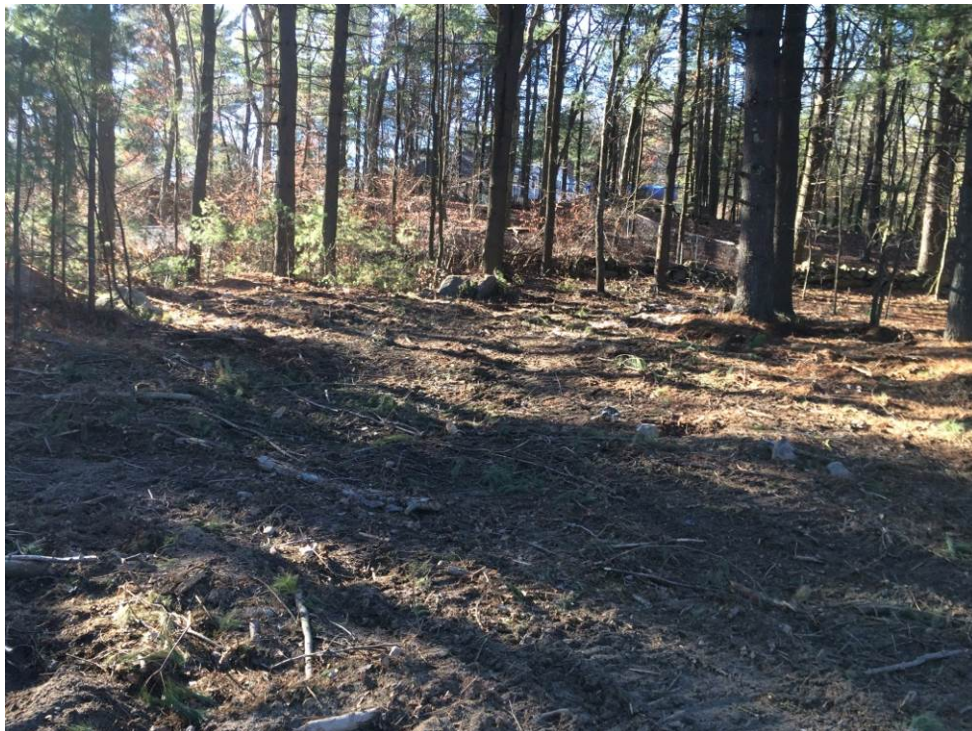
SCENE: View of final site conditions toward southwestern end of site, after completion of felled tree removal. Photograph taken facing southwest.

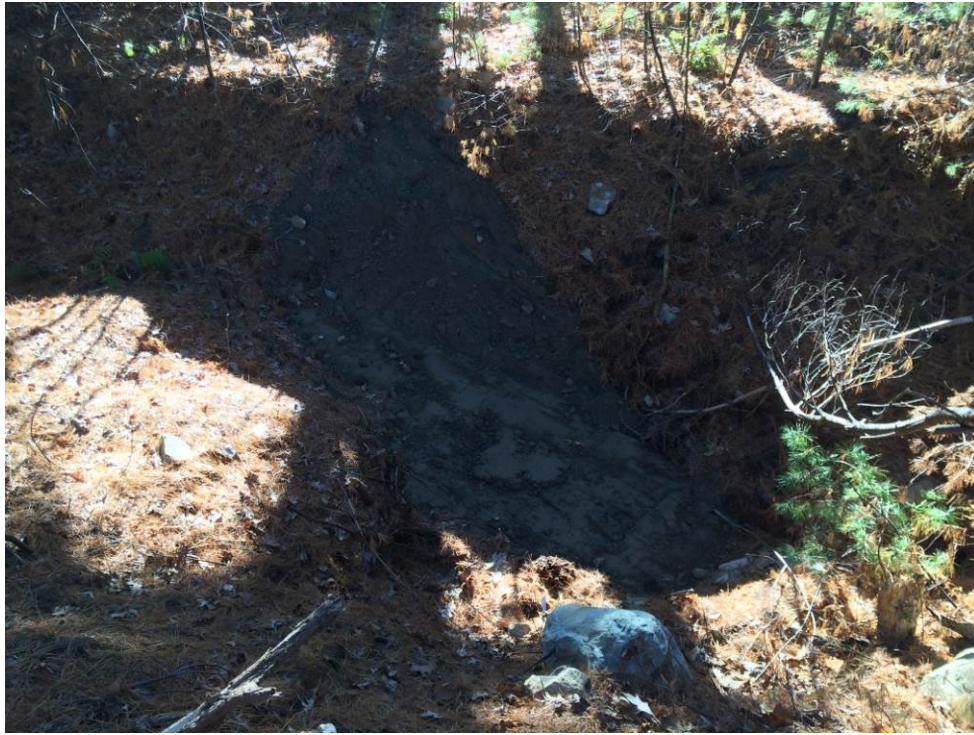
SCENE: View of final site conditions in the excavated depression in the woods following backfilling. Photograph taken facing south.

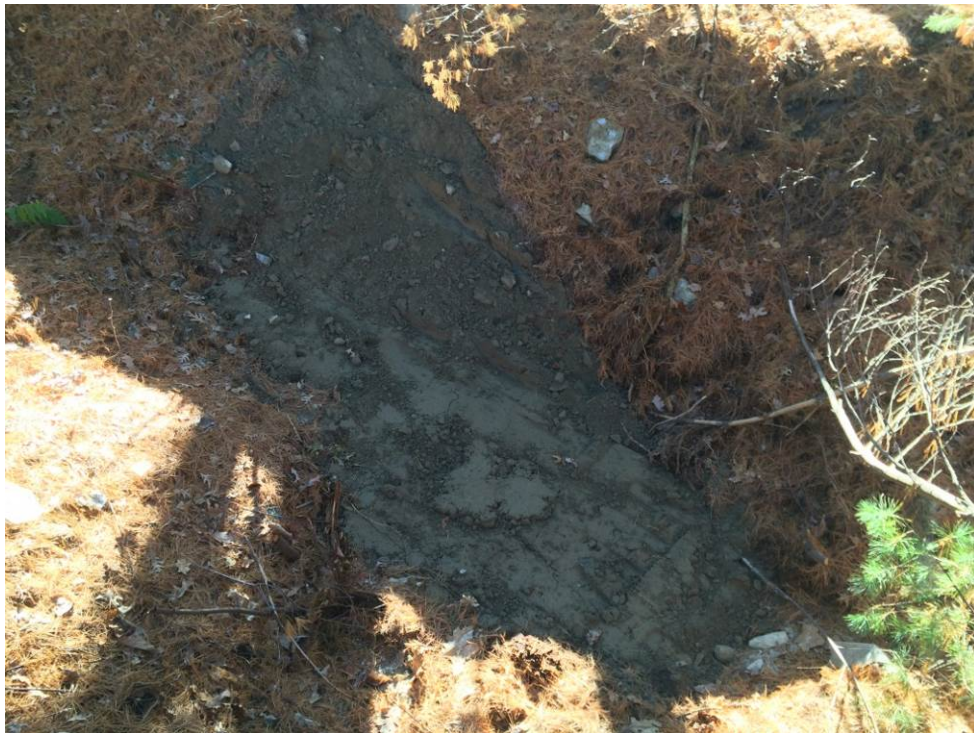
SCENE: View of final site conditions in the excavated depression in the woods following backfilling.

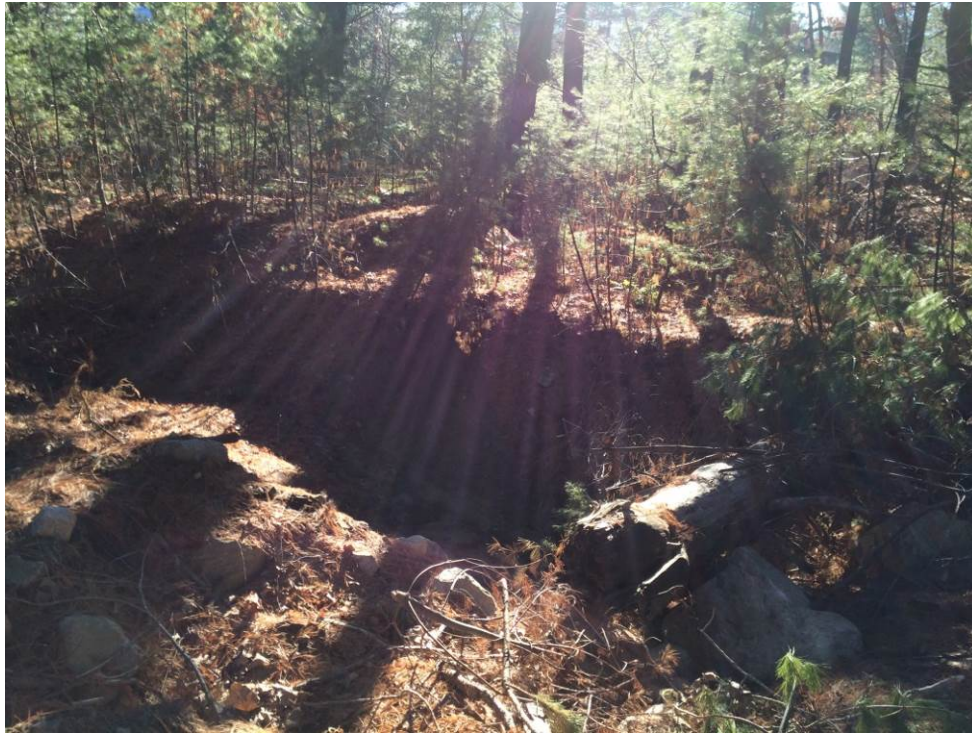
SCENE: View of final site conditions in the excavated depression in the woods following backfilling. Photograph taken facing south.

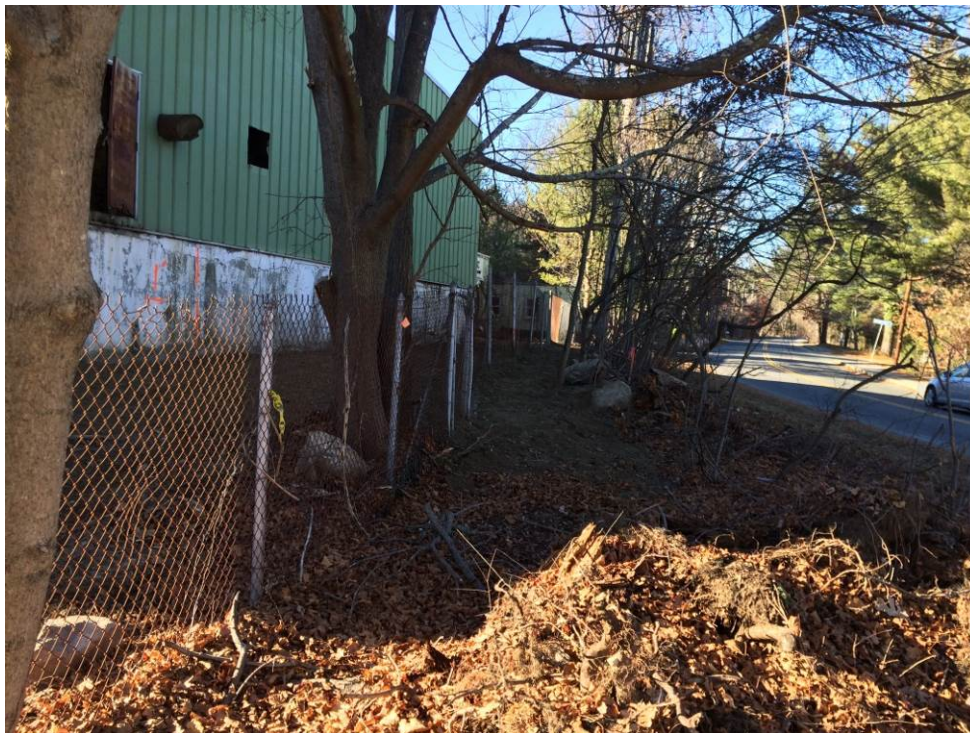
SCENE: View of final site conditions north of the manufacturing building, showing restored chain-link fence. Photograph taken facing northwest.

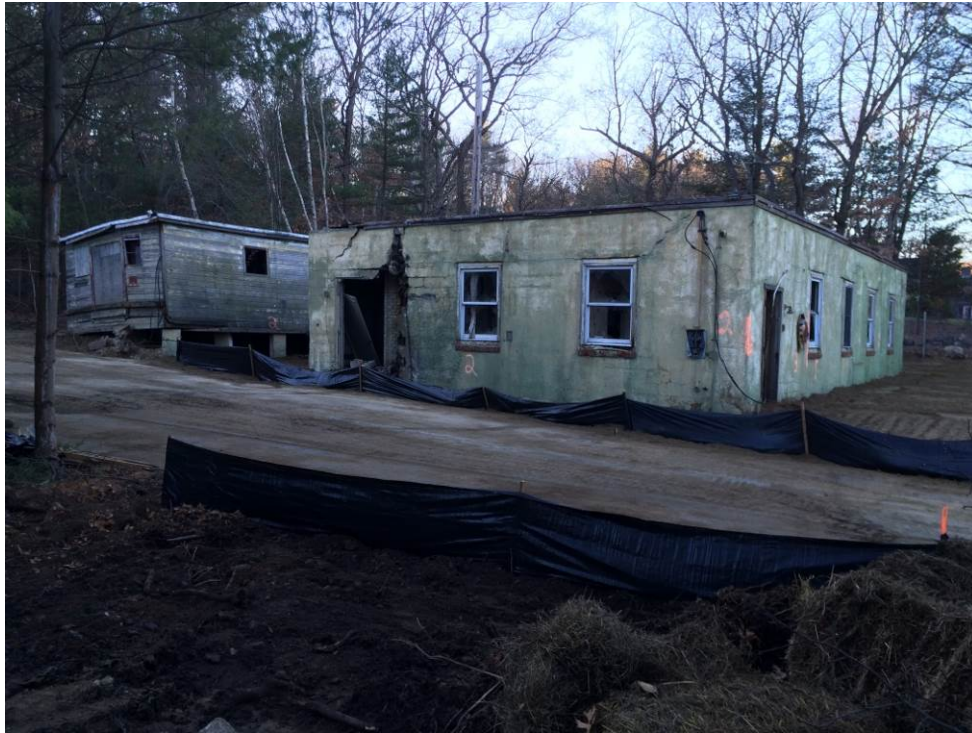
SCENE: View of final site conditions around the northern end of the lab building, showing silt fence and paved road leading to secondary gate and Eliot Street. Photograph taken facing west.

Grass seed was spread over backfilled excavated areas. Hay bales used to weigh down plastic covering soil stockpiles during the cleanup were broken up and spread over grass seed in the area southeast of the manufacturing building. Silt fence installed at the bottom of the slope in this area was left in place to prevent soil from eroding onto the paved site road, and then onto Eliot Street. For the same reason, additional silt fence was installed at other locations to prevent backfilled soil from washing off site during a heavy rain.

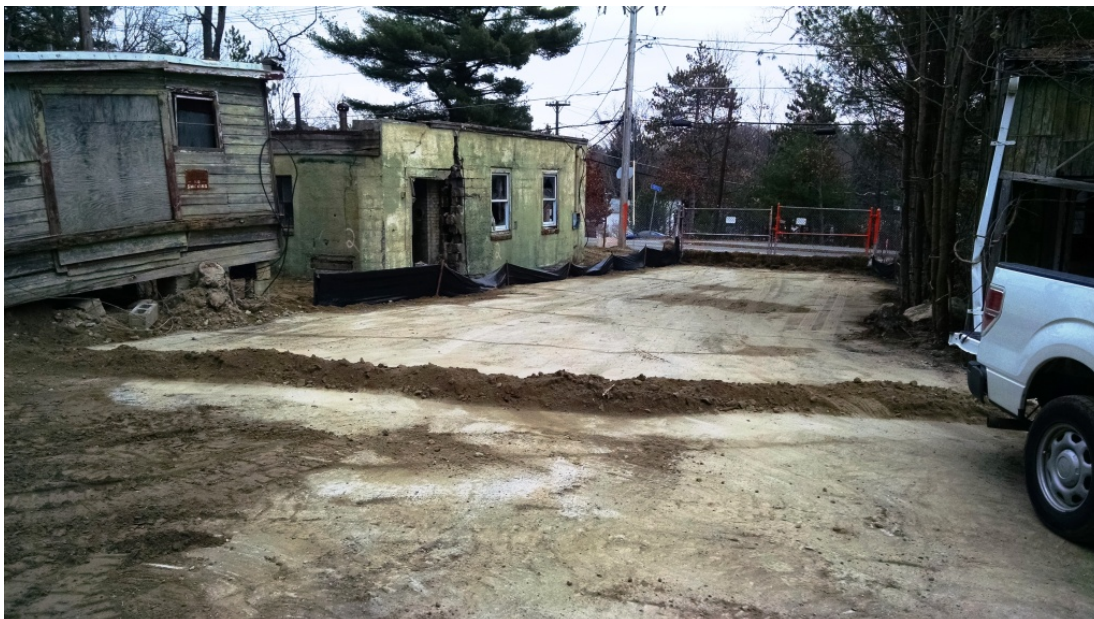
SCENE: View of final site conditions at the lab building and the road leading to Eliot Street, following backfilling activities. Silt fence, earthen berm, and hay bales put in place to minimize backfill migrating onto Eliot Street. Photograph taken facing northeast.

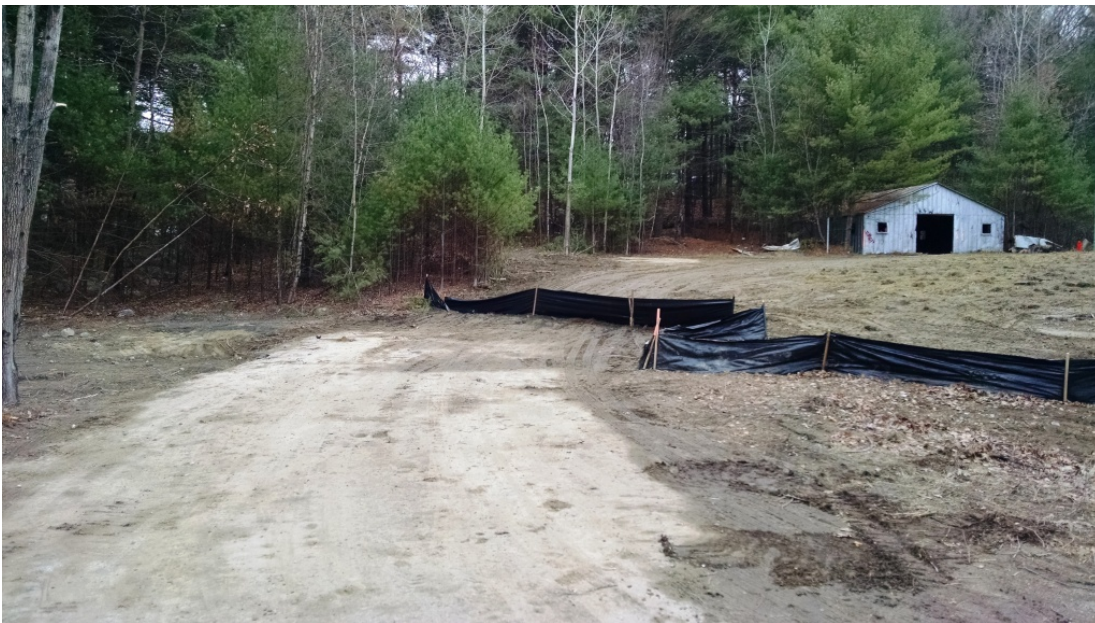
SCENE: View of final site conditions south of the manufacturing building, with hay spread over backfill and silt fence established for erosion control on the right, and the former drum carcass area to the left. Photograph taken facing northwest.
